Service Campaign S3036

Mack LRBE Cooling Box Refit

Years	Models
2022-2023	LRBE

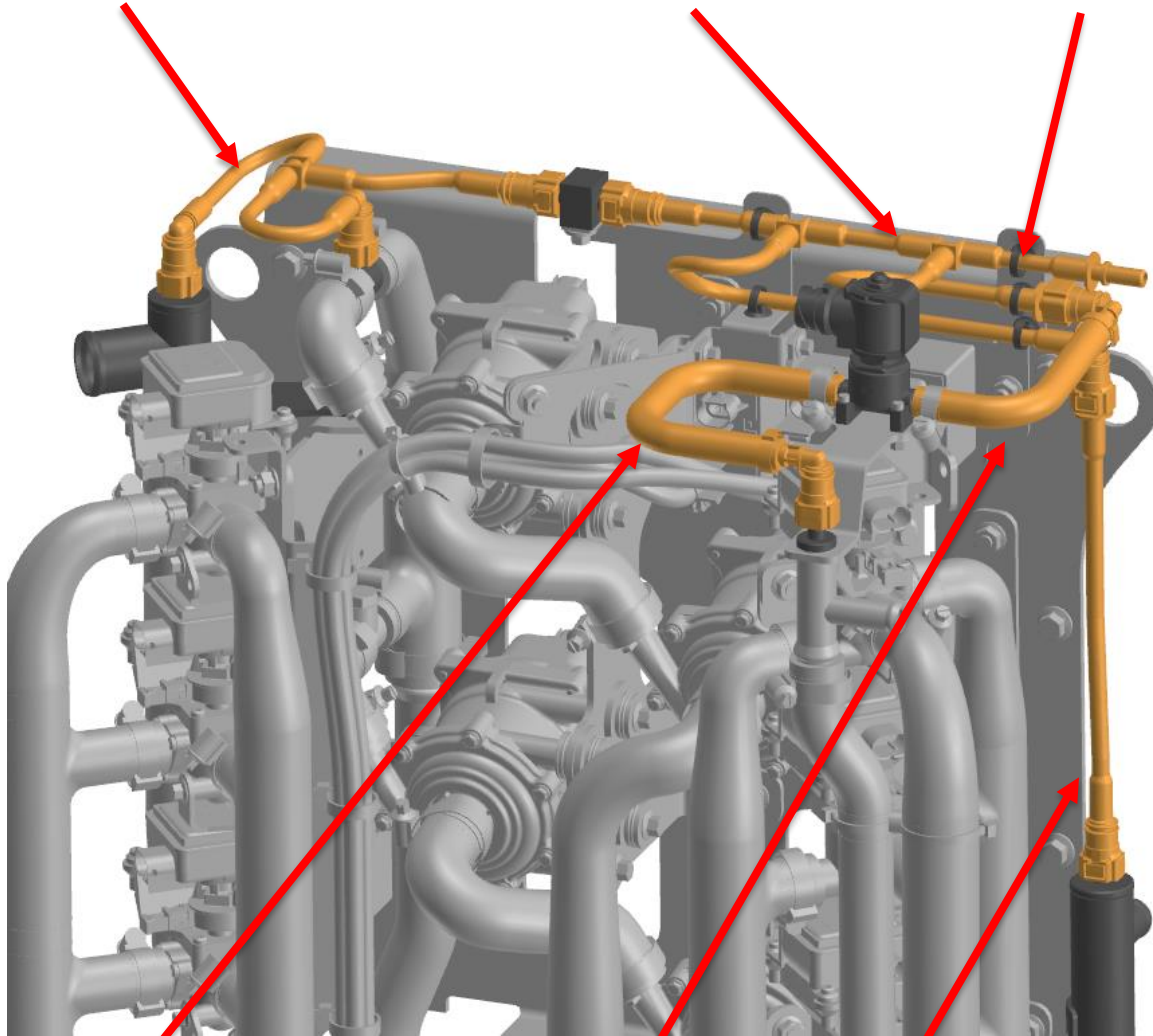
28. Install the hoses.

Part # 24150179

Part # 24143306

Part 980881 x 5

Part # 24134179

Part # 24143293

Part # 24134183

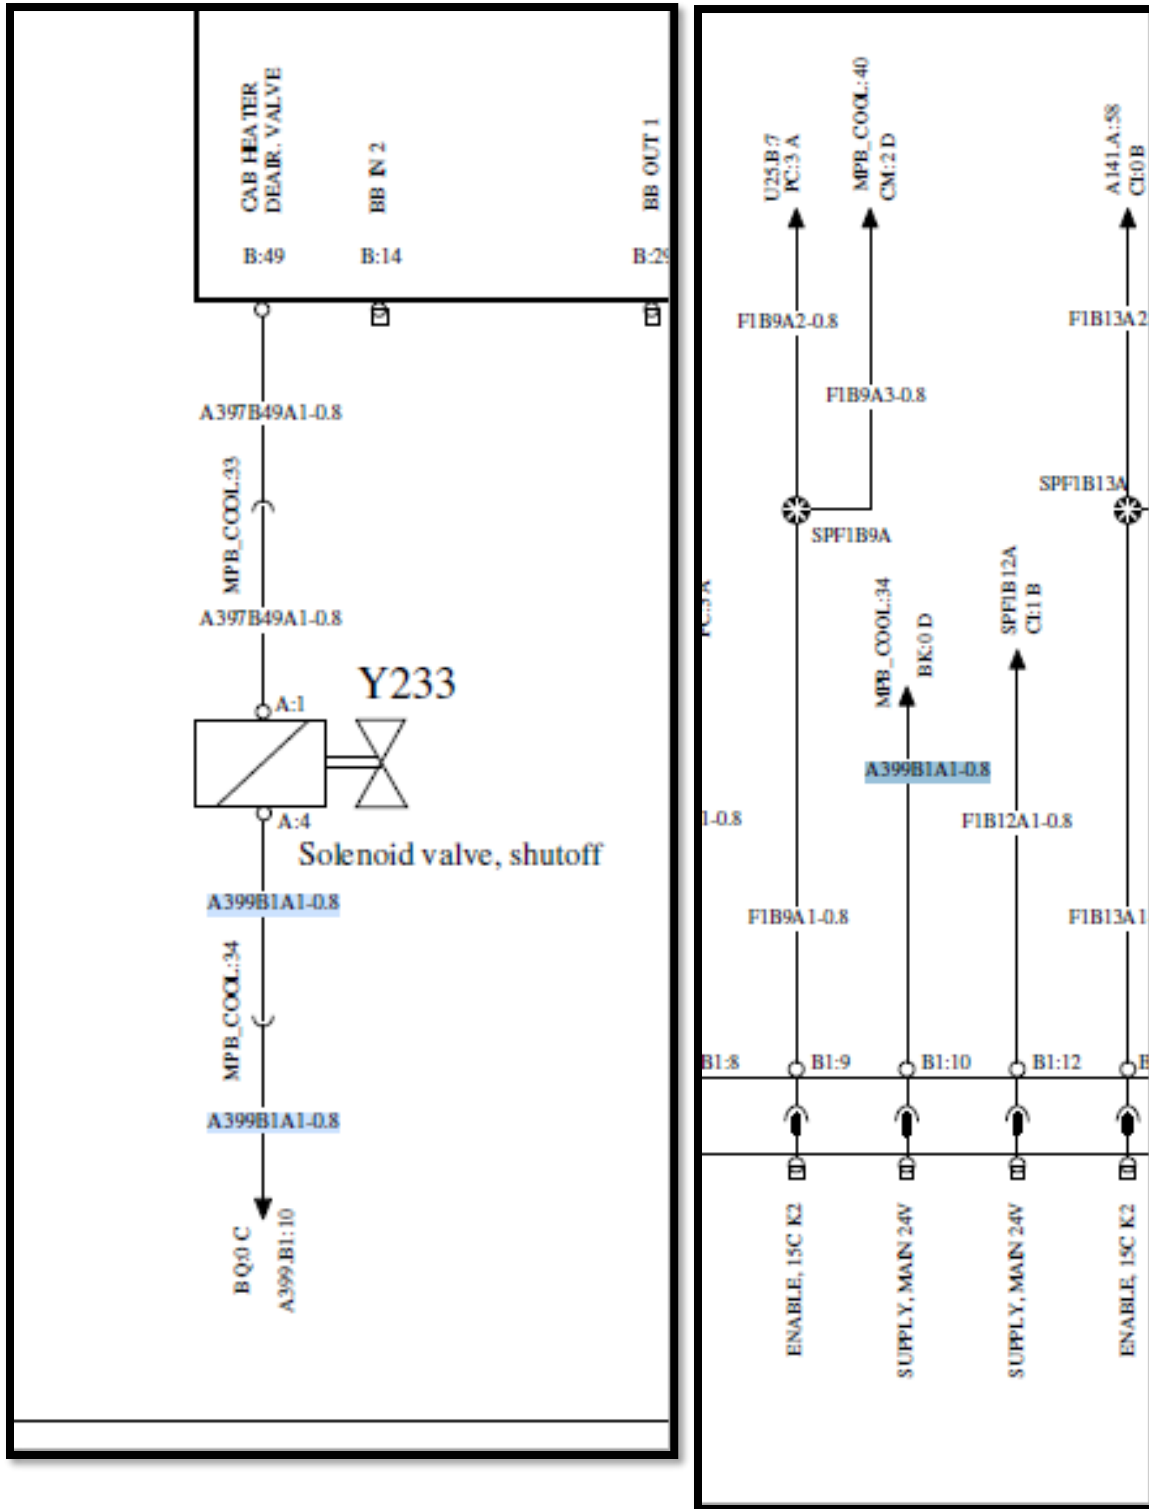
The overlay harness and new cooling box harness is adding the circuit highlighted below.
