Countries: CANADA, UNITED STATES Document ID: IK0700121
Availability: ISIS, FleetISIS, Body Builder, NotSIR Revision: 0
Major System: EXHAUST Created: 4/13/2023
Current Language: English Last Modified: 6/23/2023
Other Languages: NONE Author: Jeff Polich
Viewed: 47

Title: CV Manual Regen Message Displayed on Drivers Information Center for Emergency Vehicles
Applies To: CV Emergency Vehicles

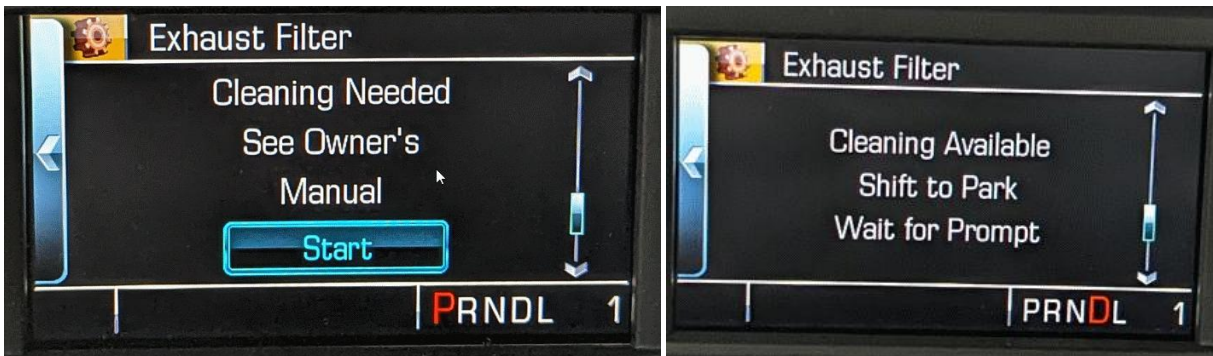
Example of Premium Cluster Messages:

Message will be displayed in the Driver Information Center (Cluster) without any active or pending fault codes in the engine ECM.

Messages on the Drivers Display Center:

Refer to the operator's manual (4328504R6) page 202 for instructions to perform a manual regen page.
