Preliminary Information

PIC6462A Mode Control Cable Kinks - Mode Control Inoperative C60

Brand:	Model:	Model Years:	VIN:		Engine:	Transmissions:
			from	to		
Chevrolet	Spark	2016 - 2022	All	All	All	All

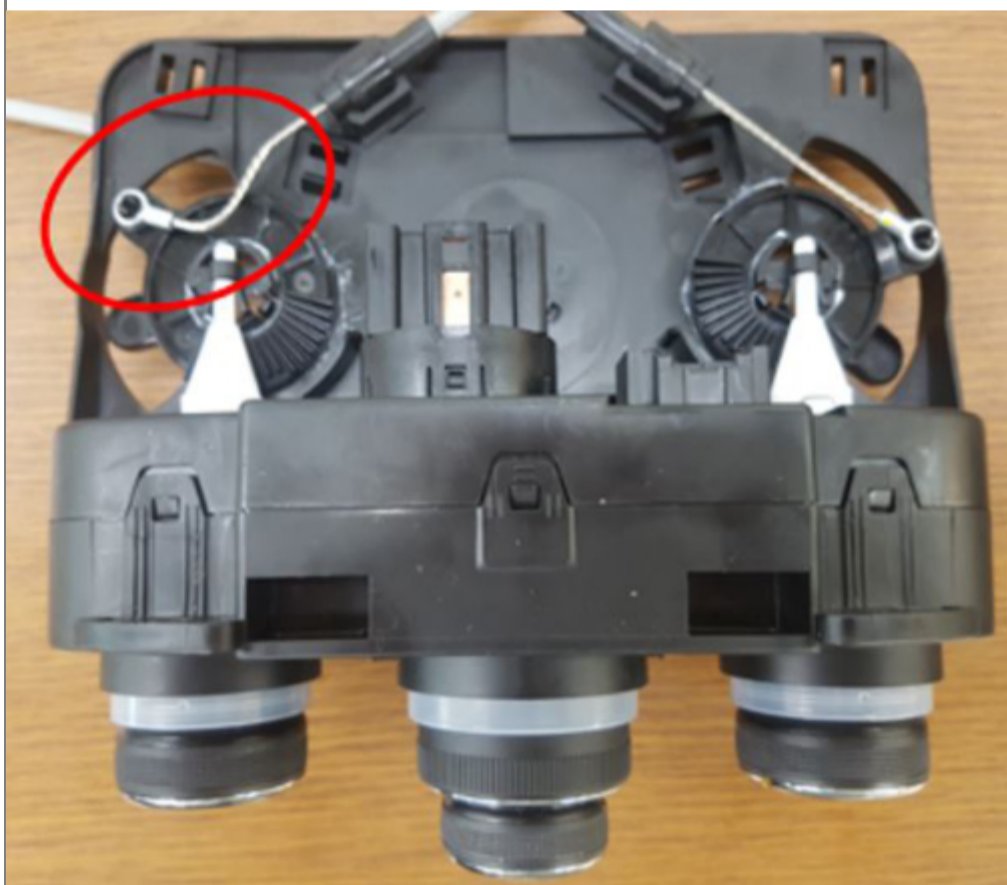
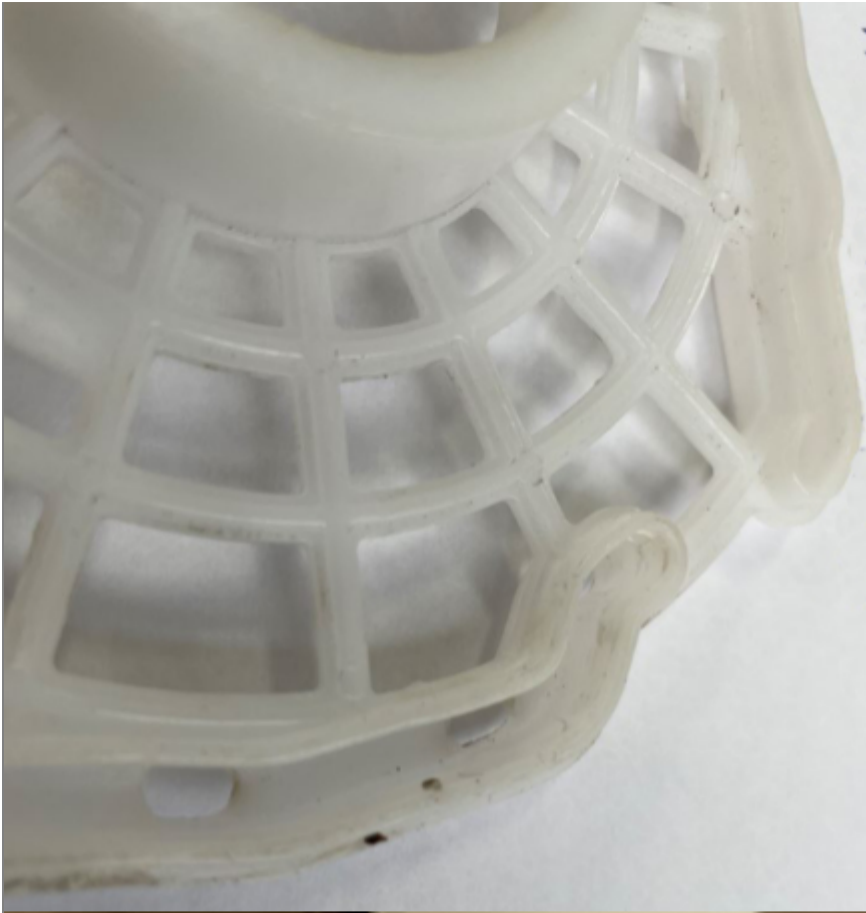
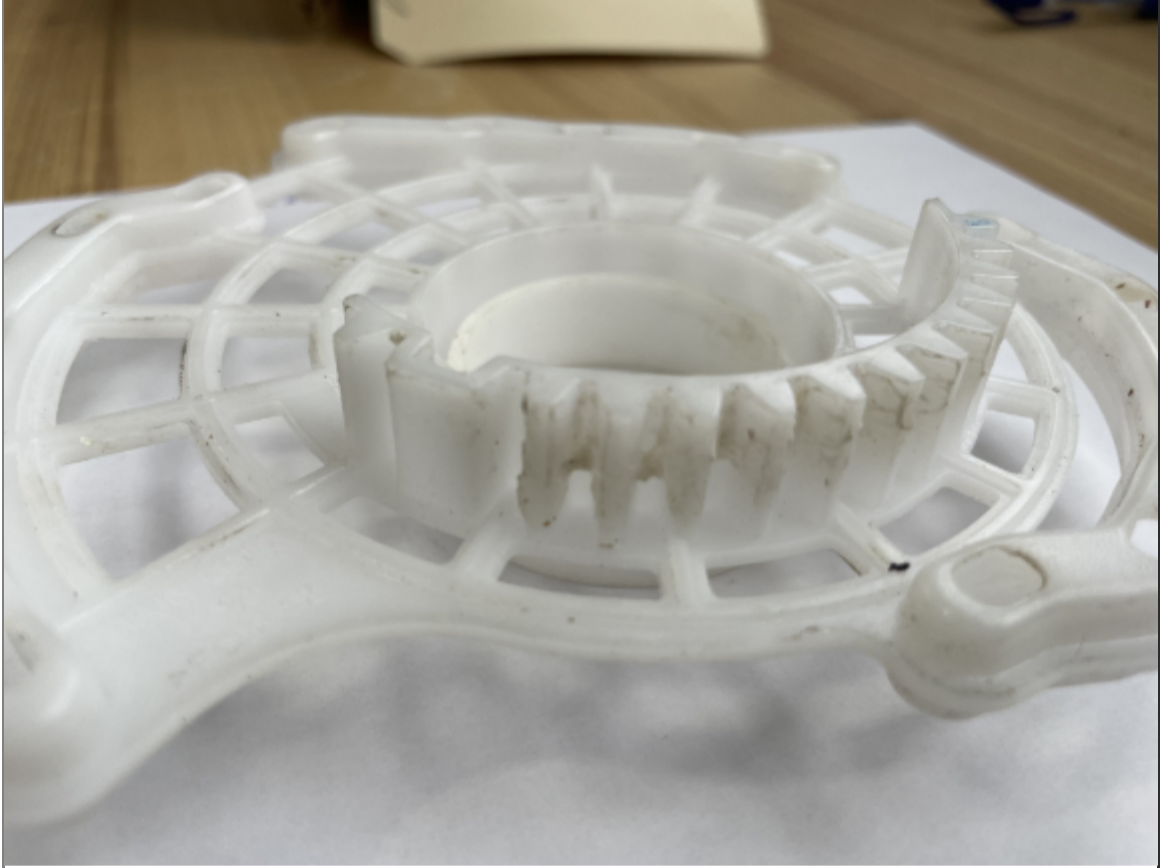
Condition
Some customer may comment that they are not able to change the HVAC modes or there is no air flow from the defroster vents.
Upon inspection, the tech may find that the mode control cable is bent.

Cause This condition may be due to a combination of increased resistance from debris in the mode valve link assembly and high air flow (fan speeds above the setting of 3) against mode doors from the blower motor.

If the above conditions are found, the tech will need to inspect the mode valve link assembly for debris or damage.

If debris is found, clean the link assembly and re-install or replace as needed.

Then, replace the mode control cable.
