# TECHNICAL SERVICE BULLETIN

Technical Service Bulletin: 73-1650

# TECHNICAL SERVICE BULLETIN 73-1650 REMEDY INSTRUCTIONS

Concern:  
THE MANUFACTURING PLANT MAY NOT  
HAVE INSTALLED THE DAMPER  
EXHAUST DOOR ON THE OVER THE  
RANGE MICROWAVE.

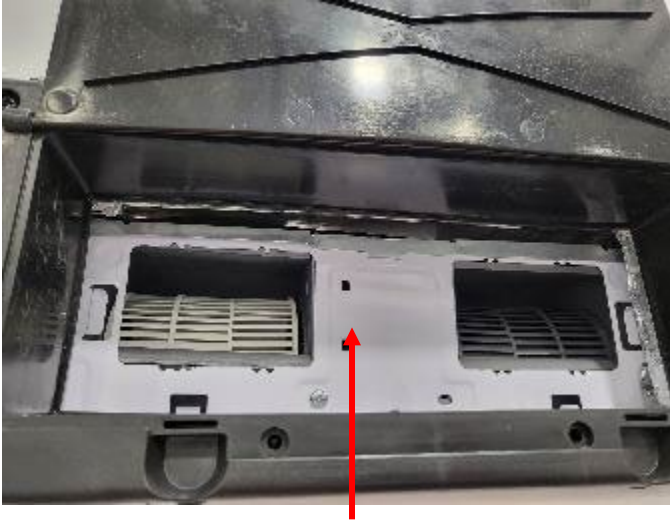
FIGURE 1

STEP 3: USE A FLASH LIGHT TO INSPECT FOR DAMPER (FIGURE 1);

- IF DAMPER IS PRESENT, CLAIM INSPECTION CODE ONLY.
- IF DAMPER IS NOT PRESENT (FIGURE 1), ORDER DAMPER FROM PARTS/SERVICE AND INSTALL TO OVER THE RANGE MICROWAVE.

NO DAMPER PRESET UNDER EXTERIOR VENT

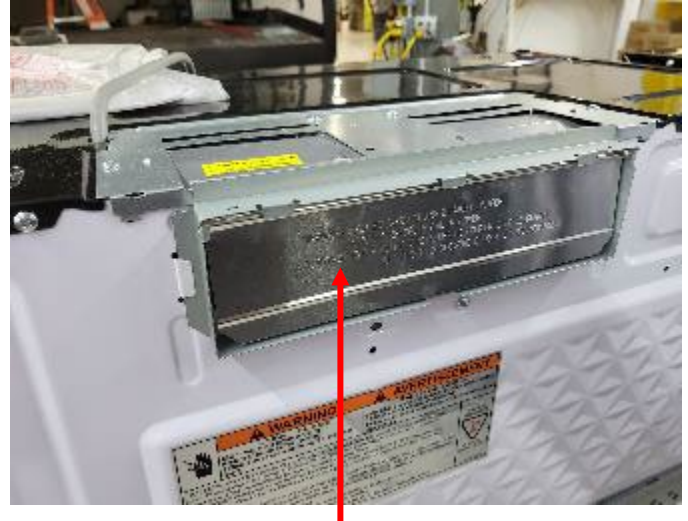
FIGURE 2

INSTALL DAMPER TO BACK OF THE MICROWAVE CHASSIS

STEP 10: SLIDE DAMPER ASSEMBLY DOOR DOWN, ENSURE IT IS RETAINED BY THE TABS PRESENT ON THE MICROWAVE CHASSIS (FIGURE 2);

STEP 11: SECURE DAMPER IN PLACE AND ENSURE THE DAMPER DOOR "FLAPS OUTWARD" FROM THE MICROWAVE";
