MAS003636 RU 23-25

# Rapid Update 636 Maserati Grecale – ICS Blistering

DATE: JUNE 13 2023

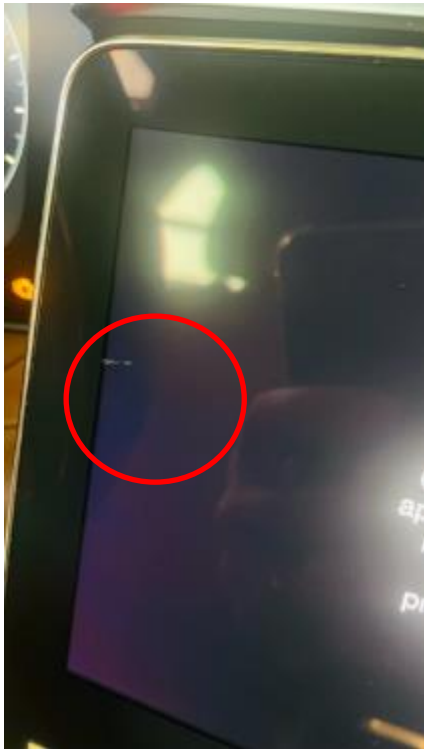
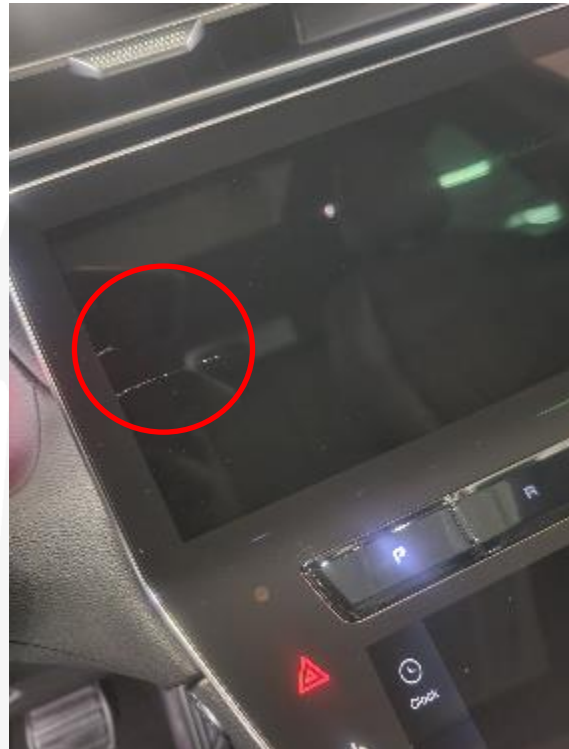
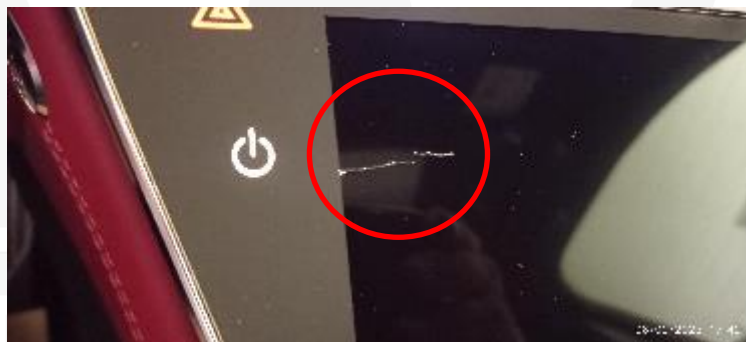
This action involves the replacement of the ICS module because due to a problem in the supplier's production process, bubbles may appear on the screen on some cars which could disturb the use of the touch screen. It is a purely aesthetic defect that does not affect the functionality of the component in any way.

Below are example pictures that show bubbling of the screen. Although the issue may not be present earlier in the vehicle's life, the anomaly can occur later. For this reason, the ICS must be replaced..

1. Always check ModisCS+ to see if the vehicle is involved in this action and if it has not been previously performed.
2. Disconnect the 12V battery by following the procedure in the workshop manual:
  - a. **08.20.001 - BATTERY - Connection-disconnection of power supply**
3. Replace the display following the procedure in the workshop manual:
  - a. **8.71.240 DISPLAY - E208 Integrated central dashboard (ICS) Removal-Refitting or Replacement**
4. Reassemble all removed parts in reverse order following the workshop manual procedures.
5. Carry out all functional test.
6. Procedure complete.
