RCA-38-23-002-2: Install Halfshaft Washers

Rivian is initiating a customer satisfaction campaign for some model year 2022 R1T and R1S vehicles that may have been built with excessive clearance space between the halfshafts and wheel hubs. In some instances, this may result in a brief noise coming from the front and/or rear of the vehicle when accelerating or decelerating that is noticeable to the customer but would not result in any changes in the performance of the vehicle. Rivian will install washers on both the front and rear halfshafts to remove the excess clearance and eliminate the noise. Rivian is launching this campaign for customer satisfaction and to ensure the quality of Rivian vehicles.

Document Type	Customer Satisfaction Campaign Bulletin
Date	July 19, 2023
Affected Region(s)	USA
Affected Model(s)	R1T, R1S
Model Year(s)	2022
Approximate Build Dates	May 2022 - November 2022

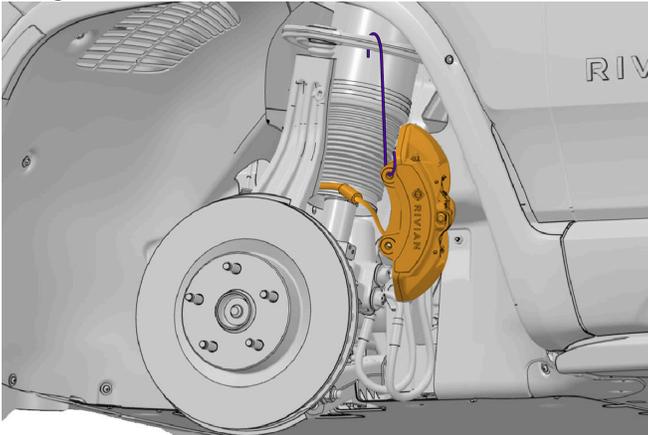
8. Using the S-hook:

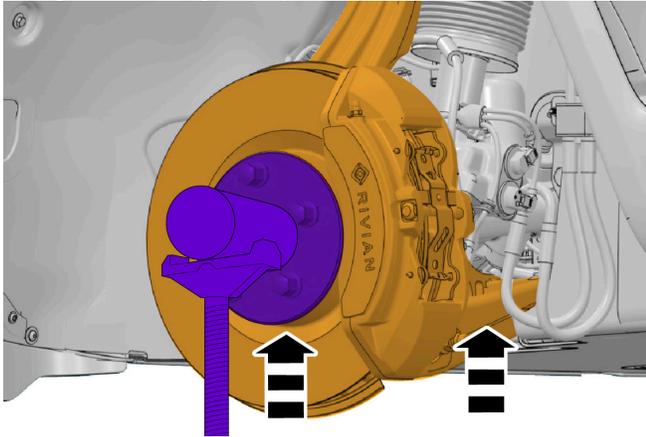
b. Using the ride height torque tool:

**Note:** Refer to the special tool instructions for important information.

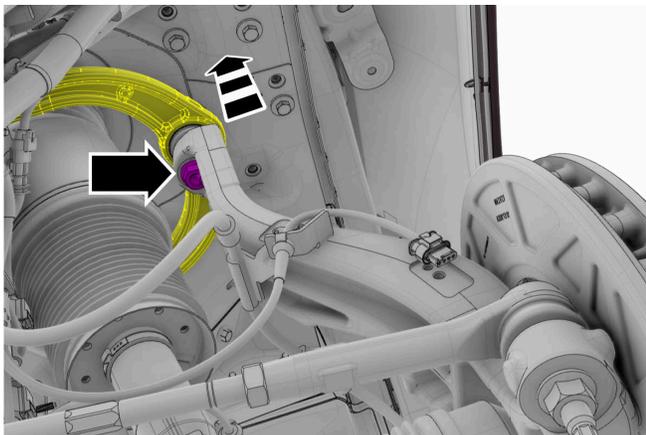
c. Using the ball joint separator: Separate the components.

**CAUTION:** Potentially non-reusable component(s).

Step Number	Torque (Nm)
7	217
9	18
10	128
11.d	120

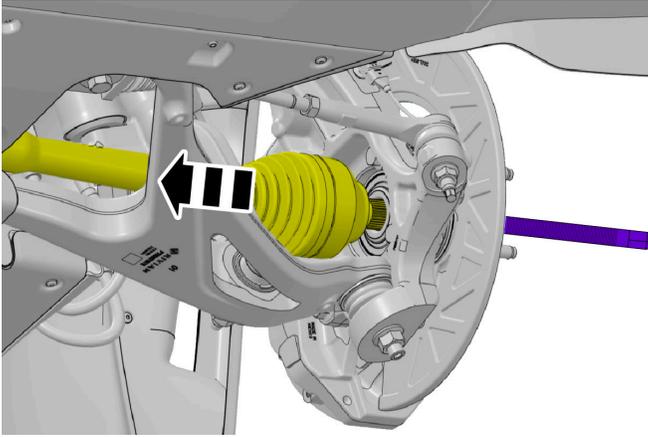
12. Using the special tool:

Refer to the special tool instructions for important information.

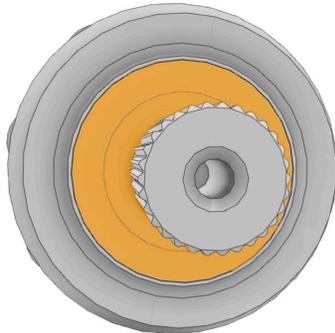
14. Using a nylon mesh scuff pad: Clean the highlighted area(s).

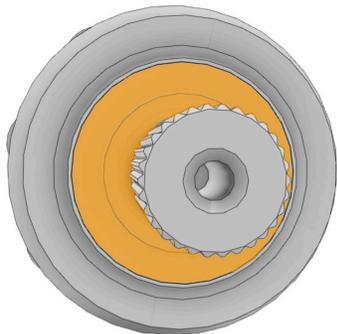
15. Apply grease to the highlighted area(s).

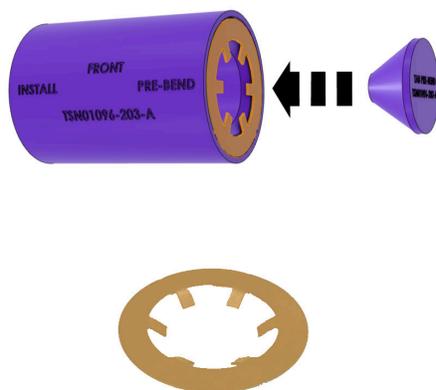
16. Position the washer in the "PRE-BEND" side of the front washer sleeve.

17. Push the pre-bend tool into the sleeve to bend the washer tabs. Continue pressing until the tabs do not bend any further.

**Tip:** If necessary: Use a vise or C-clamp to apply pressure to the pre-bend tool.

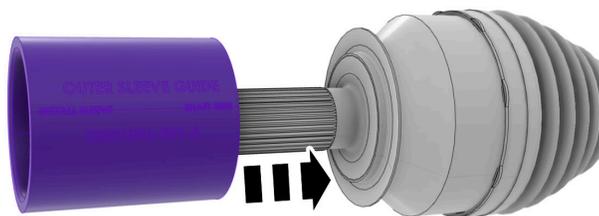
18. Position the outer sleeve onto the halfshaft. Make sure that the side of the sleeve labeled "SHAFT SIDE" points toward the vehicle.

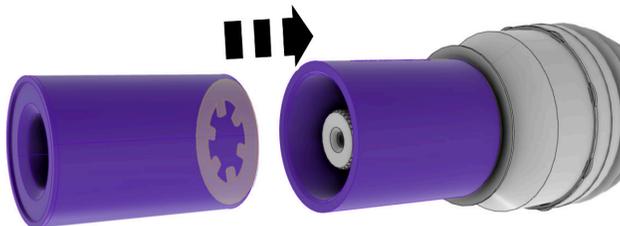
19. Position the washer in the "INSTALL" side of the front washer sleeve. Make sure that the bent tabs point toward the inside of the tool.

20. Install the front washer sleeve into the outer sleeve. Make sure that the side of the tool labeled "INSTALL" points toward the vehicle.

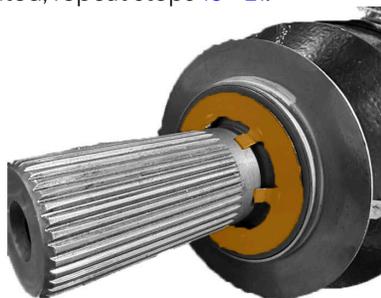
21. Push on the front washer sleeve to fully seat the washer onto the halfshaft. If necessary: Use a mallet.
 22. Remove the special tools. Make sure that the washer is fully seated onto the halfshaft. If the washer is not fully seated, repeat steps [18 - 21](#).

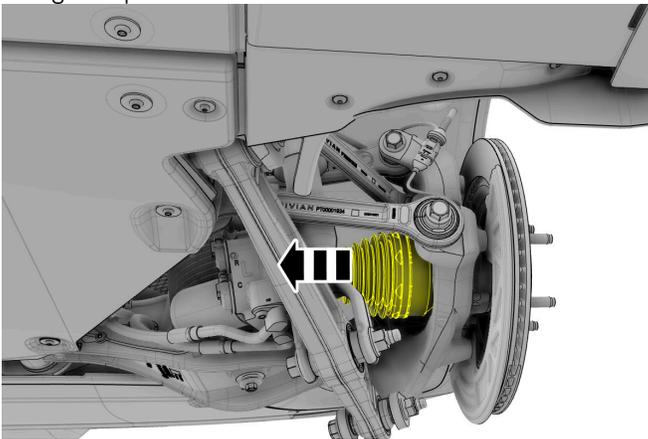
3. Using the special tool:

Note: Refer to the special tool instructions for important information.

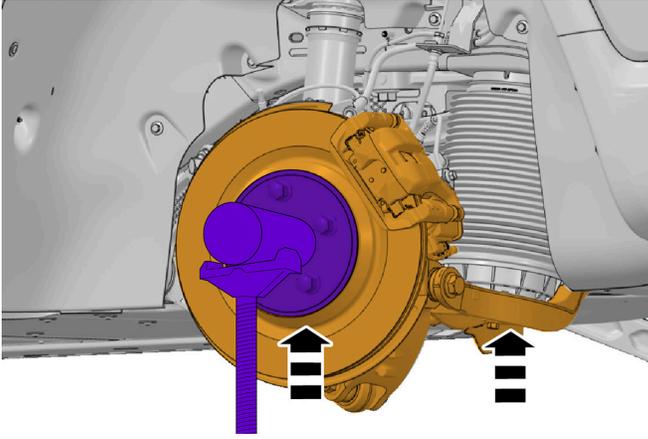
4. Using the ride height torque tool:

Note: Refer to the [special tool instructions](#) for important information.

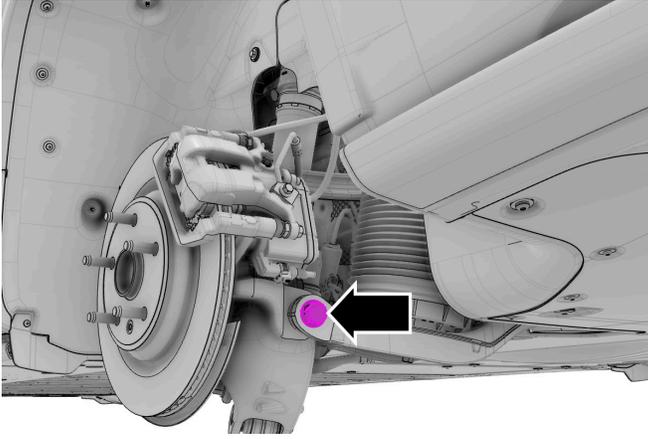
7. Support the component.

Step Number	Torque (Nm)
2	128
5	175
6	175
7	270
