GLOBAL SAFETY FIELD INVESTIGATIONS
DCS6649
URGENT - DISTRIBUTE IMMEDIATELY

Subject: N232409550 - Customer Satisfaction Program
Incorrect Refrigerant Label

Models: 2023 Cadillac LYRIQ

N232409550 Incorrect Refrigerant Label

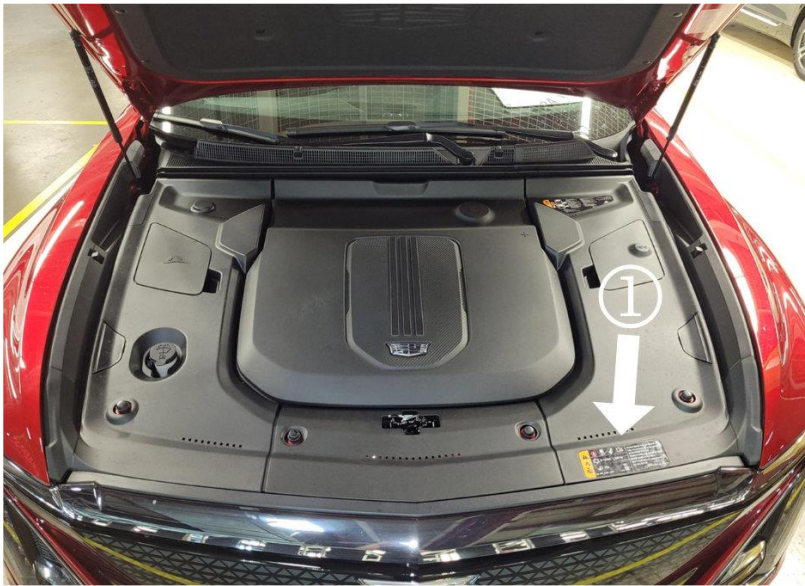
6399000

1. Open the Hood.

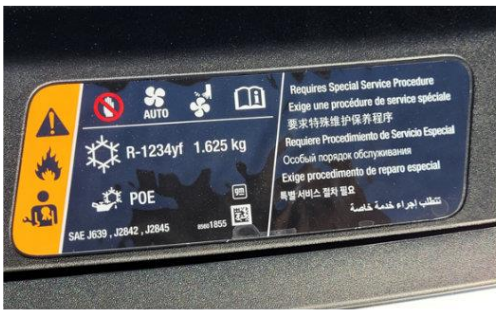
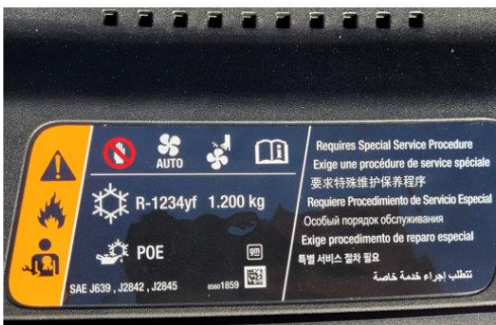
6408868

2. Locate the Refrigerant Label (1) under the hood.

Note: The old incorrect label (1) is for 1.625 kg, the **NEW CORRECT** label (2) is for 1.200 kg.

Note: Receiving surface **MUST** be clean, dry, and free of any contaminants.

3. Remove the OLD Refrigerant Label (1) and any residue using a non-oil based cleaner, preferably isopropyl alcohol (rubbing alcohol), Kent Acrysol, P/N 20005, or equivalent cleaning solvent and dry with clean, lint free cloth.

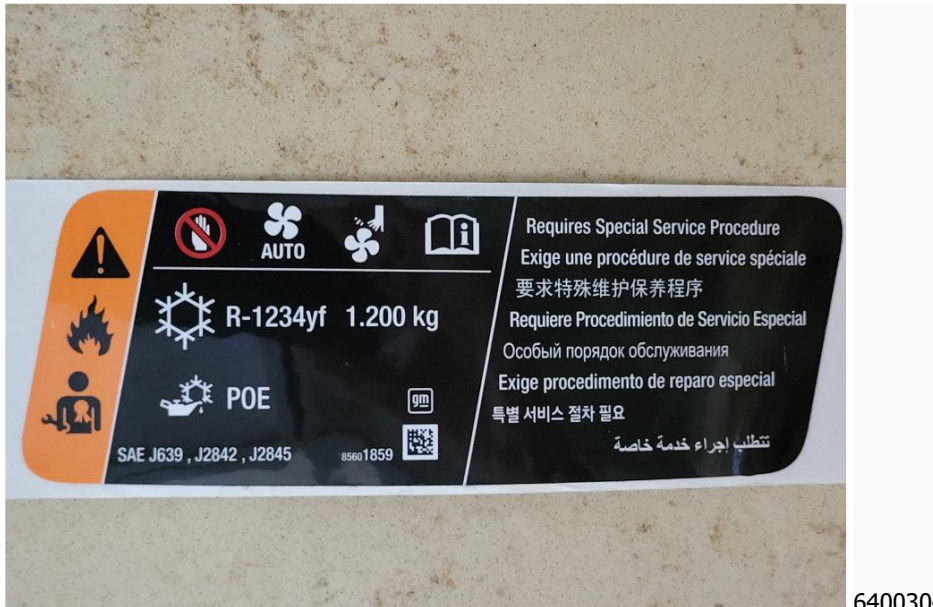
4. Firmly hold the NEW label, shown above, and peel protective liner from the back side, being careful not to touch or contaminate the adhesive with dirt or foreign matter.
5. Carefully align new label to the surface. Press firmly and smooth out entire label ensuring corners are fully adhered.
