Volvo Car USA LLC

Technical Journal

Technical Journal Title iCUP, "Searching for GPS" message in DIM / CSD		Ref. No. TJ 36691.2.0	
Issuer (Dept.) Technical Service		Issue Date 7/17/23	Status Date 7/25/23
Car Market United States and Canada	Partner 3 US 7510 Volvo Car USA	Function Group 3900	
Function Description Media, navigation and communication		Page Page 1 of 3

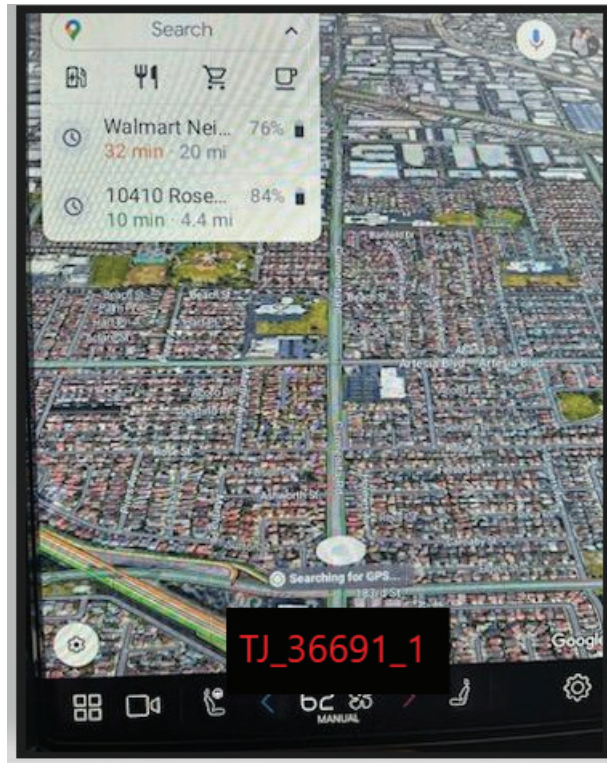
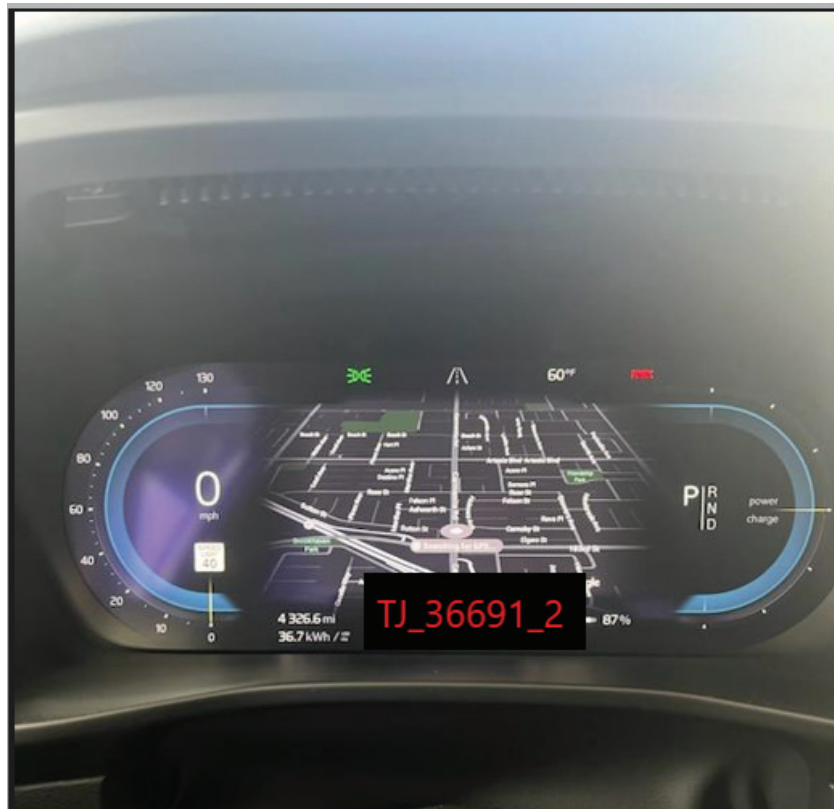
If customer sees a message "Searching for GPS" in CSD and DIM during startup while LTE connection is fully established (see attachment TJ_36691_1 & 2), then follow advice under "Service".

Do not replace any components for this issue.

A temporary fix for this symptom is mentioned in TJ 36082 (Restart IHU via home button).

The symptom is known and work is ongoing to solve it, an improved IHU software is scheduled for release in week 42 of 2023.
