**Volvo Car USA LLC****Technical Journal**

Technical Journal Title		Ref. No.	
WPC, none or unstable charging		TJ 36693.1.0	
Issuer (Dept.)		Issue Date	Status Date
Technical Service		7/18/23	7/25/23
Car Market	Partner	Function Group	
United States and Canada	3 US 7510 Volvo Car USA	3942	
Function Description		Page	
Mobile telephone		Page 1 of 3

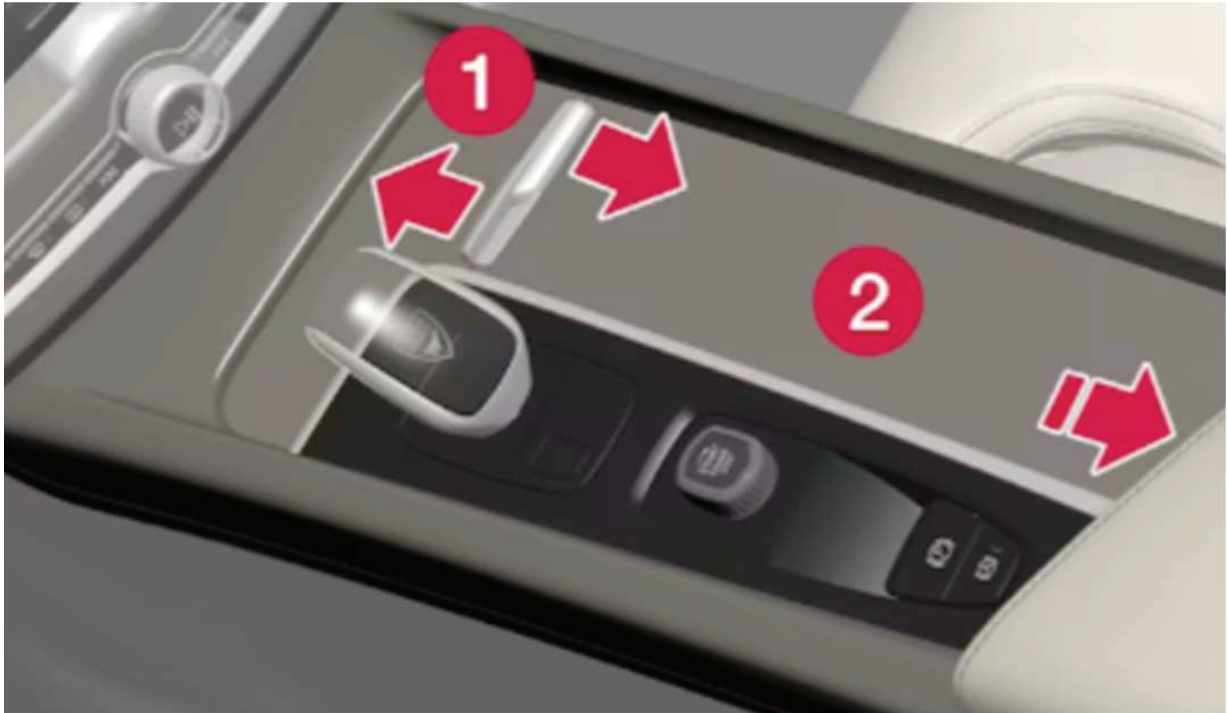
TJ 36693

When performing PDS SWDL on MY24 cars with WPC, hardware part no 32359823, it is crucial that no phone or other metallic object is placed on top of or near (up to 60mm) the WPC. Car radio must be off. For SPA cars, also open the blinds/hatches in the tunnel console (see attachment).

To solve this issue, recalibrate the WPC by performing a WPC reload. Be sure to follow above instructions.
