Leveling Valve, Leak Test

V-728-005A

Valid for

Volvo trucks built from July 6, 2015, equipped with Barksdale suspension leveling valve.

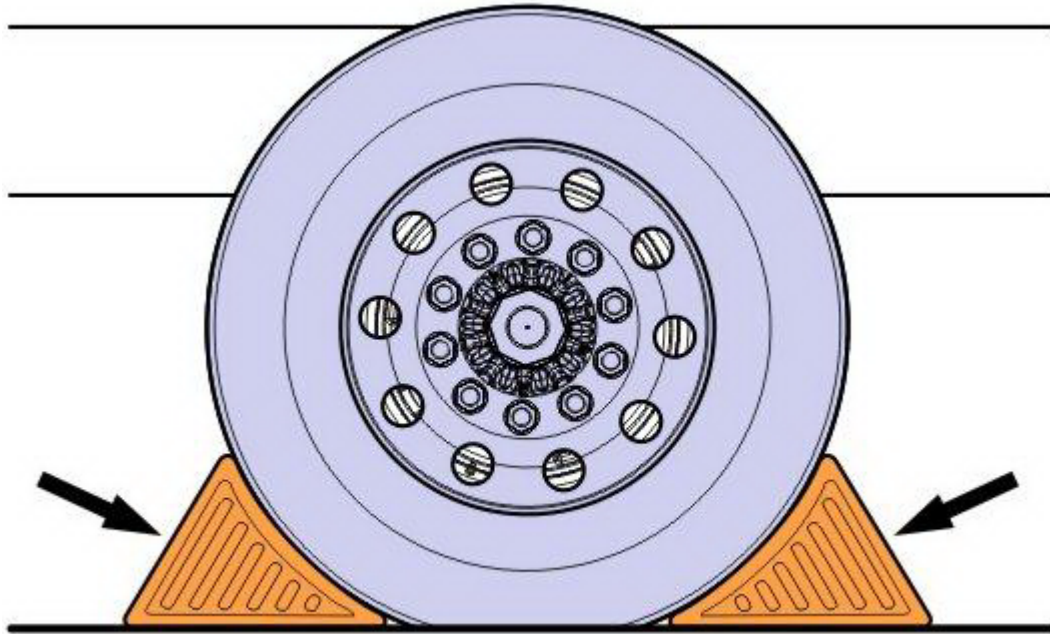
1. Park the vehicle on a flat and level surface.

2. Apply the parking brake.
3. Place the transmission in neutral or park.
4. Install the wheel chocks.

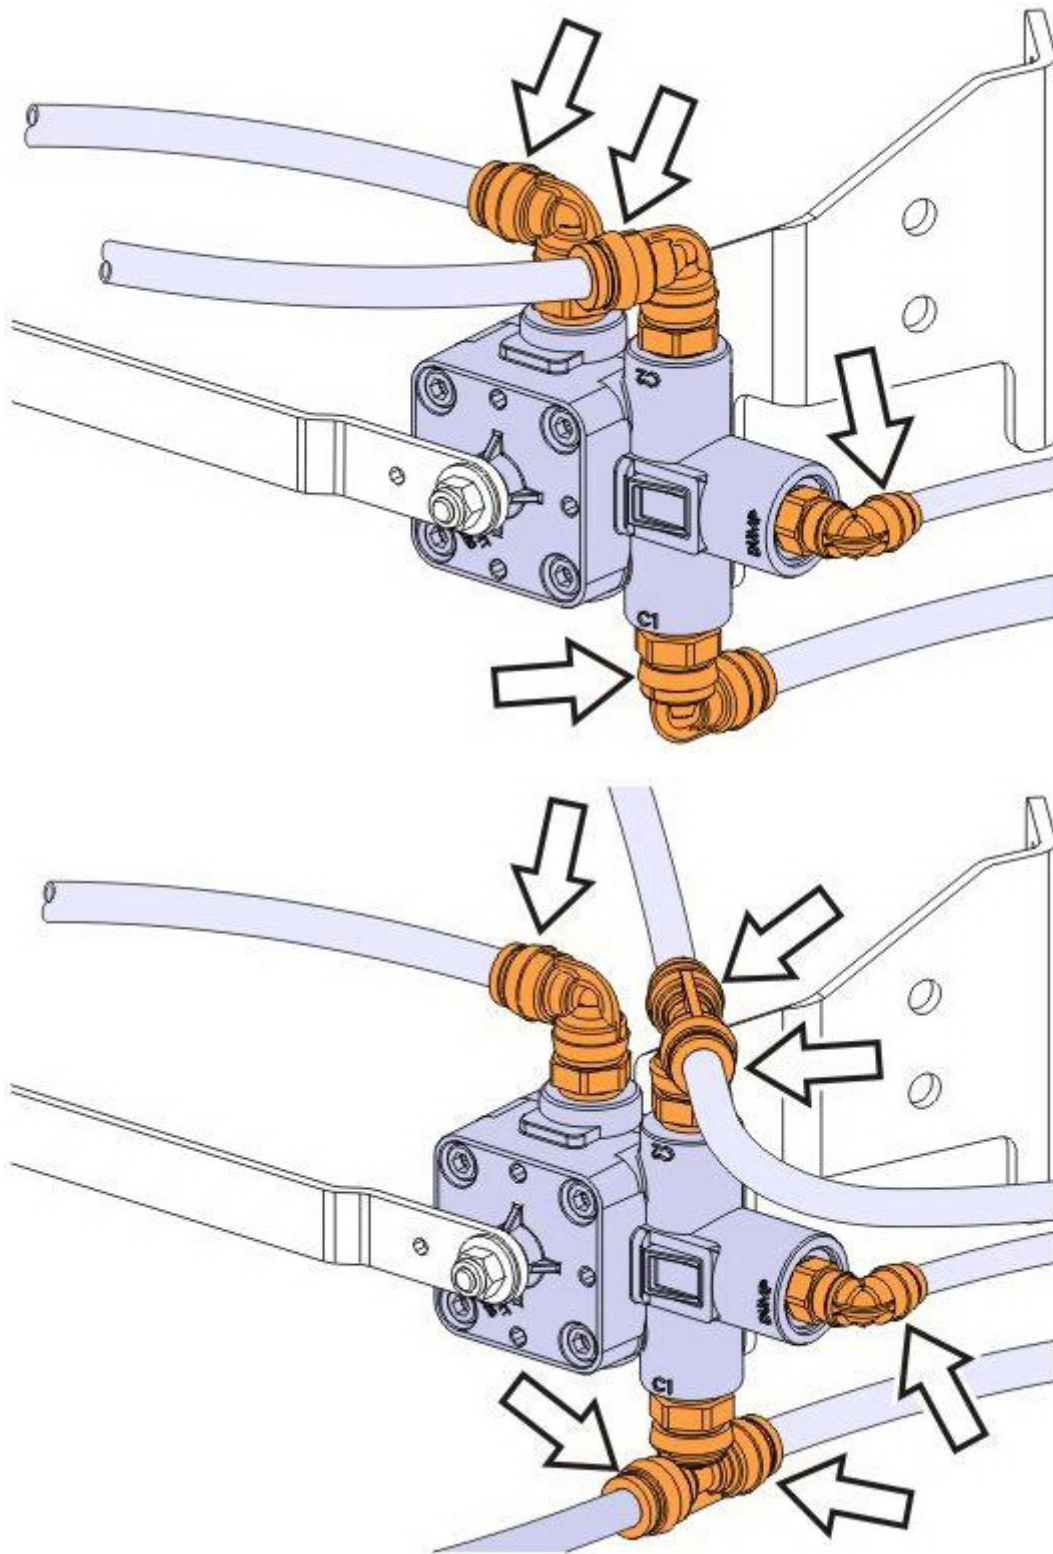
4. Listen for air leakage. If audible air is detected after 10 minutes, proceed to Step 5.
5. Using a spray bottle, fill it soap-and-water solution for air leak testing.
6. Spray soap-and-water solution on all fittings, airline tube connections and valve body as shown in the figure below.

7. If air bubbles form in any area of the fittings near the valve body, retighten fittings and repeat soap-and-water solution test.
8. If air bubbles form at airline tube connections, recut tubing, reinsert into fittings and repeat soap-and-water solution test.
9. If any fittings show signs of leakage after steps 7 and 8 are complete, replace only the fittings that are leaking.

Note: Do not replace the entire valve.

10. Fitting kits 85154049 and 85154050 are available in PDC. See Barksdale Repair and Fitting Kits table for the correct repair part numbers.

11. If there are still bubbles present after Step 10, please replace the valve and submit the valve through normal warranty process for further analysis.

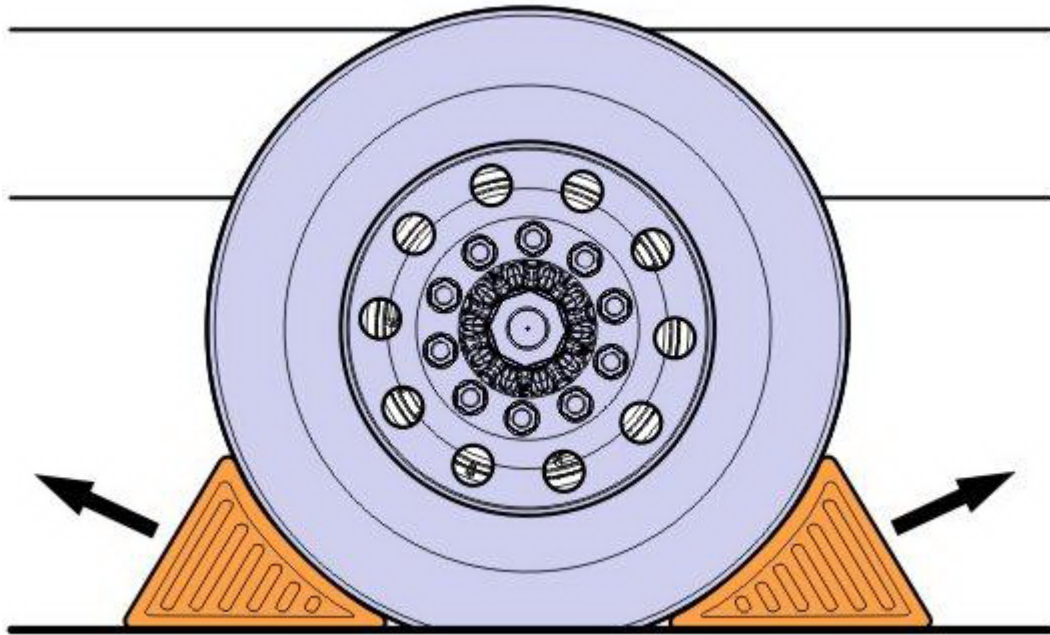
1. Start the truck and build the air system up to normal operating pressure.
2. Remove the wheel chocks.
