# TECHNICAL SERVICE BULLETIN

Classification: KS23-004	Reference: NTB23-067	Date: August 29, 2023
-----------------------------	-------------------------	--------------------------

## 2014-2020 ROGUE & 2017-2022 ROGUE SPORT; REPLACEMENT JACKKNIFE (FLIP STYLE) KEYS

**APPLIED VEHICLES:** 2014-2020 Rogue (T32)  
2017-2022 Rogue Sport (J11)

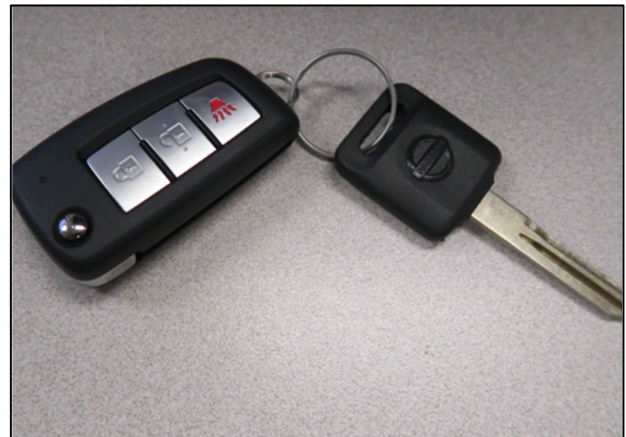
Figure 1

- If the jackknife key is replaced with 80560-4BA1E, the new part provided will no longer be equipped with a key blade.
- New service parts will have a keyless entry remote with a separate mechanical key.
- Each vehicle can have a maximum of four (4) keys registered to the BCM. Each service part contains one (1) key and one (1) remote and will use two (2) of the available slots.
- Follow the **SERVICE PROCEDURE** starting on page 2 to register the new mechanical key and remote.

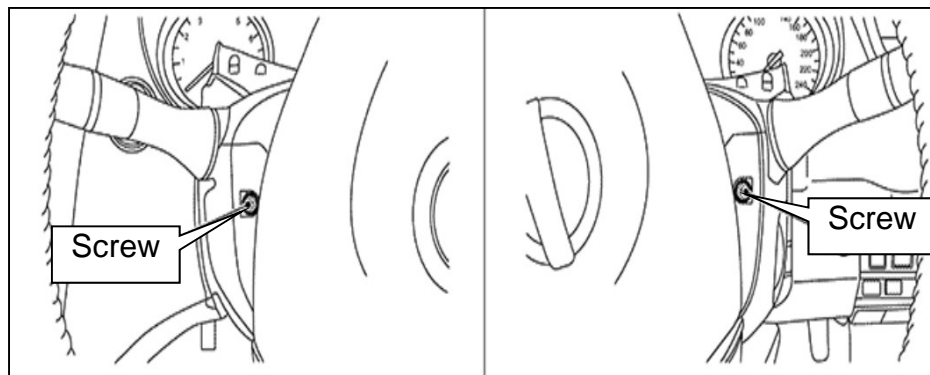
Figure 2

2. Remove the two (2) steering column cover screws.
  - Turn the steering wheel to the 9 o'clock position and remove the LH steering column cover screw.
  - Turn the steering wheel to the 3 o'clock position and remove the RH steering column cover screw.

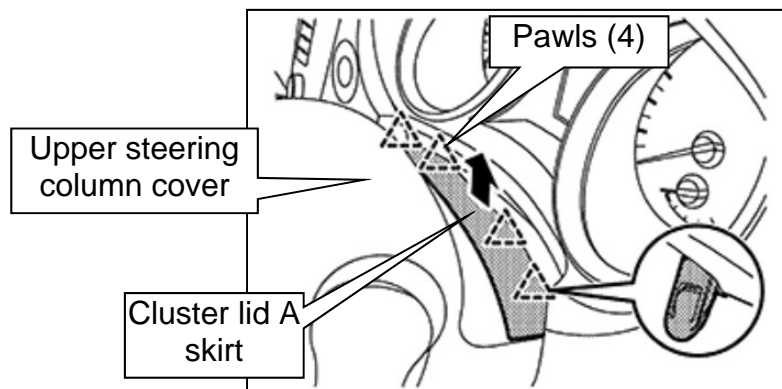
Figure 3

3. Disengage the four (4) fixing pawls, and then remove the cluster lid A skirt from the upper steering column cover.

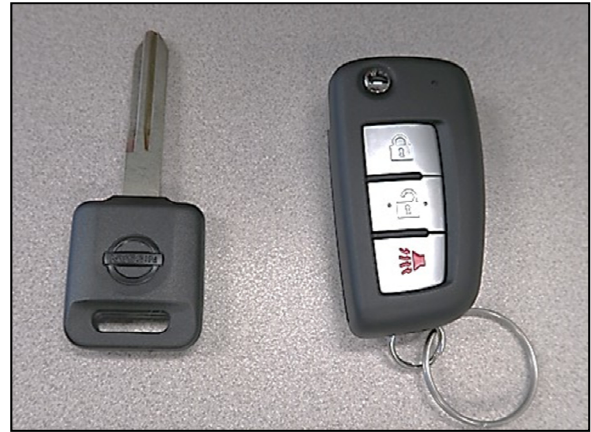
Figure 4

6. Remove the new mechanical key from the key ring.
7. Have the new mechanical key cut using the vehicle's key cut code.

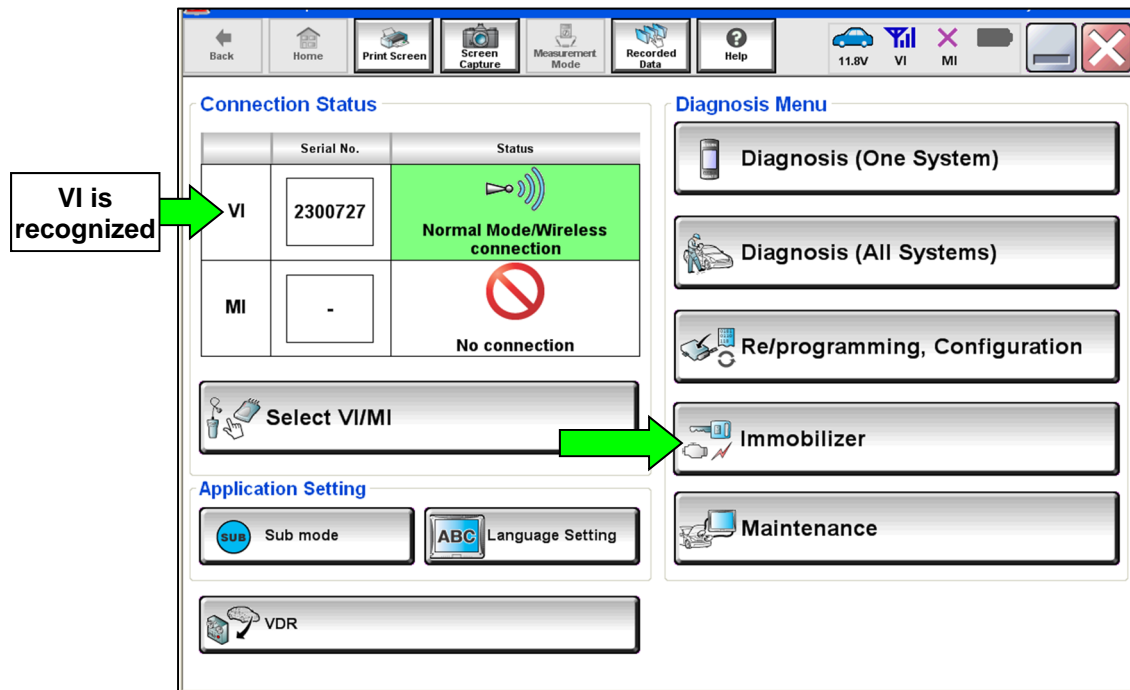
Figure 5

8. Connect the CONSULT PC to the vehicle.
9. Start C-III plus.
10. Wait for the VI to be recognized.
  - The serial number will display when the VI is recognized.
11. Select **Immobilizer**.

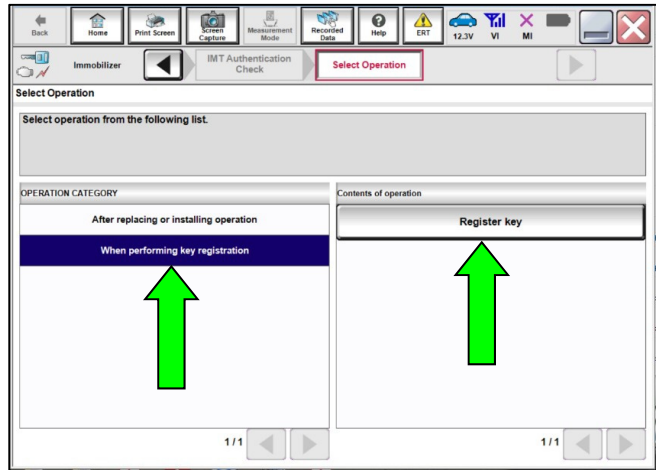
Figure 6

12. Follow the screen prompts to navigate to the screen shown in Figure 6.
13. Select **When performing key registration**.
14. Select **Register key**.
  - If needed, refer to the CONSULT III+ Operations Manual for key registration information.

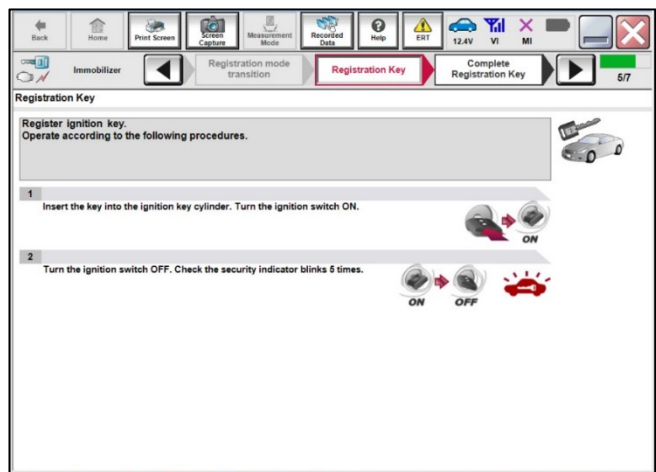
Figure 7

15. Follow the screen prompts to navigate to the screen shown in Figure 7.
16. Insert the new mechanical key and turn the ignition to the ON position to register.
17. Verify the Red Security lamp in the combination meter blinks five (5) times.
18. Once the key is registered, the screen shown in Figure 8 will be displayed.
19. Continue to step 20 to register the new keyless entry remote.

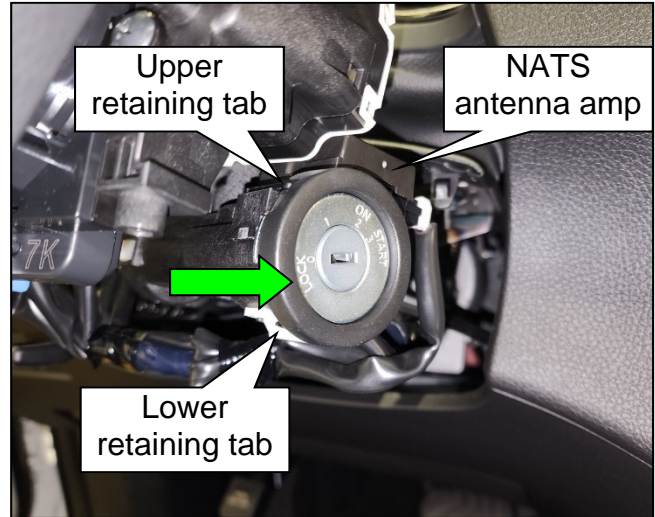
Figure 9

21. Remove the NATS antenna amp from the ignition switch while leaving the electrical harness connector connected.

- Lift the two (2) retaining tabs from the NATS antenna amp and slide the NATS antenna amp away from the ignition switch.

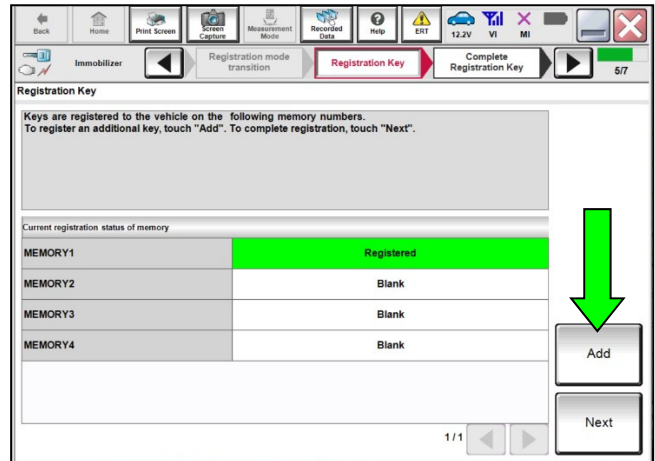
- a. Select **Add**.
- b. Insert the mechanical key into the ignition switch.
- c. Hold the keyless entry remote in the center of the NATS antenna amp as shown in Figure 11.
- d. While holding the keyless entry remote in the center of the NATS antenna amp, turn the ignition ON.
- e. Verify the Red Security light flashes five (5) times and the screen shown in Figure 10 indicates that two (2) keys have been registered.
