Service Bulletin

Bulletin No.: 23-NA-138

Subject: Diagnostic Tip for Malfunction Indicator Lamp (MIL) Illuminated - DTC P2C7A, P2BAA, P20FE, and/or P2EAD Set

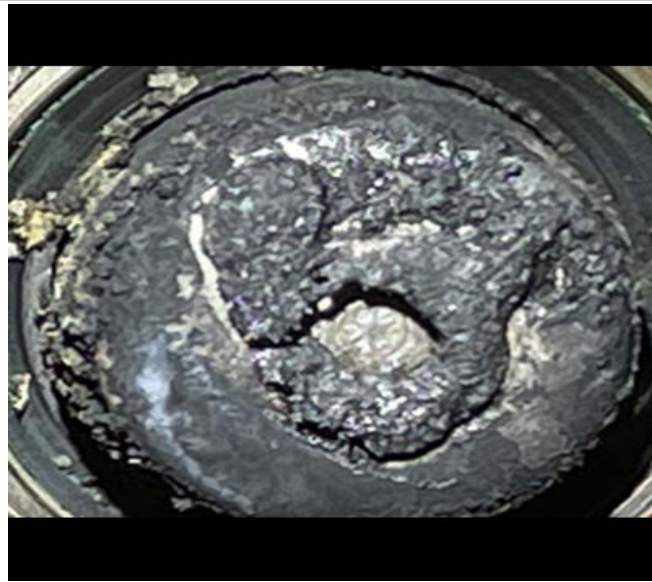
6406213

The graphic above is an example of a partially blocked DEF injector.

Deposits like this can block the flow of DEF out of the injector resulting in the vehicle setting P2BAA on LM2 powered vehicles, P20EF on the first injector of a LZ0 powered vehicle, or P2EAD on the second injector of a LZ0 powered vehicle. These crystals can be cleaned with warm water and a soft brush.

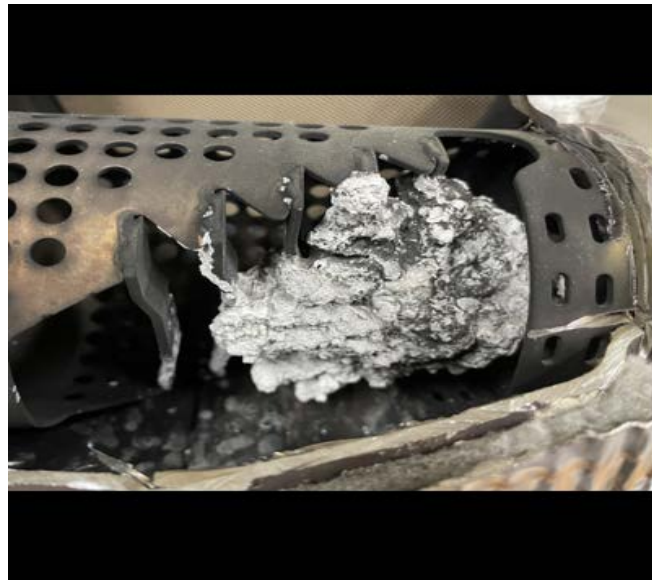
6406218

The graphic above is an example of a blocked SCR.

This cutaway of the exhaust system illustrates how crystals can form to prevent the flow of DEF onto the NOx Catalytic Converter. This type of blockage could certainly cause a P20EE or P2C7A. These deposits can be cleaned by performing a service regeneration.

The main contributor to these crystals forming are induction leaks and exhaust leaks. It is also important to not reuse the seal or the clamp on a DEF injector once removed. Always clean the sealing surface prior to installing the injector.
