STAR ONLINE PUBLICATION

Case Number: S2308000083

Symptom/Vehicle Issue: Rear Heated Seat Inoperative, Diagnostic Trouble Code (DTC) B1E9C-13 – Rear Right Heater Control 1 Circuit Open

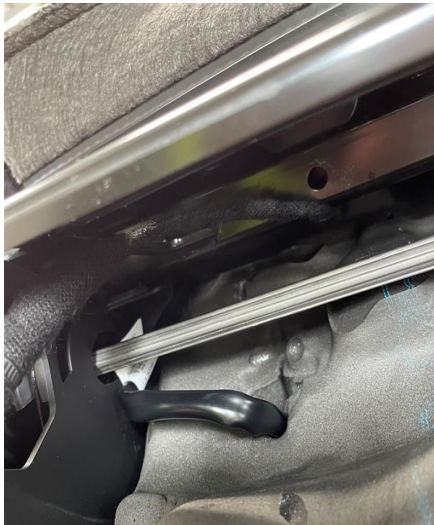
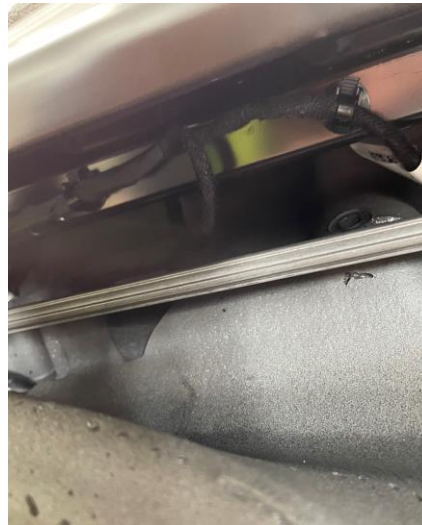
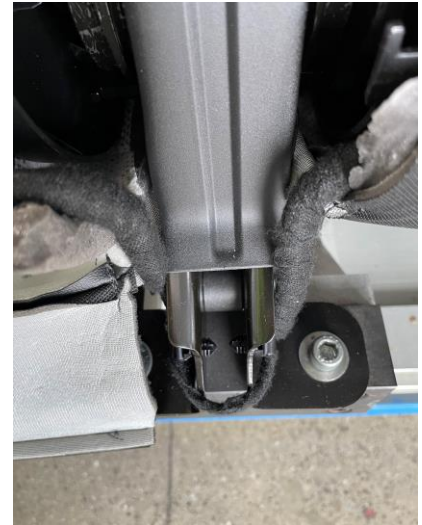
Example of proper routing in 2nd row Seatback

Repair Procedure: Open the rear seat back by releasing the large J clip at the base of the rear of the seat. Inspect the routing of the seat wiring harness to ensure the harness is clipped and positioned correctly without any signs of pinching. Repair any pinched harness conditions using the harness repair guidelines within Service Library and reposition and secure the harness as needed to complete.
