STAR ONLINE PUBLICATION

Case Number: S2305000003

Symptom/Vehicle Issue: P0258B Electric Vacuum Pump (EVP) Performance Diagnostic Trouble Code (DTC)

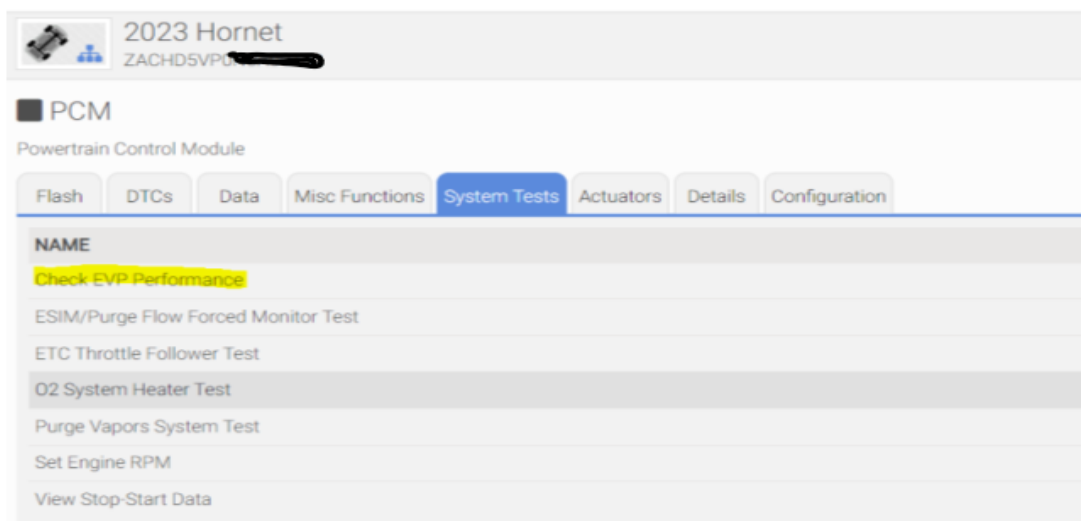
Discussion: WiTECH has added a new routine to aid in EVP diagnosis. Use this routine in addition to DTC diagnostics and service publications that apply. The routine to test the vacuum pump is in the PCM. Navigate to the System Tests tab. Select “Check EVP Performance” (Fig 1). Follow the on-screen directions to complete the test.

Fig 1.
Check EVP Performance routine location.
