# TECHNICAL SERVICE BULLETIN

<b>TSB #:</b>	TSB40082301	<b>Release Date:</b>	9/12/2023
<b>Main Group:</b>	40 - Interior		
<b>Subject:</b>	Instrument Panel (IP) Vents – Malfunction and Replacement		
<b>Vehicle:</b>	FM29 OCEAN	<b>Production Range:</b>	SORP
<b>Model Year(s):</b>	2023	<b>Region(s):</b>	Global
<b>Mobile Service:</b>	<b>NO</b>

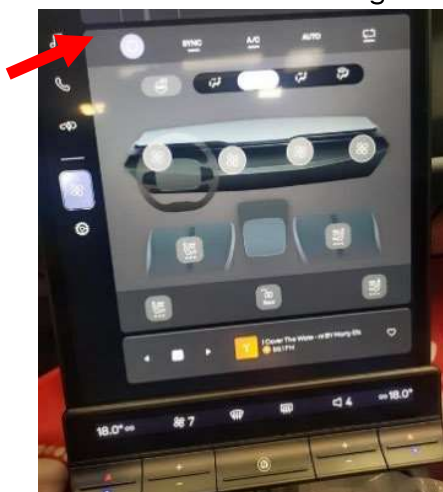
1. Turn on the air conditioning in the CID screen.

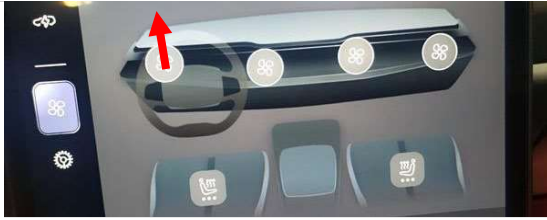
2. Press the button on the screen that represents a vent, slide it to the top of the screen and then release it. Observe the selected vent on the IP if it is moving. Note the visual inspection results.

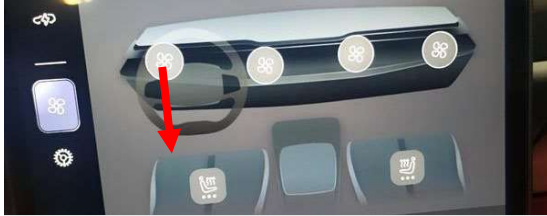
3. Press the button on the screen that represents a vent, slide to the bottom of the screen, and then release it. Observe the selected vent on the IP if it is moving. Note the visual inspection results.

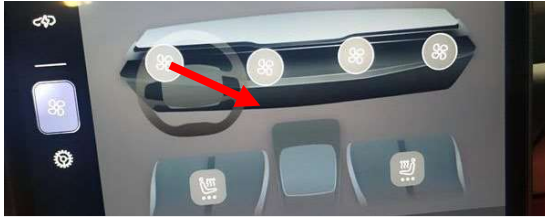
4. Press the button on the screen that represents a vent, slide it to full right and then release it. Observe the selected vent on the IP if it is moving. Note the visual inspection results.

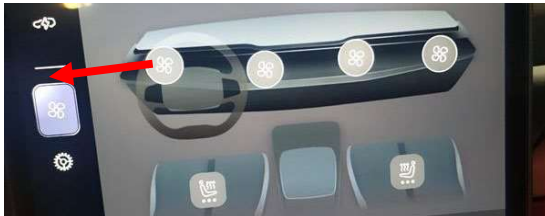
5. Press the button on the screen that represents a vent, slide it to full left and then release it. Observe the selected vent on the IP if it is moving. Note the visual inspection results.

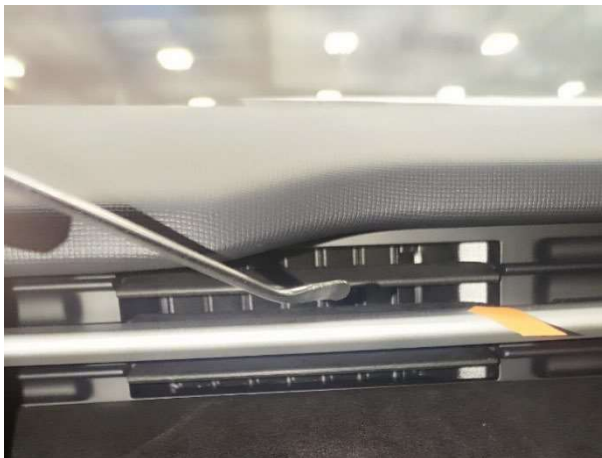
6. Repeat steps 2 to 5 for the other 3 vents.
7. If there is one or more vents that didn't move while performing the steps 2 to 5, grab a small tool of 8mm diameter (a No. 2 pencil or pen can also be used).
8. Use the tool and place it near the vents which didn't move from the previous steps (see Notes), and gently move the vent from side to side.

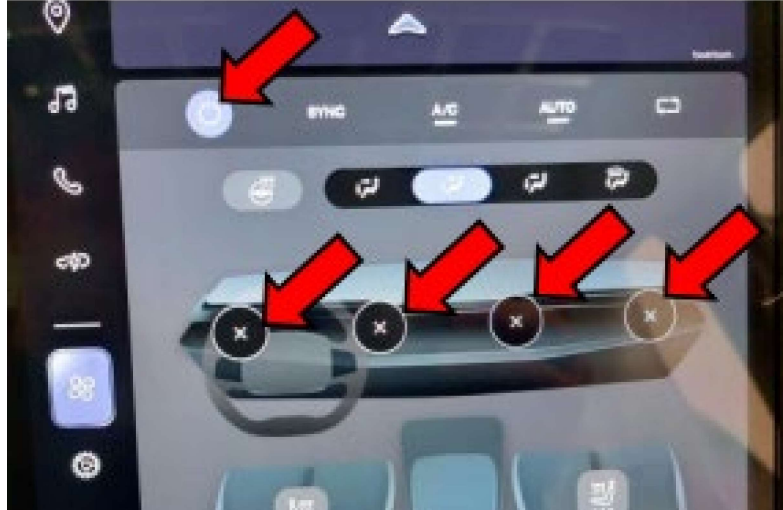
1. Vehicle is on READY status and must remain on READY throughout the entire process.
2. Make sure that all the vents are off in the AC display function.

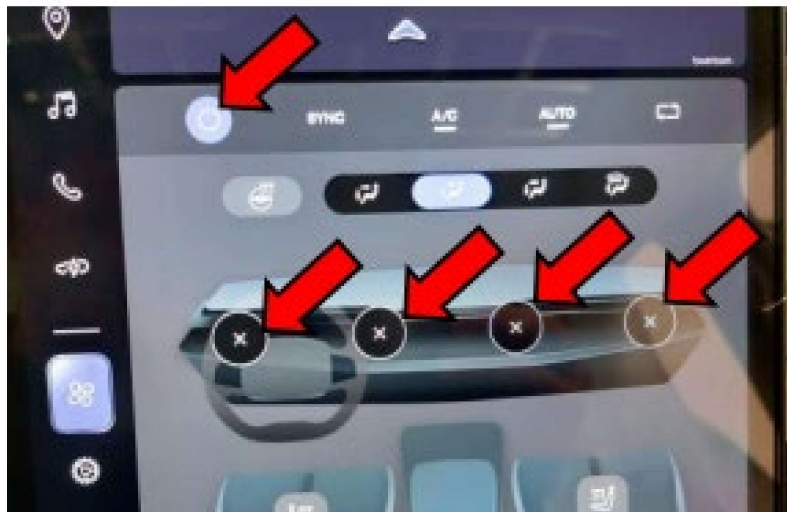
5. Re-connect the plug connection to the MDV control unit & wait at least 4 minutes for the following step.
6. Re-connect both connectors to the right Air-Vent (passenger outboard side).
7. Disconnect again the plug connection to the MDV control unit.
8. Connect the MDV control unit plug connections (unplugging/plugging in).
9. After Air-Vents are re-addressed (calibrated), reactivate air conditioning functions via display and all 4 Air-Vents are set to function.

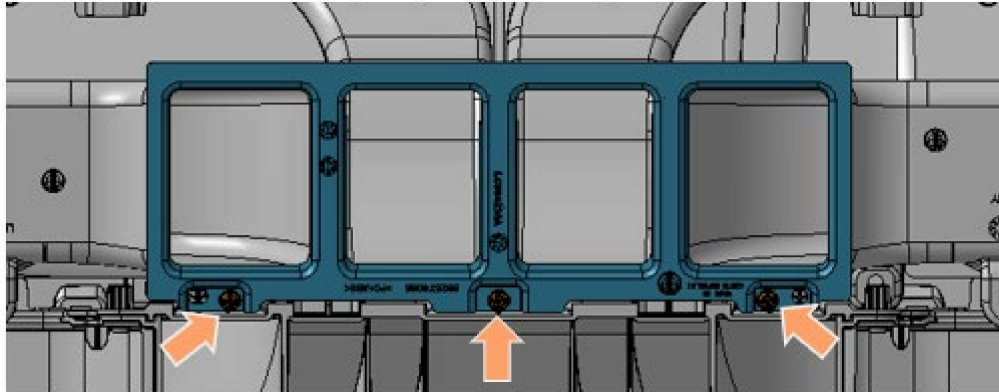
1. Remove T4x12 (x3) securing the IP duct manifold.
