September 28, 2023

Version 3

**Warranty Extension: 2016-2021 Civic A/C Compressor Shaft Seal Leak (1.5T, 2.0, 2.0T)**Supersedes 23-039, Dated June 15, 2023, to revise the information highlighted in **yellow****AFFECTED VEHICLES**

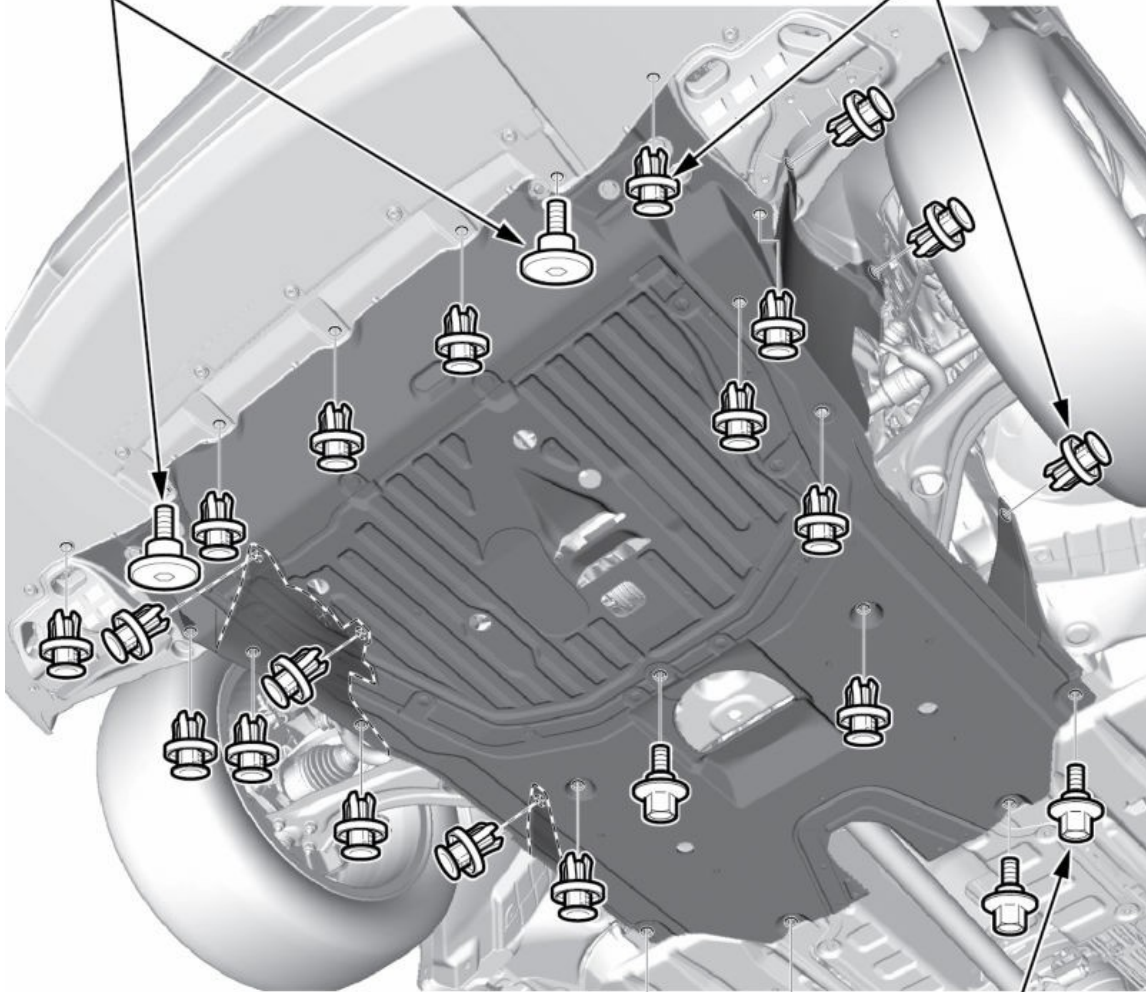
1. Remove the right front tire.
2. Remove the undercover assembly.

**SCREWS (2)**  
9.3 N·m (6.9 lb-ft)  
Remove.

**CLIPS (19)**  
Remove.

**BOLTS (5)**  
9.3 N·m (6.9 lb-ft)  
Remove.

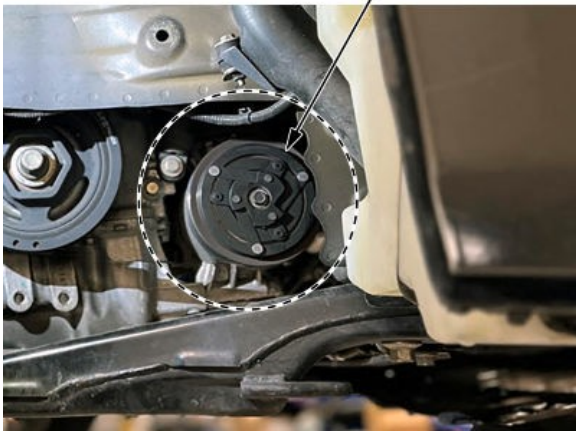
4. Inspect for oil on the clutch area of the compressor while in the on-car position.

NOTE: If oil is stuck to the clutch area of the compressor, then proceed to the repair procedure.

Inspect for oil.

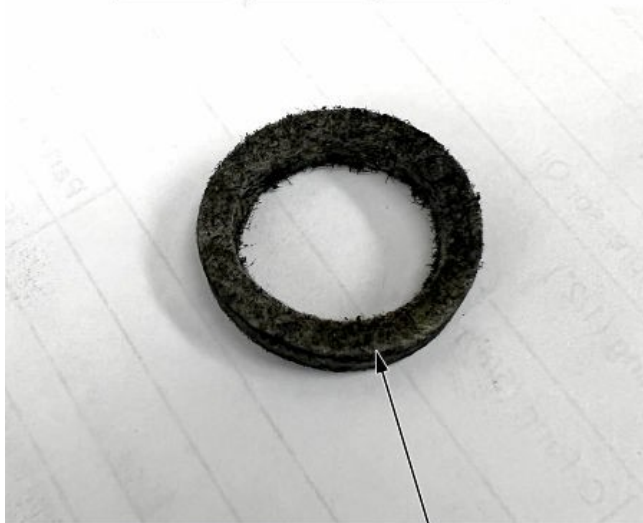
6. Remove the felt washer from the compressor and gently place it on a clean sheet of copier paper.

NOTE: If oil transfers from felt washer to paper after **10 seconds**, then proceed to the repair procedure. If not, then proceed to step 7.

Observe for excess oil.

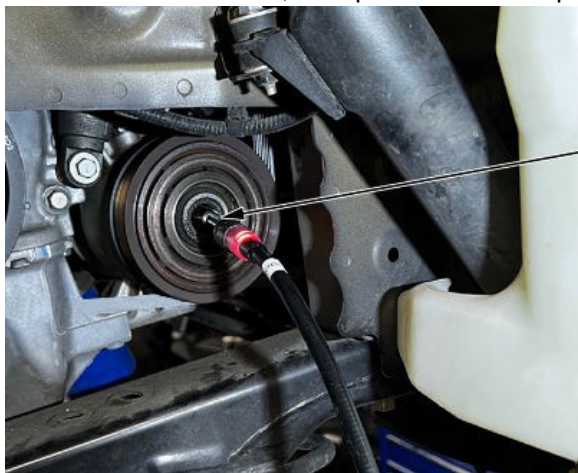
SNOUT OF  
COMPRESSOR

7. Using a calibrated sniffer, check for a leak.

- Use the sniffer for at least **five minutes** around the snout of the compressor.
- The longer an A/C compressor has not been ran, the better chance you will have at detecting a leak.
- A higher vehicle temperature produces more accurate results.
- If a leak is detected, then proceed to the repair procedure.

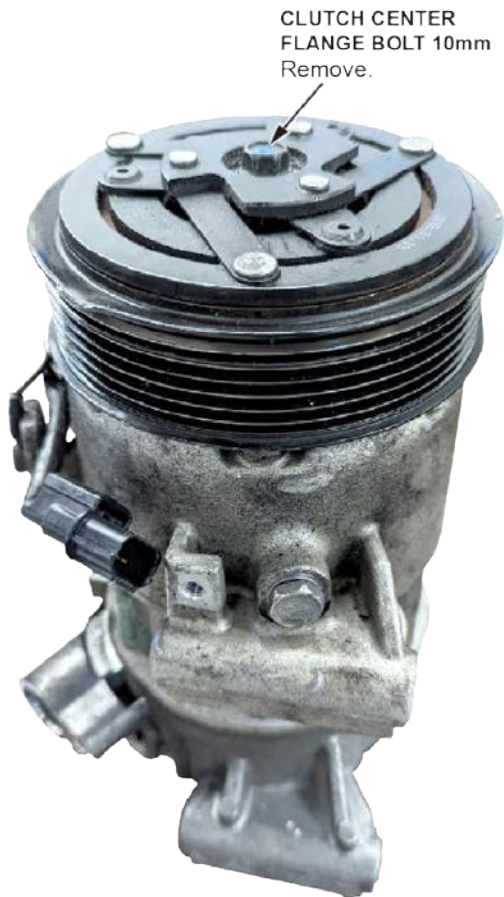
5. If not already removed, remove the clutch center flange bolt (**10 mm**), tightened at **17 N·m (13 lb-ft)**.

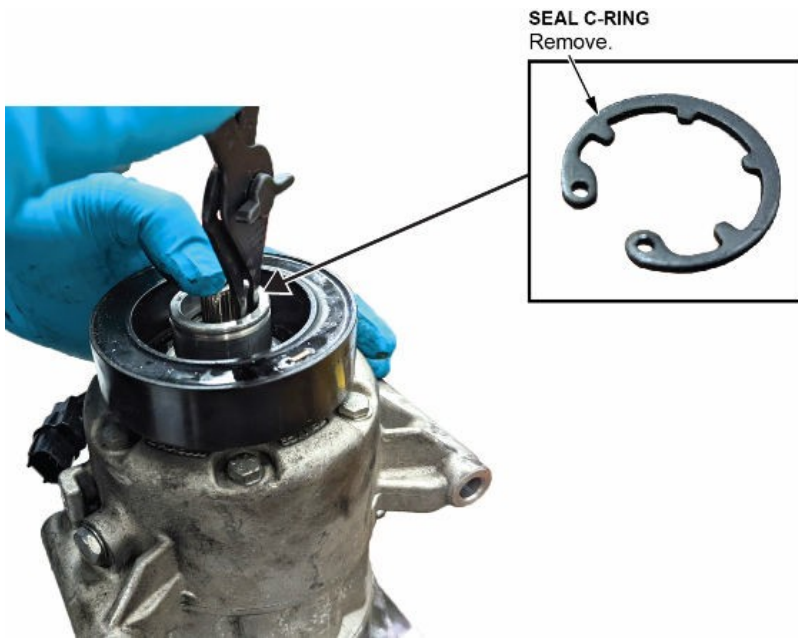
10. Remove the seal C-ring.

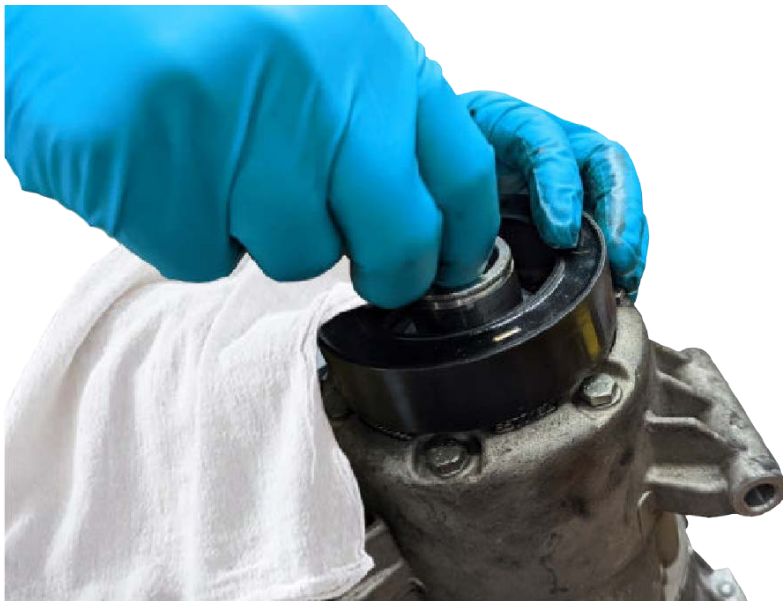
11. Thoroughly clean the bore and shaft with a lint free cloth.

NOTE: Do not use compressed air. The bore needs to be very clean as to prevent debris from entering the compressor once the seal is removed. Failure to remove all debris will result in a future failure.

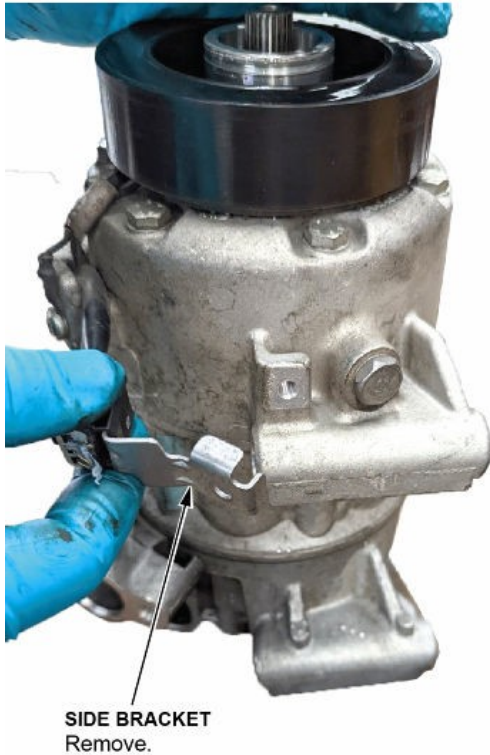
1.5L ONLY

12. Remove the side bracket.

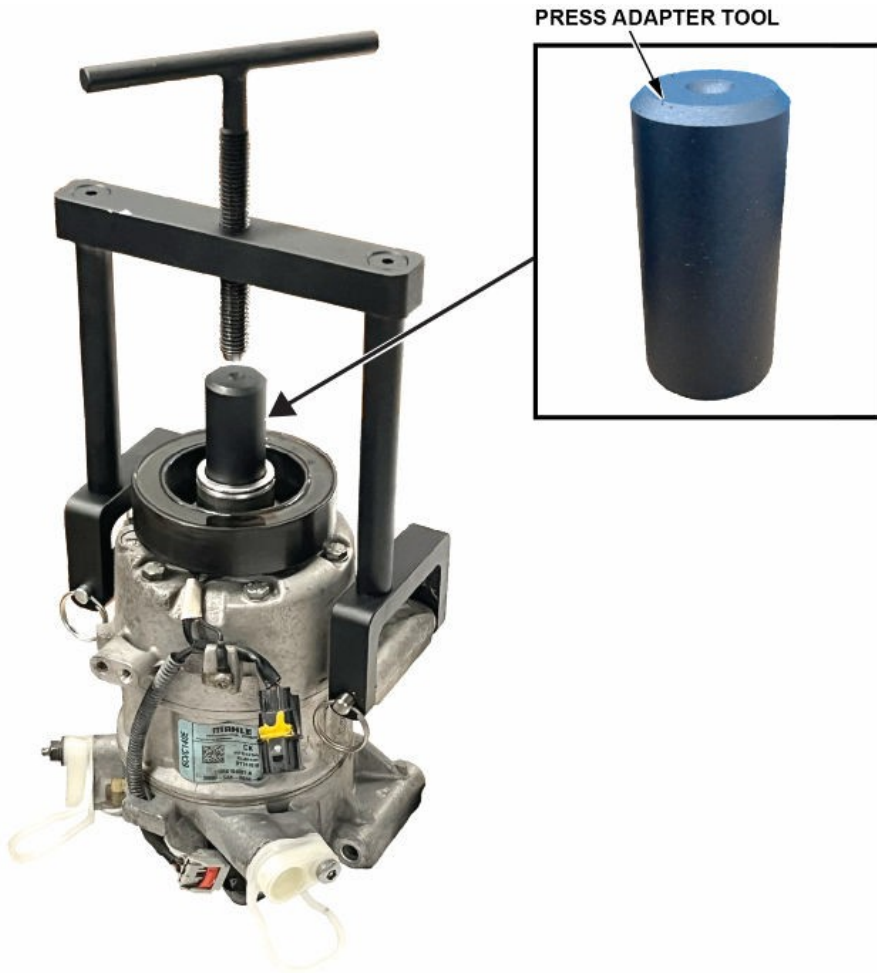
14. Add the press adapter tool.

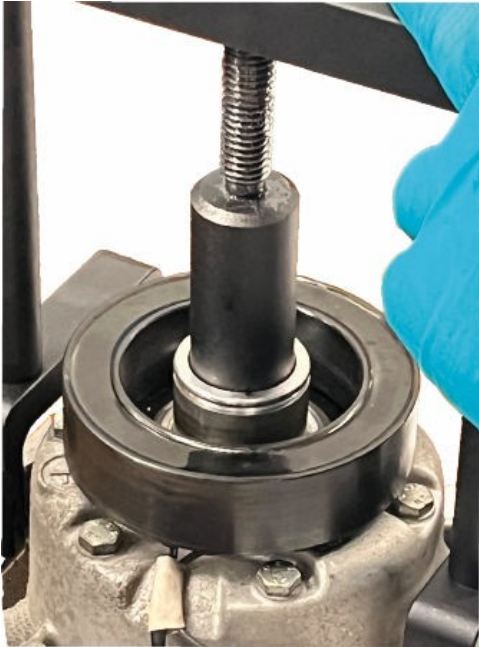
16. Tighten the press until there is no clearance, and then **3/4 turn (270°)**.

- The purpose of this step is to break the compressor shaft seal loose.
- Turning the handle more than **3/4 turn (270°)** can damage the tool and seal making it difficult to remove the compressor shaft seal.

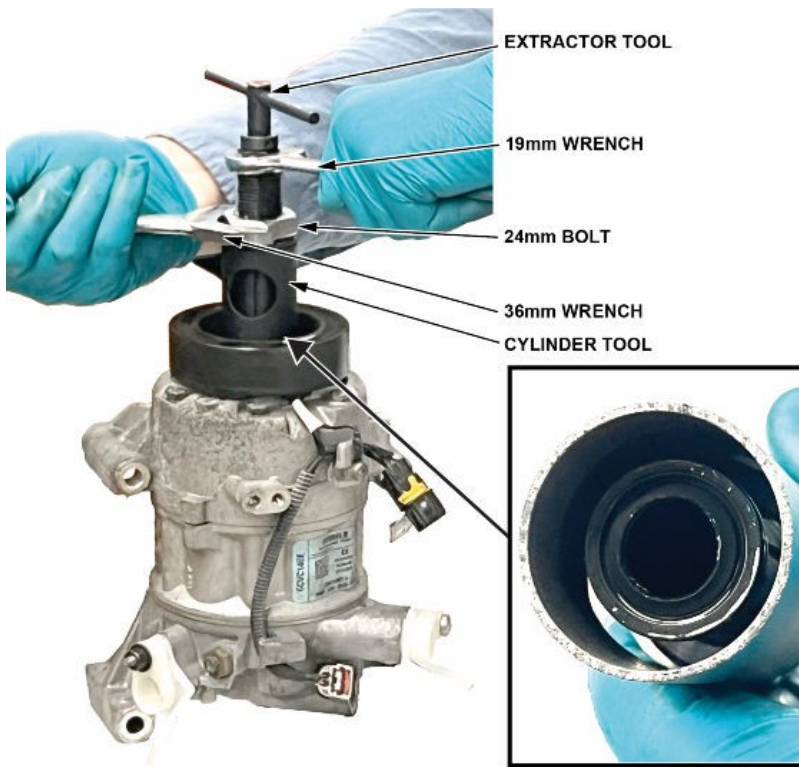
22. With the **19 mm** wrench in place, lower the **24 mm** nut down until it reaches the cylinder. Slowly and carefully adjust until the extractor tool comes out freely with the seal.

- Resistance will be felt while lowering **24 mm** nut and will cease once the seal is extracted.
- If the seal does not come out on the first step, repeat the process starting at step 13.

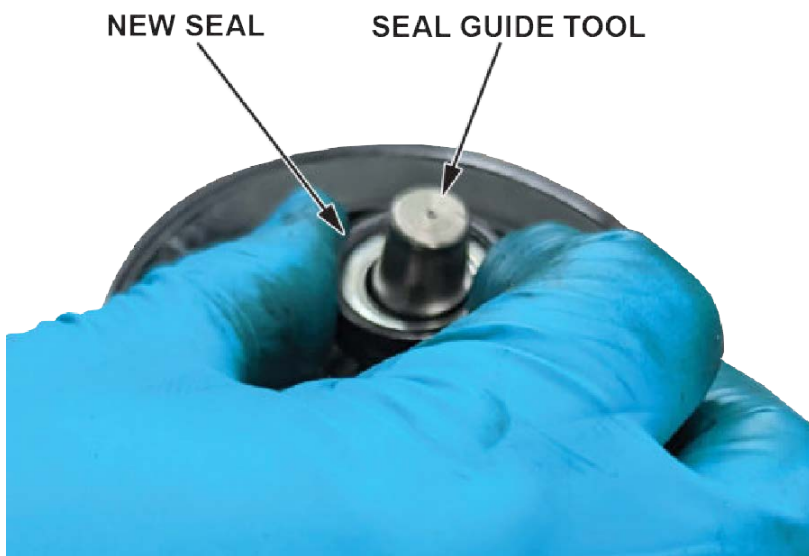
27. Insert the new seal onto the seal guide tool.

NOTE: The seal is directional and must be placed with the metal side upwards as shown in step 27.

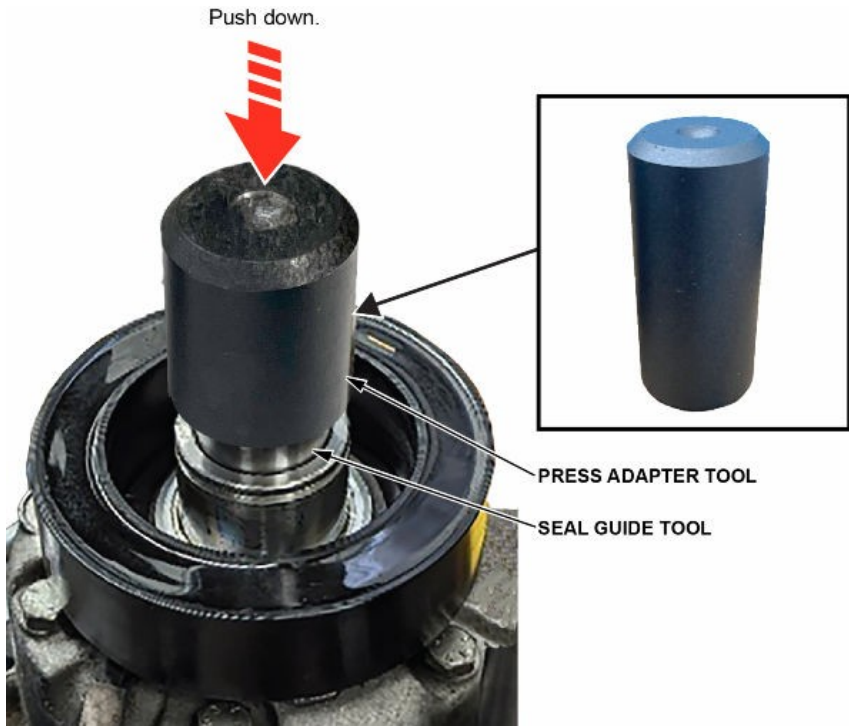
28. Insert the press adapter tool over the seal guide.

29. By hand, press down just enough to seat and install the new seal.

NOTE: Seat the seal about **5 mm** below the bore.
