Warranty Extension: 2017-22 CR-V A/C Compressor Shaft Seal Leak

Supersedes 23-040, dated June 15, 2023, to revise the information highlighted in **yellow**.

AFFECTED VEHICLES

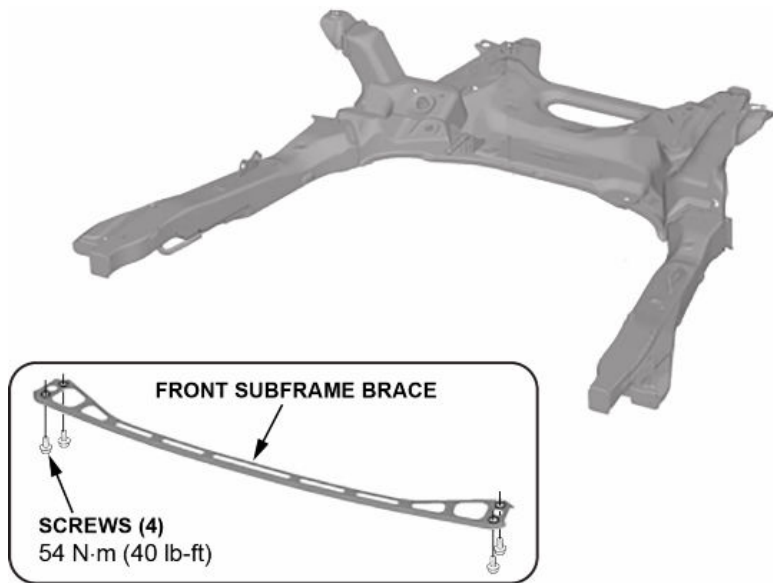
3. Remove the front subframe brace.

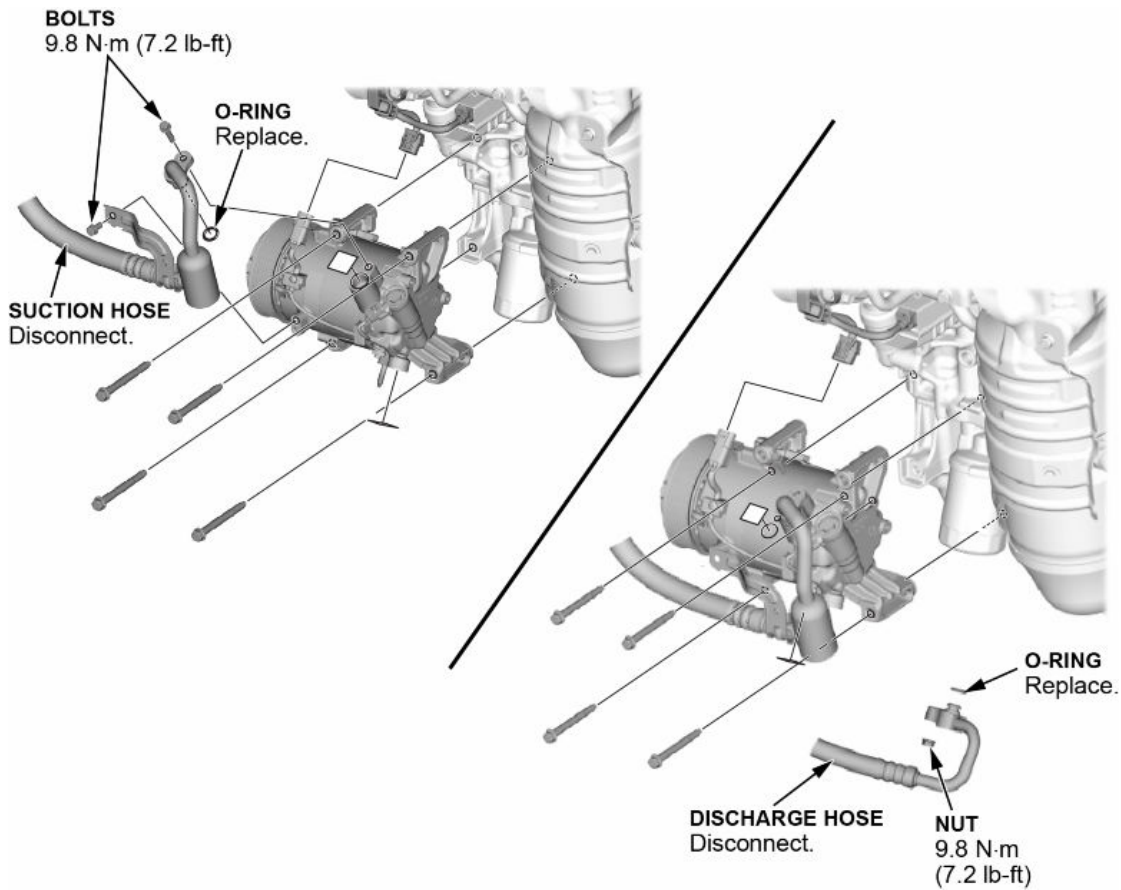
3. Disconnect the discharge and suction hose.

NOTE: Use the port plugs in the seal assembly kit to immediately seal the ports after disconnection. This avoids moisture and dust contamination from entering the air conditioning compressor. Installing an A/C compressor into a contaminated system can result in premature A/C compressor failure.

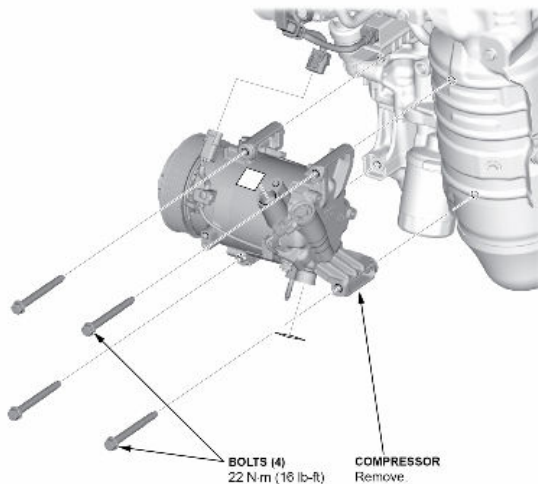
4. Remove the A/C compressor.

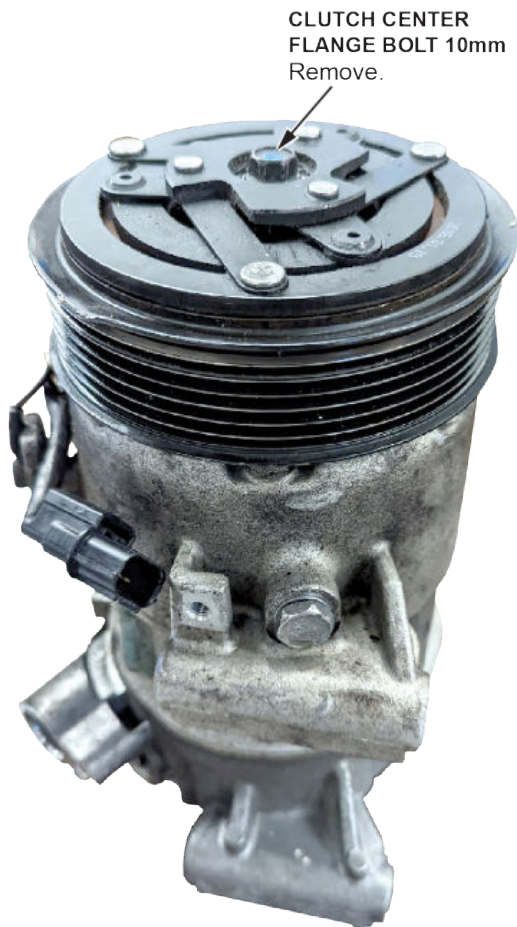
5. If the clutch has not been removed from a previous step, remove the clutch center flange bolt (17 N.m 13 lb-ft).

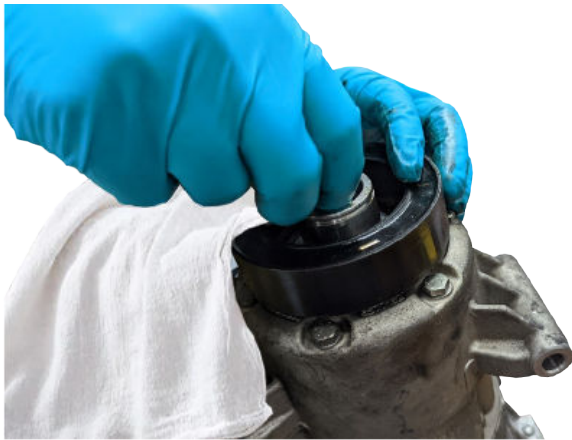
11. Thoroughly clean the bore and shaft with a lint free cloth.

NOTE: Do not use compressed air. The bore needs to be very clean as to prevent debris from entering the compressor once the seal is removed. Failure to remove all debris will result in future failure .

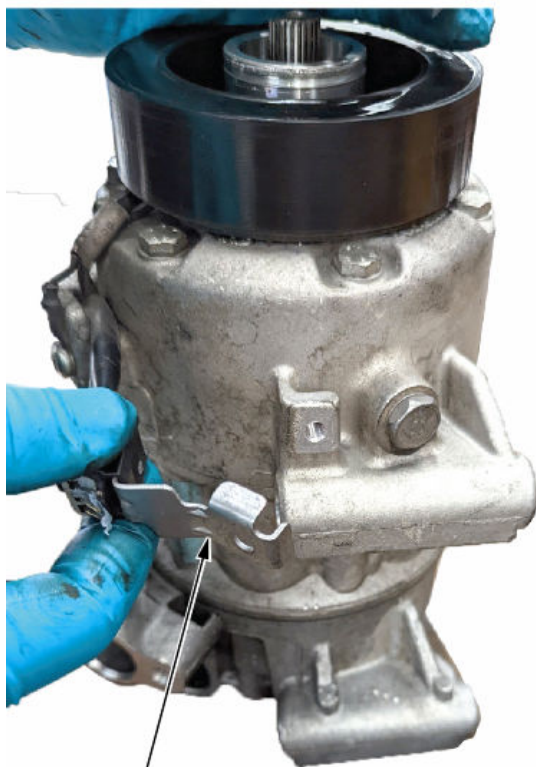
1.5L ONLY

12. Remove the side bracket (1.5L engine only).

SIDE BRACKET
Remove.

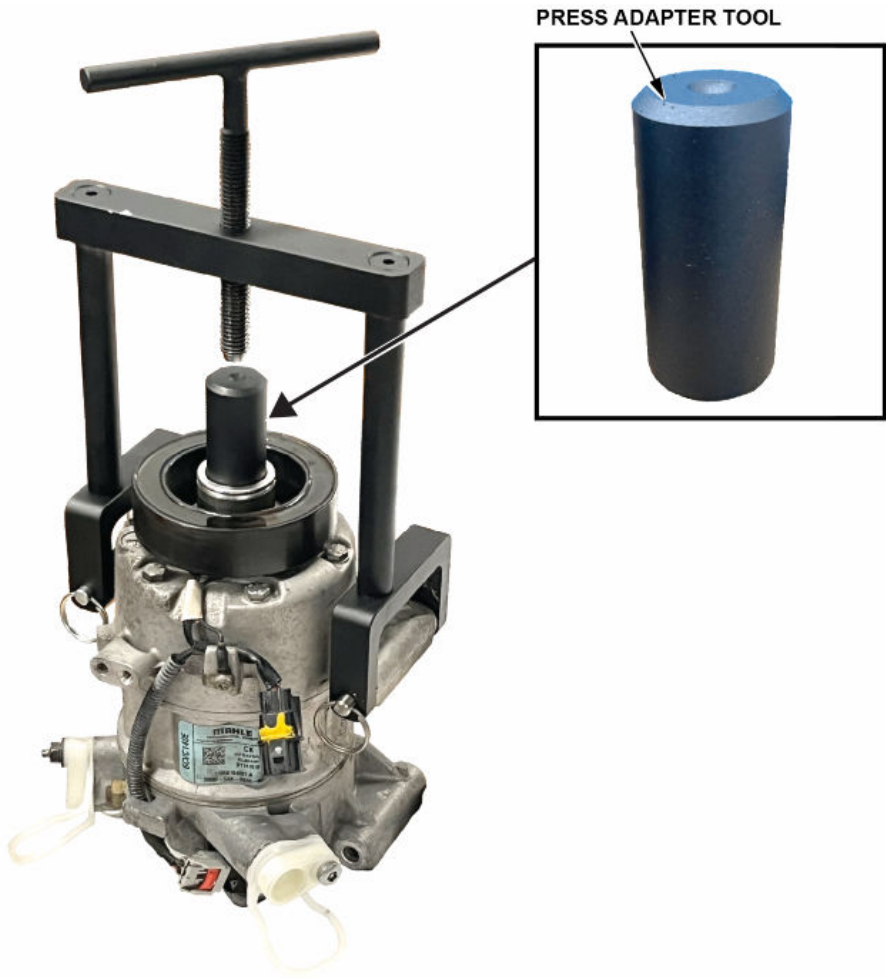
14. Add the press adapter tool.

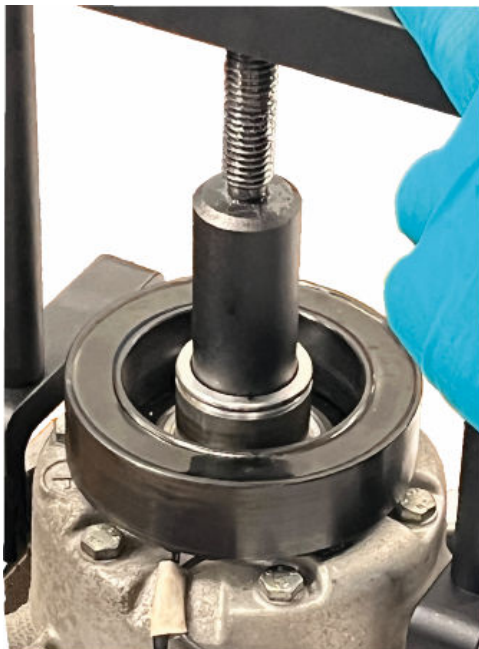
16. Tighten the press until there is no clearance, then **3/4 turn (270°)**.

- The purpose of this step is to break the compressor shaft seal loose.
- Turning the handle more than **3/4 turn (270°)** can damage the tool and seal making it difficult to remove the compressor shaft seal.

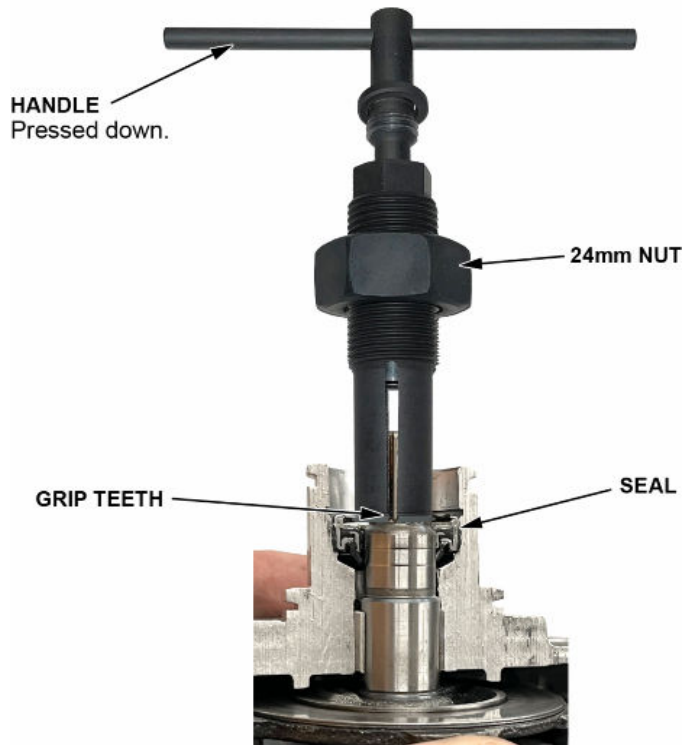
19. Insert the extractor tool, and make sure the **24 mm** nut is positioned towards the top. Look into the cylinder window to align the extractor tool onto the flange and press the handle fully down to grab the seal.

NOTE: The **24 mm** nut will use a **36 mm** wrench.

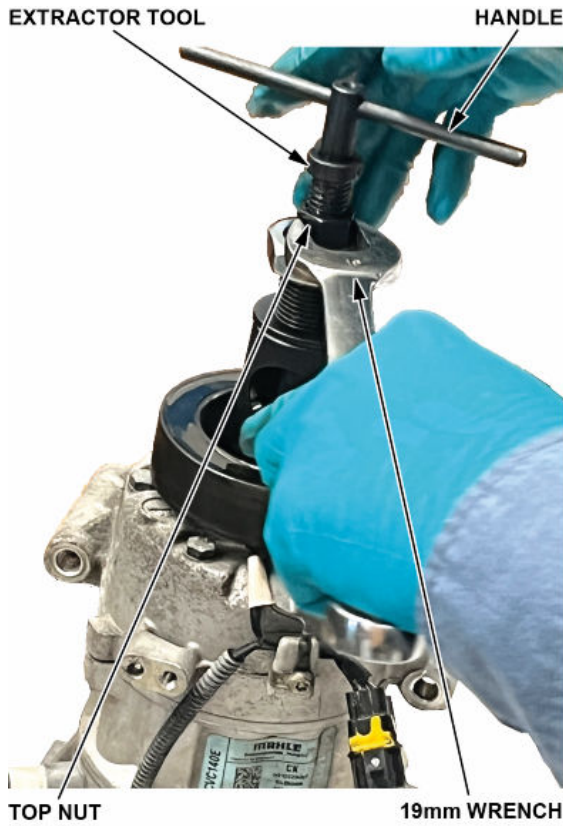
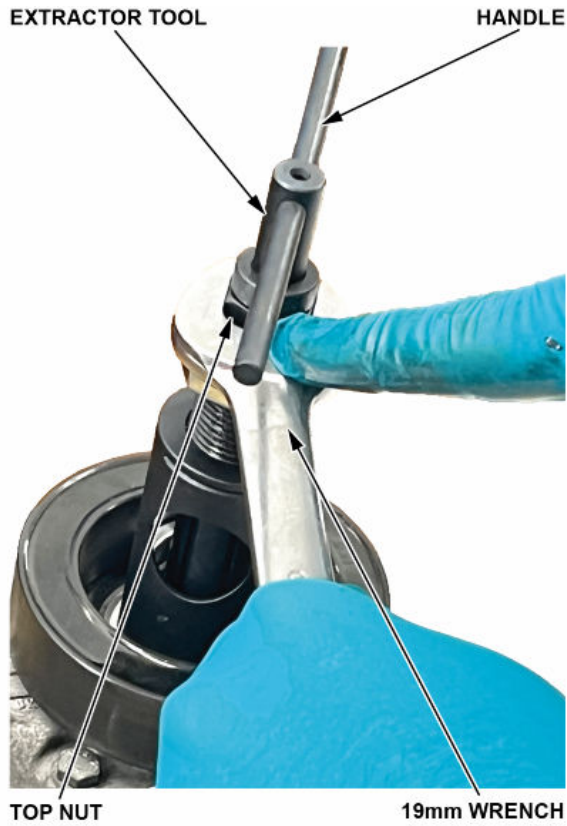
20. Stabilize the extractor tool using a **19 mm** wrench on the top. Then, turn the handle clockwise until the resistance is felt. Make sure that the space between the **19 mm** wrench and the bottom portion of the extractor tool is minimal.

NOTE: To confirm the extractor is engaged, hold the extractor tool and lift the compressor up.

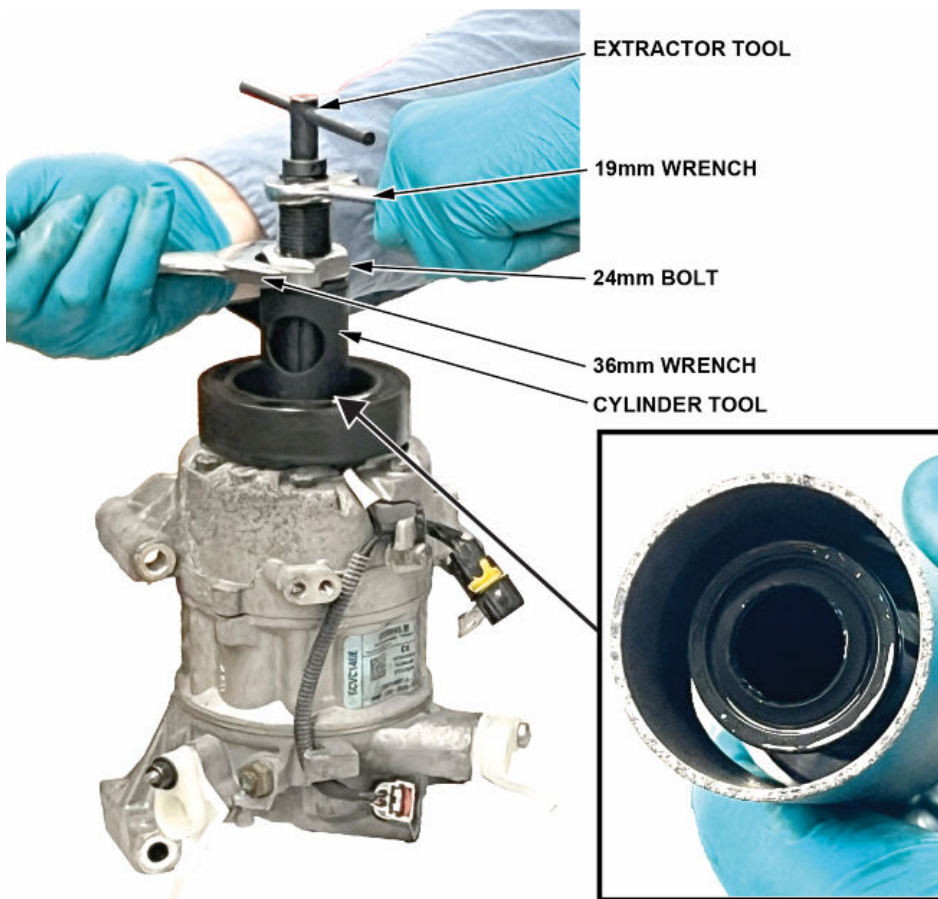
22. With the **19 mm** wrench in place, lower the **24 mm** nut down until it reaches the cylinder. Slowly and carefully adjust until the extractor tool comes out freely with the seal.

- Resistance will be felt while lowering **24 mm** nut and will cease once the seal is extracted.
- If the seal does not come out on the first step, repeat the process starting at step 13.

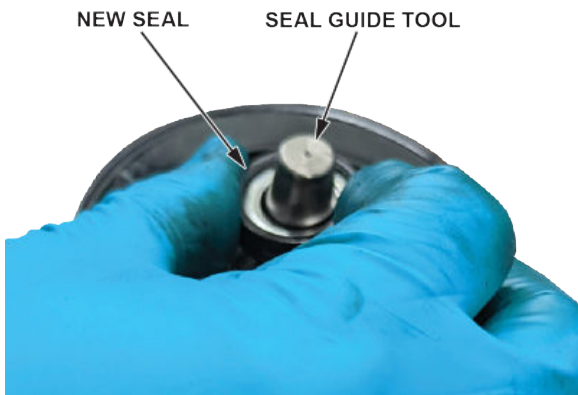
27. Insert the new seal onto the seal guide tool.

NOTE: The seal is directional and must be placed with the metal side upward.

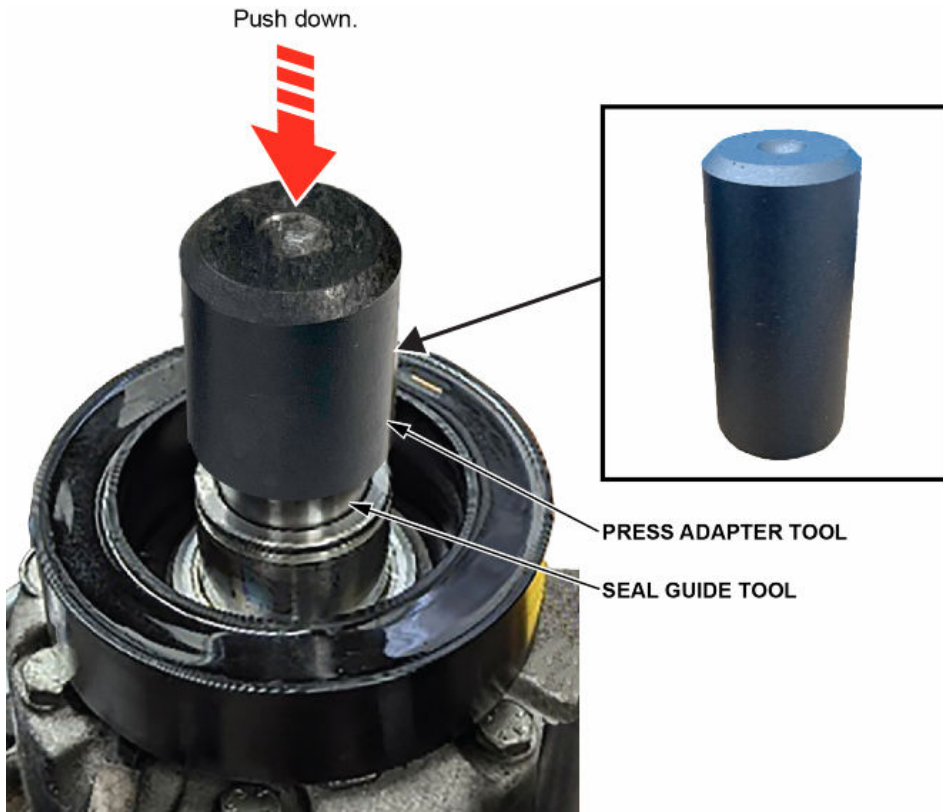
28. Insert the press adapter tool over the seal guide.

29. By hand, press down to seat the new seal about **5 mm** below the top edge of the bore and remove the press adapter.

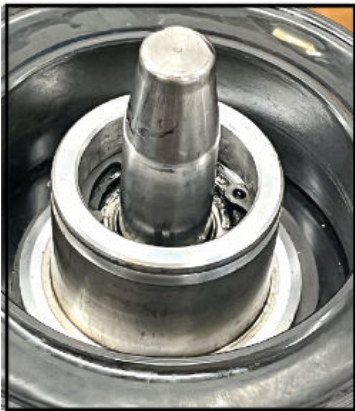
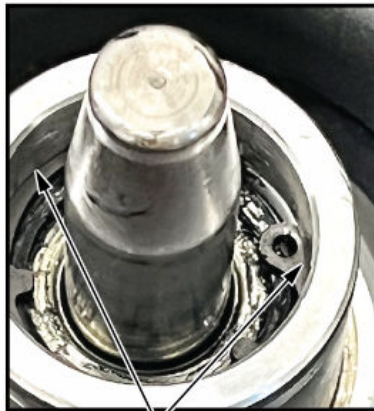
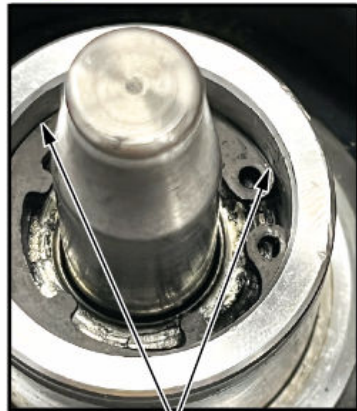
30. Insert the seal C-ring with the teeth's rounded side pointing down into the bore.
