Technical Journal

Upper front suspension creaking/knocking noise

REF NO: TJ 36527.3.0	ISSUING DEPARTMENT: Technical Service	CAR MARKET: United States and Canada	
PARTNER: 3 US 7515 Polestar		ISSUE DATE: 2023-07-13	STATUS DATE: 2023-10-20
FUNC GROUP: 7233	FUNC DESC: Mounting	Page 1 of 3

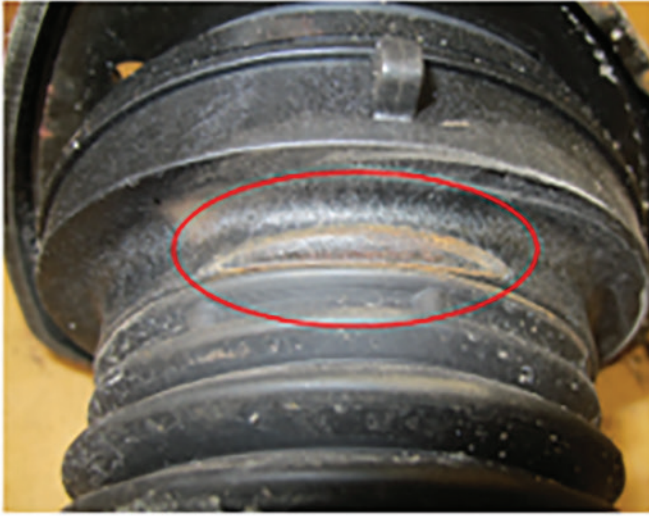
- During acceleration/braking (knocking noise.MOV and picture 1)
- During (slowly) driving over bumps and into turns (knocking noise.MOV and picture 1)
- During turning to left or right when standing still (Creaking noise.mp4 and picture 2)
- During parking maneuvering (Creaking noise.mp4 and picture 2)

* Do not replace any parts and do not fault trace due to this behavior.

* There will be a new upper bearing released during quarter 4 year 2023.
