Dealer Service Instructions for:

## **Emissions Recall 06A VECI Label**

**2014-2015, 2017 & 2019-2022 DJ Cab Chassis**

**2014-2015, 2017 & 2019-2022 D2 Cab Chassis**

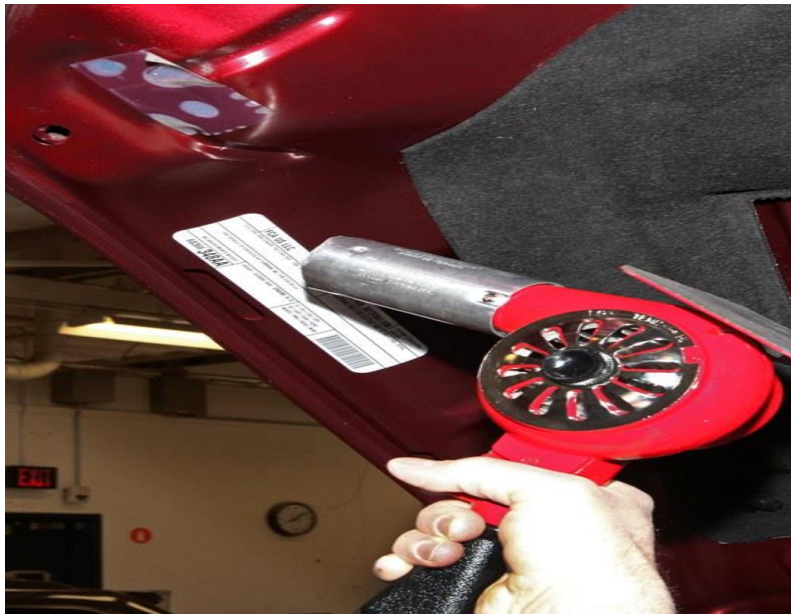
(Figure 1)

1. Raise the hood and support it with the prop rod if equipped.
2. Locate the original VECI label on the underside of the hood (Figure 1).

3. Use a heat gun or equivalent to soften the VECI label adhesive (Figure 1).

**CAUTION:** The heat source must be positioned far enough away from the painted surface to avoid damage to the clear coat.

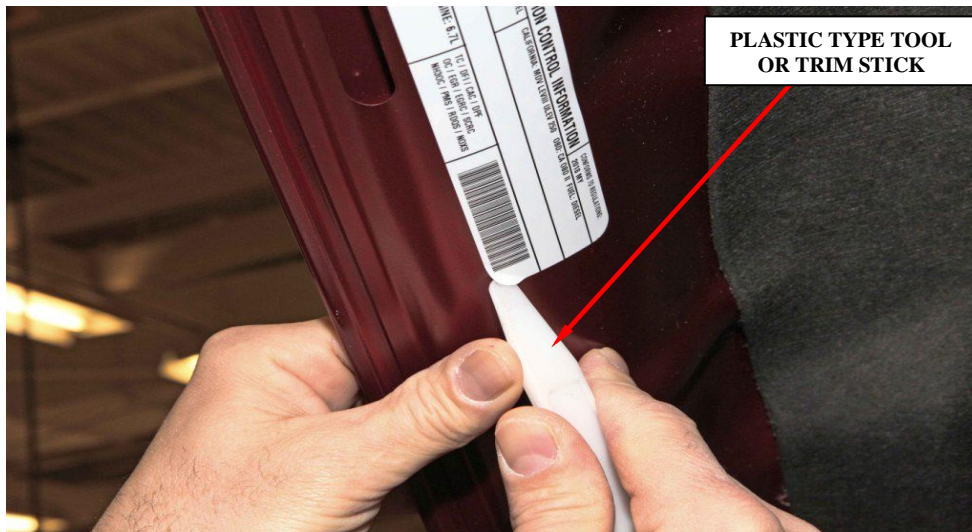
**Figure 2 – Removing Label**

4. Use a thin plastic or rubber type tool to begin lifting a corner of the VECI label (Figure 2).

5. Peel the VECI label slowly at a 45-degree angle to remove.

**CAUTION: Do not at any time “scratch” or “scrape” at the adhesive. Care is to be taken so that the substrate underneath the VECI label is not marred in any manner.**

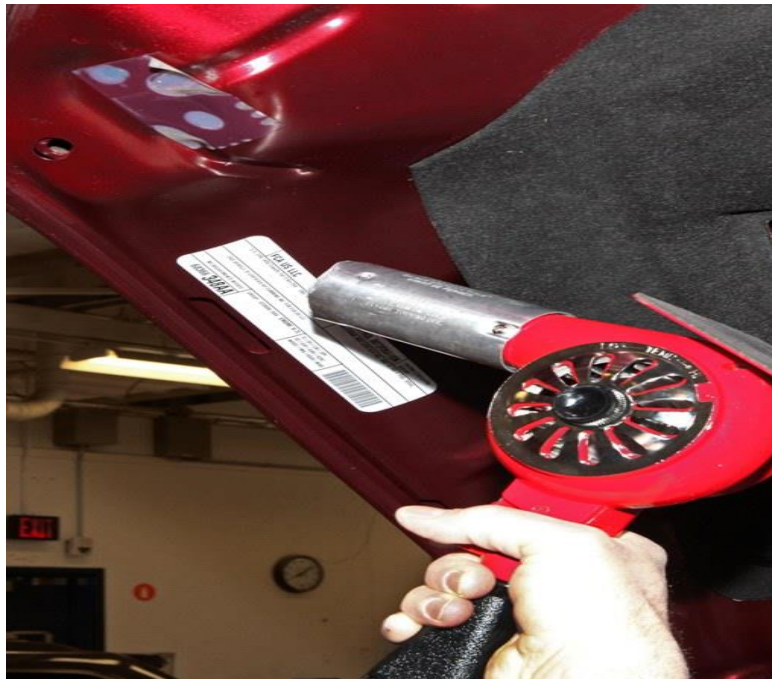
**Figure 1 – Label Removal**

1. Raise the hood and support it with the prop rod if equipped.
2. Locate the original VECI label on the underside of the hood (Figure 1).
3. Use a heat gun or hair dryer to soften the VECI label adhesive (Figure 1).

**CAUTION: The heat source must be positioned far enough away from the painted surface to avoid damage to the clear coat.**

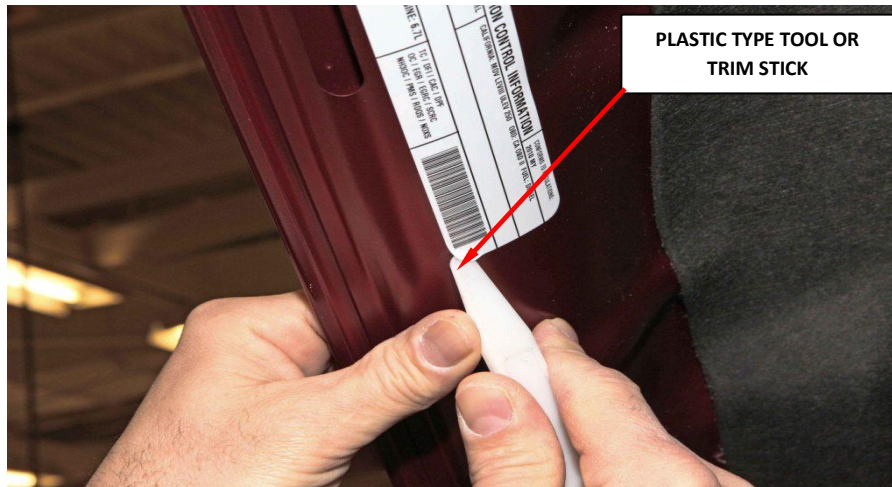
Figure 2 – Removing Label

4. Use a thin plastic or rubber type tool to begin lifting a corner of the VECI label (Figure 2).

5. Peel the VECI label slowly at a 45-degree angle to remove.

**CAUTION: Do not at any time “scratch” or “scrape” at the adhesive. Care is to be taken so that the substrate underneath the VECI label is not marred in any manner.**
