Technical Service Bulletin

44 Tires cracks visible in sidewall
44 23 04 2071800/1 October 20, 2023.

Model(s)	Year	VIN Range	Vehicle-Specific Equipment
RS 6, and RS 7	2024	All	Not Applicable

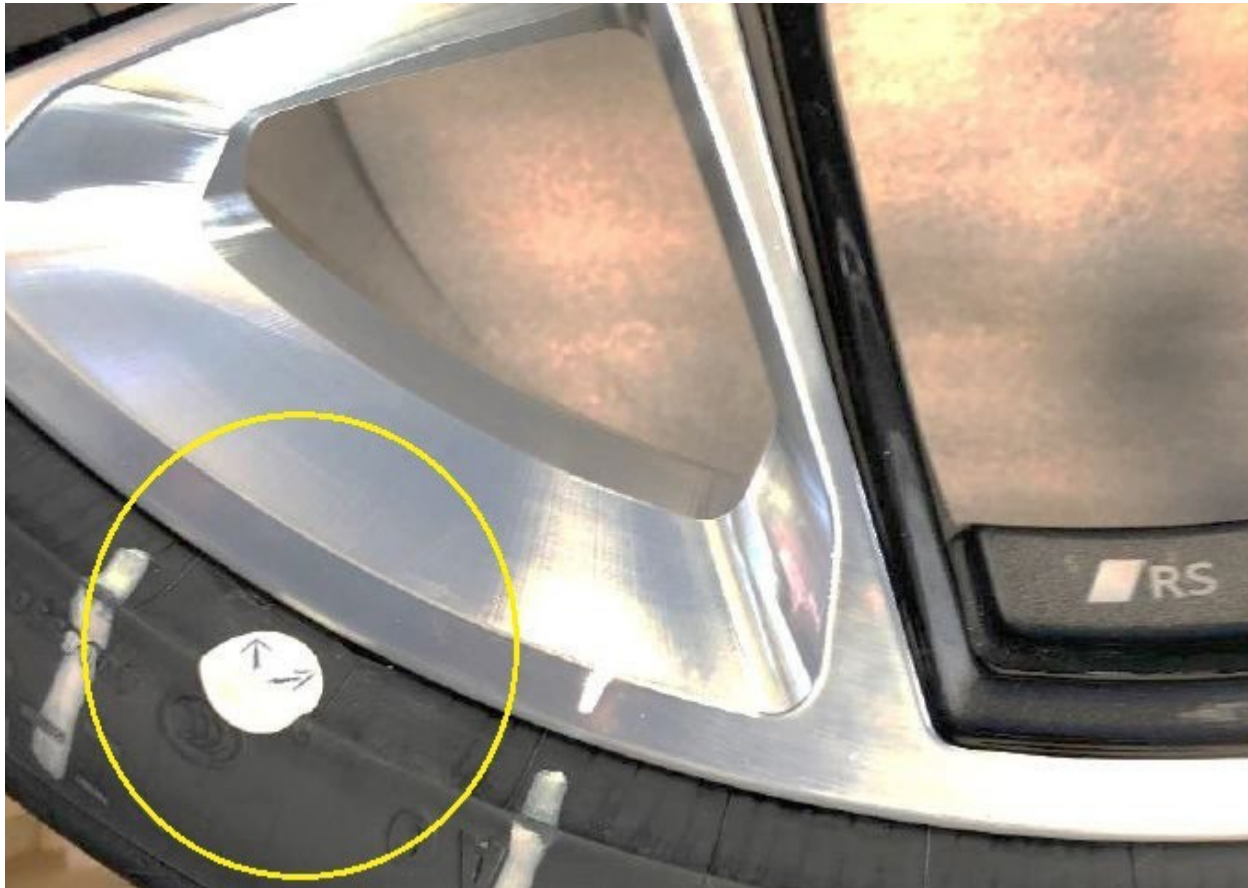
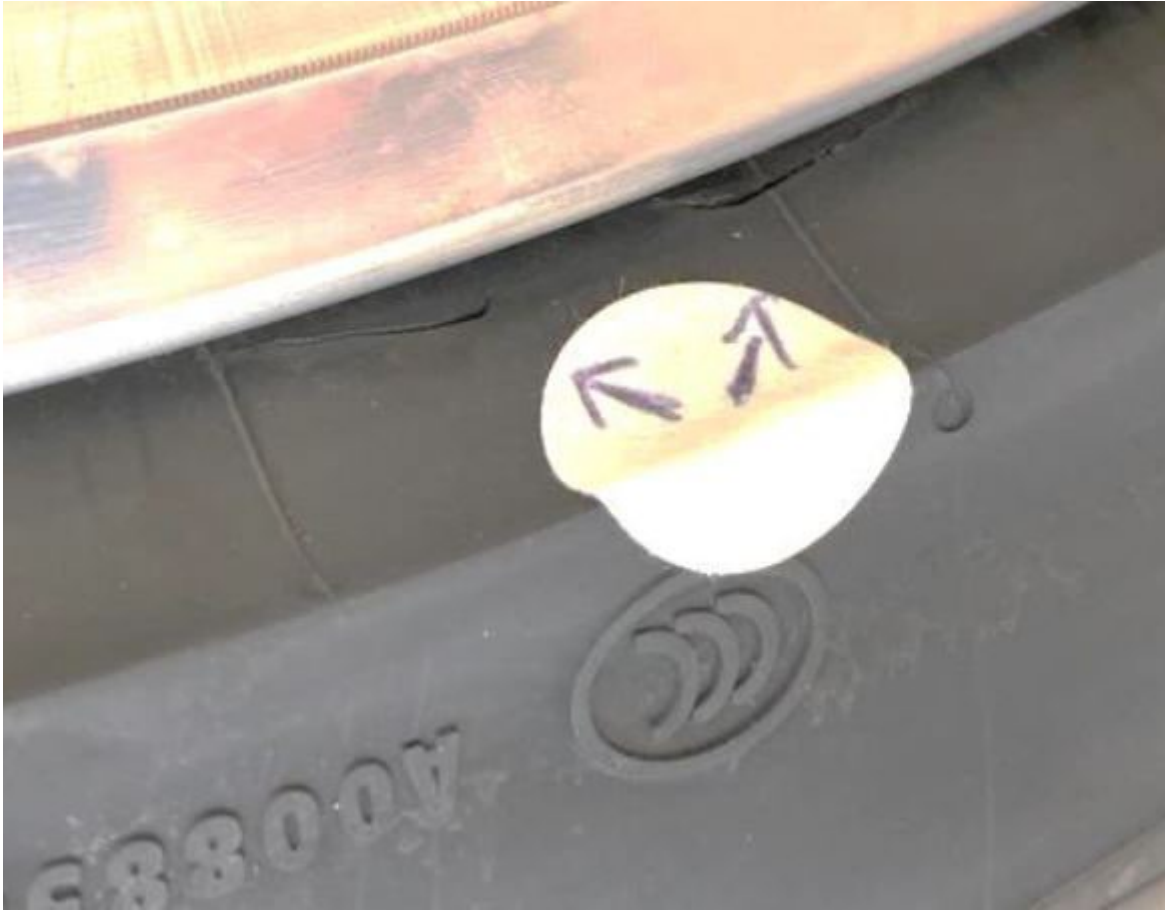
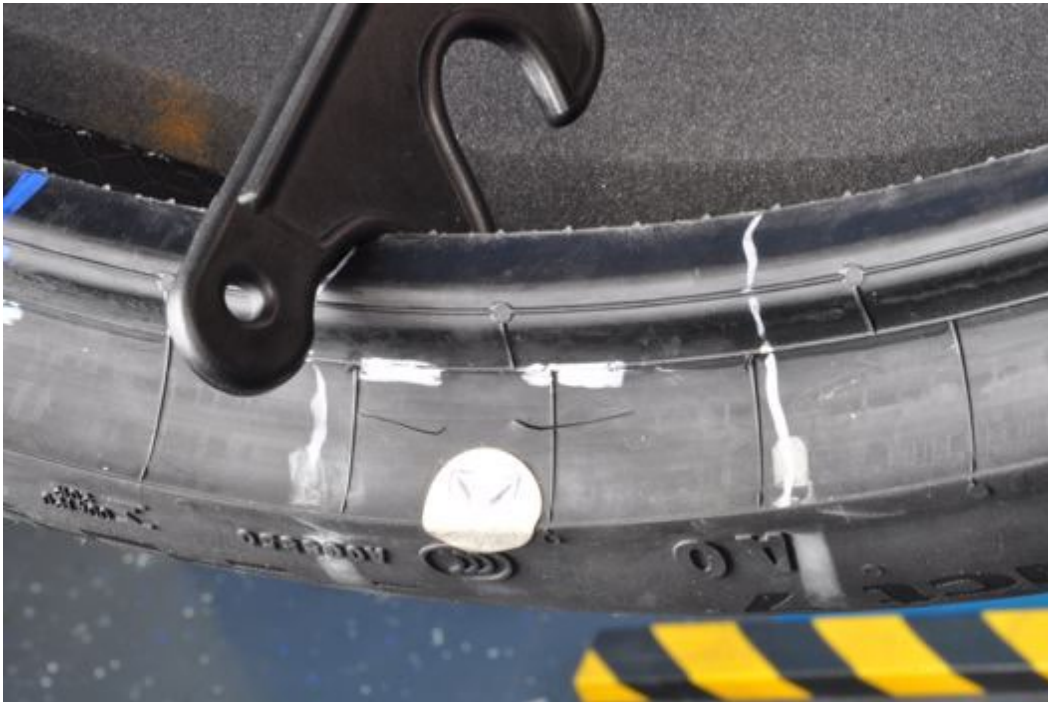
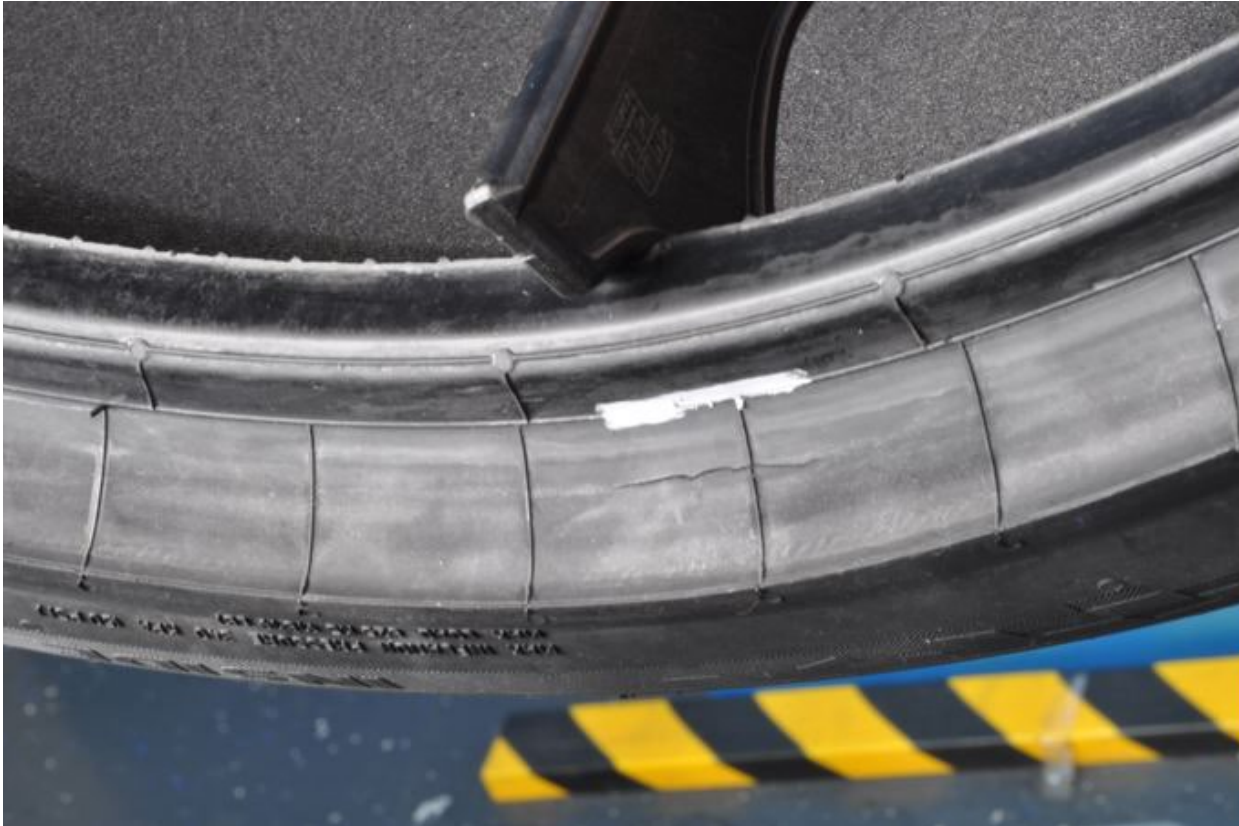
Figures 1 to 4: Cracks in the sidewall

One or multiple cracks can be seen in the rubber on the tire sidewall. Individual crack or multiple cracks spread across the tire bead. They are 1-2 mm deep (Figures 1 to 4).

As part of the manufacturing process, optical deviations may occur on the tire sidewall.

The cracks are only superficial and do not impact the tire function.

- Replace the affected(s) tire(s).
- Submit tires through Warranty Claim Portal on Dealer Tire Website.
