Subject: DOOR GARNISH GAP	Service Alert No.: SA-064/23
	Last Issued : 10/17/2023

2024 CX-90

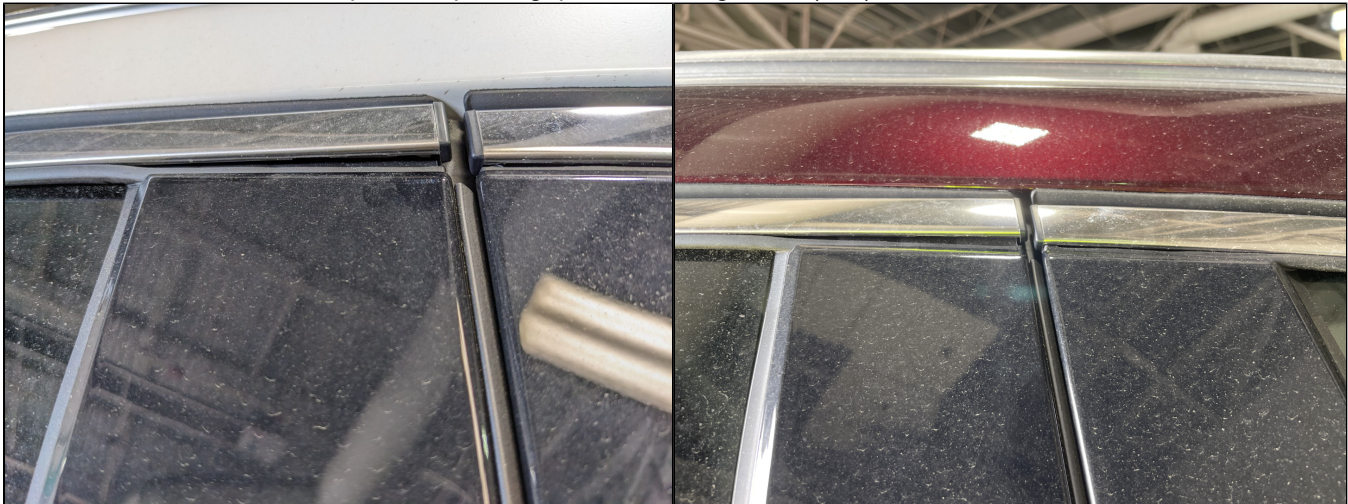
Some customers or dealerships will report a gap at the door garnish (trim).

1. Verify the customer concern,
2. Replace the rear glass run channel on the affected door(s) using the LEFT FRONT DOOR GLASS RUN-CHANNEL REMOVAL/INSTALLATION, RIGHT FRONT DOOR GLASS RUN-CHANNEL REMOVAL/INSTALLATION, or REAR DOOR GLASS RUN-CHANNEL REMOVAL/INSTALLATION procedure.
3. Verify the repair.
