<b>Subject:</b>  PUSH BUTTON START MALFUNCTION HAVE THE VEHICLE INSPECTED WARNING MESSAGE AND DTC C0040:24 / P0504:00	<b>Service Alert No.:</b> SA-062/23
	<b>Last Issued :</b> 10/16/2023

2024 CX-90 (KK)

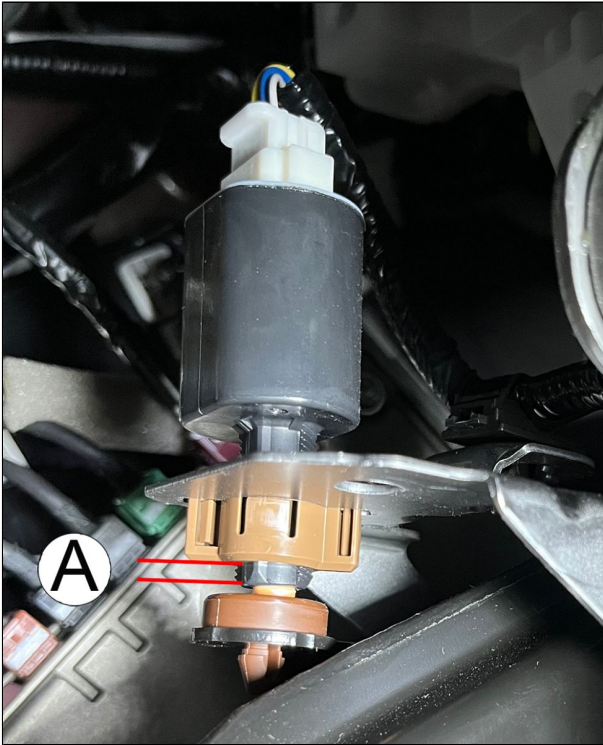
(A) 2 notches

1. Verify customer concern.
2. Inspect brake switch and count adjustment notches as shown below:

If set to 2 notches (A), adjust to 3 notches (B).
