# Technical product information

<b>Topic</b>	Bentayga - Engine oil pressure warning
<b>Market area</b>	Australia E04 Bentley rest Asia and Australia (6E04),China 723 Volkswagen (Anhui) Automotive CO (6723),China 796 VW Import Comp. Ltd (Vico), Beijing (6796),Germany E02 Bentley rest Europe (6E02),Japan E03 Bentley Japan (6E03),Korea, (South) E08 Bentley South Korea (6E08),United Arab Emirates E06 Bentley Middle East and Africa (6E06),United Kingdom E01 Bentley UK (6E01),United States E05 Bentley USA and rest America (6E05)
<b>Brand</b>	Bentley
<b>Transaction No.</b>	2045686/6
<b>Level</b>	EH
<b>Status</b>	Released for publishing
<b>Release date</b>	25-Sep-2023

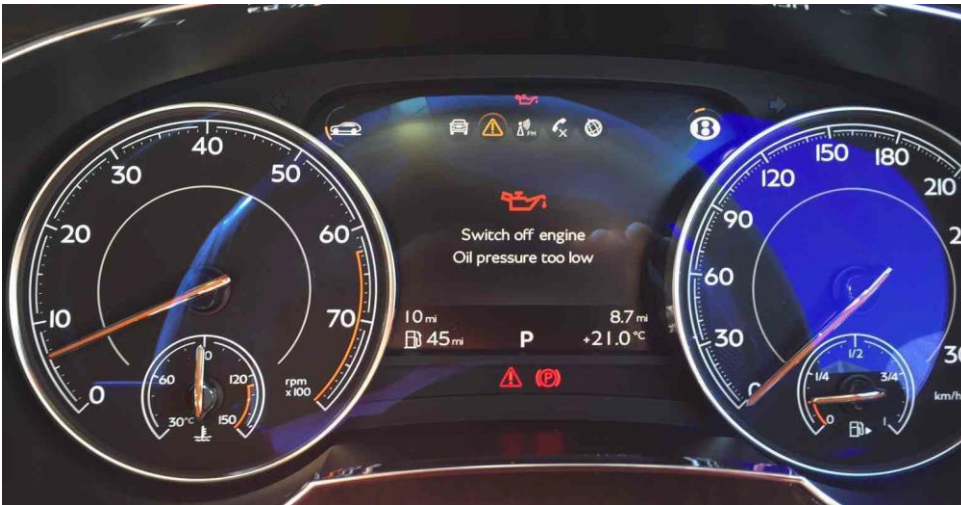
Low oil pressure warning illuminated in the driver instrument panel as shown in Figure 1 and event code P15AA00 is evident in one or both of the Engine Control Modules

In the event of *Oil pressure too low* warning displayed in the driver instrument panel as shown in Figure 1 and event code P15AA00 evident in one or both of the engine control modules then carry out the following checks to confirm the diagnosis is correct before considering replacing the oil control valve (item 1 Figure 2)

1. Confirm engine oil level is correct, if not then correct and retest car
2. Drain and inspect engine oil and engine oil filter for debris (Refill with new engine oil and fit new engine oil filter). If debris is present investigate cause. If required raise a DISS concern for Product Support assistance.
3. Check the function of the suspect solenoid by using the following process:
