Keystone Fifth Wheel – Sidewall Crack Repair

This process describes the safe and proper procedure to repair any unit which experiences a crack at the bottom corner of a slideout at the gooseneck of a 5th wheel by opening the side wall to add reinforcement. This Keystone Service Bulletin explains how to perform the repair.

Model and Serial Numbers Included: 2020-2022 Avalanche and Alpine Fifth Wheel Units
2020-2023 Montana, High Country Montana and Fuzion Fifth Wheel Units

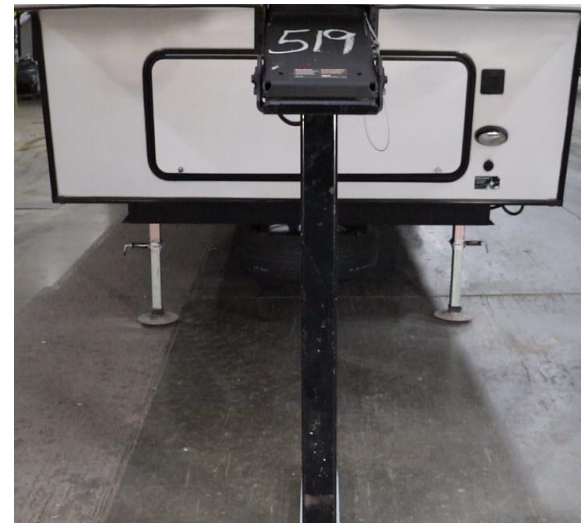
Fig 1

Use the front landing legs, lower the unit on to a tripod so that the front legs are just off the ground placing the weight of the unit on the tripod. Throughout this repair it is very important to not raise the unit. Leave the weight of the RV on the tripod during the repair. **See Figure 1**

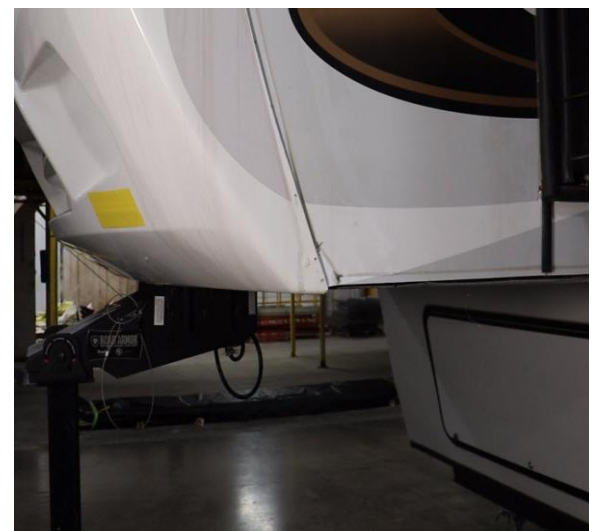
Fig 2

Remove the pre-bent trim from the bottom and both sides of the front cap. **See Figure 2**

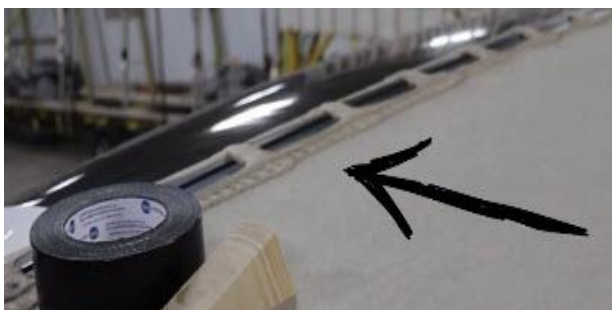
Fig 3

DO NOT remove the screws from the top roof line where the cap attaches. See Figure 3

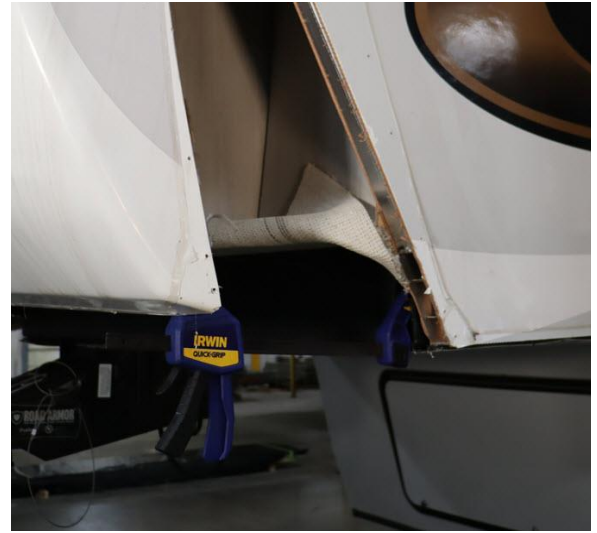
Fig 4

Extend the bottom of the cap approximately 1 foot and brace to hold the cap back out of the way.

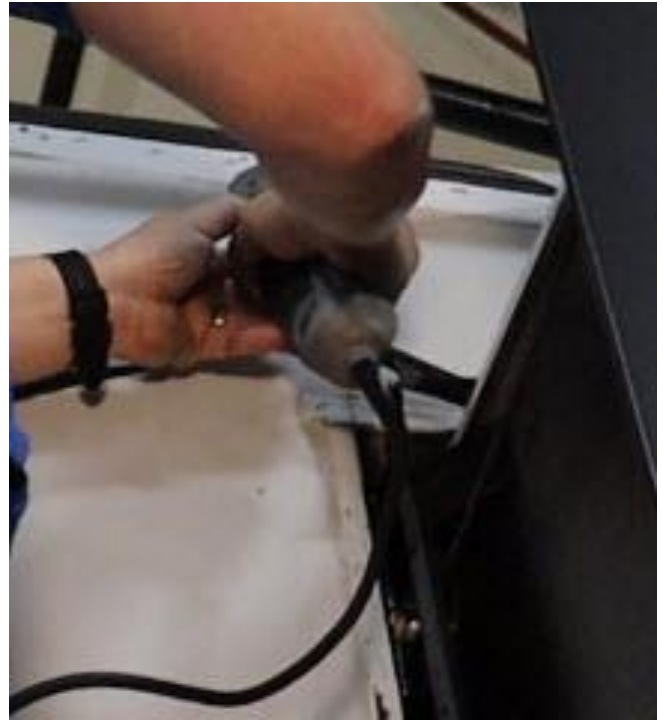
Use the framing square to mark the wall and use the Dremel tool to cut the upper expansion joint even with the slideout opening all the way to the roof line. The cut should only leave a 1/16" gap for the t-molding to tightly fit into. **See Figure 5 and Figure 6**

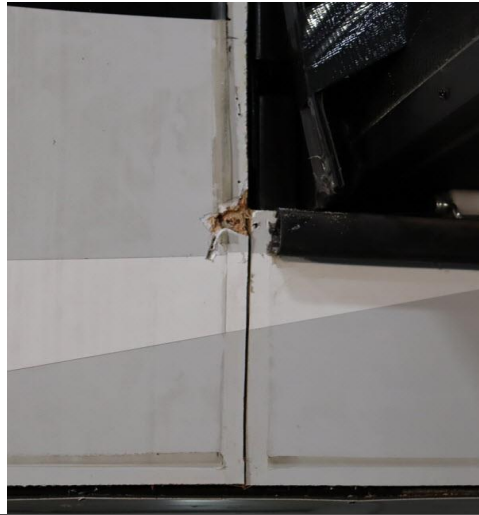
Fig 7

If the unit already has a lower expansion joint remove the t-molding and make sure the joint is cut all the way through, use the Dremel tool to fully cut through top to bottom. If the unit does not have a lower expansion joint cut one even with the slideout opening all the way to the bottom of the filon. Again, the cut should only leave a 1/16" gap for the t-molding to tightly fit into.

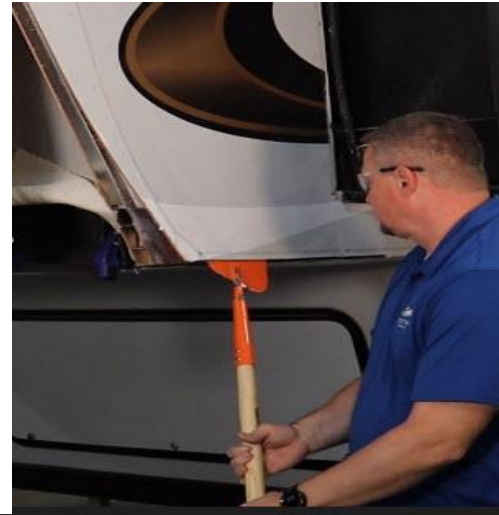
**Fig 8**

Peel back the forward portion of filon to the corner of the slideout top and bottom using a pry bar and flat scraper to release the luan from the aluminum frame and foam. Remove the filon in one piece to use as a template for the new piece. See Figure 8

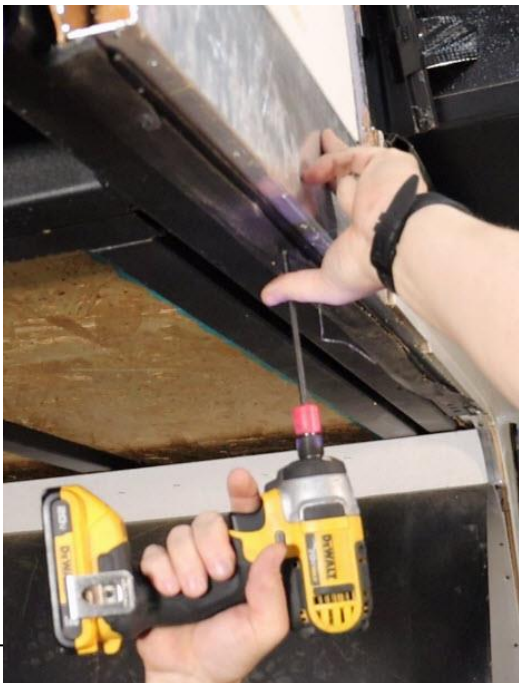
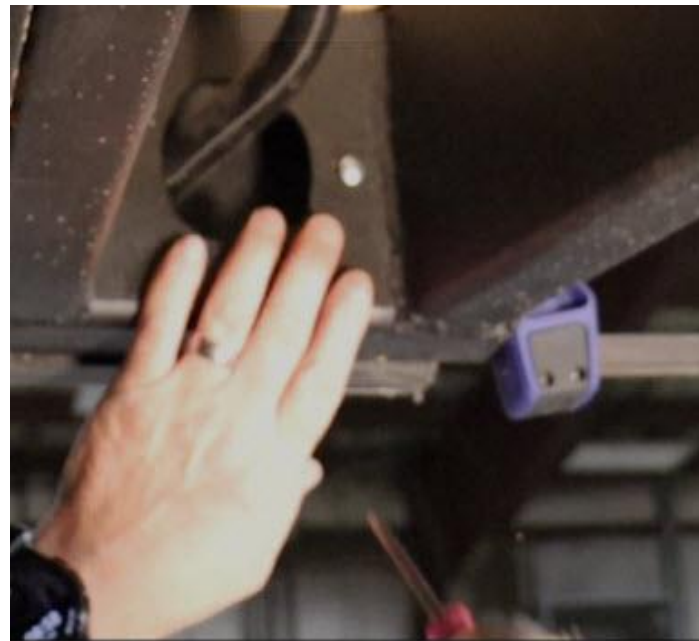
Remove the Bulkhead cover to access and remove the screws from the sidewall straps that hold the sidewalls in place on both sides of the RV. **Figure 9** Check for screws on the backside of the steel frame tube, if screws are found remove them. **See Figure 10** Inspect the sidewall straps for cracks **Figure 9** - if cracked contact LCI to perform repairs to sidewall straps first.

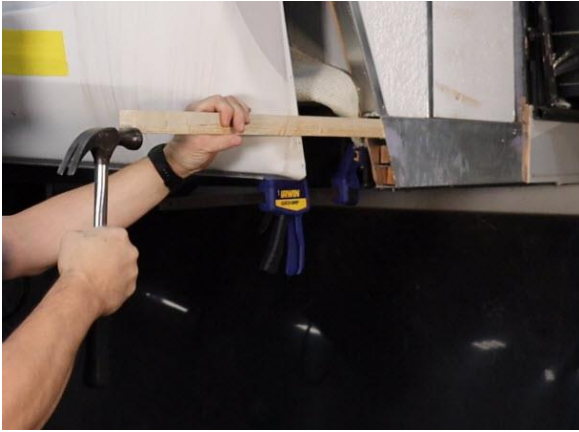
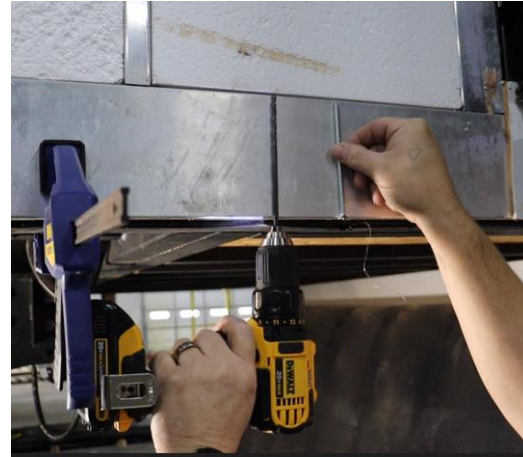
Inspect the 3 sidewall tubes for missing wood. If wood is missing stuff the tubes on both sides of the RV using 1 ¼" x 1 ¼" wood and 1 ¾" x 1 ¼" wood which can be ripped down out of 2x4's or 2x6's Typical length of the wood is 53". If the cap is in the way just release the quick clamp holding the cap out to allow room to insert the wood. **(See Video/Link Top of Front page)** Use a hammer if necessary to drive them in. **See Figure 11** After all tubes have wood installed, pull the sidewall tight to the frame with a clamp and use a 3/16th drill bit to predrill up through the exiting screw holes in the sidewall strap through the wood stuffed tubes, then install #14 X 5" screws. **See Figure 12**

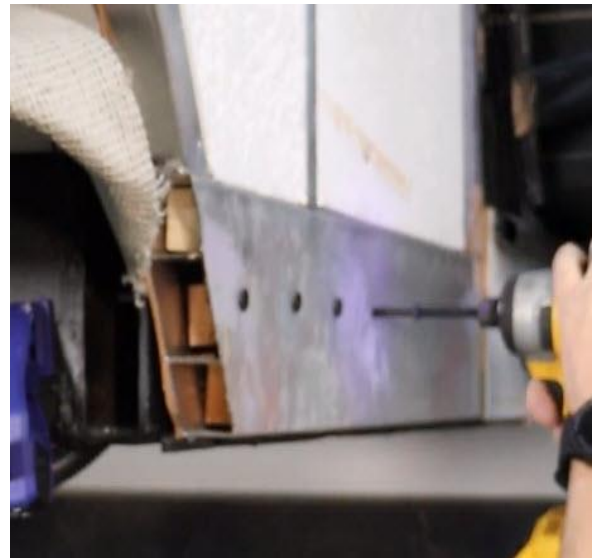
Secure the sidewall to the chassis frame. If wires are present in that tube be sure to install a stop on the drill bit to avoid damaging the wires. **See Figure 13** Using a 7/32" drill bit pre-drill holes through the sidewall and through the 2X6 LCI steel tube. Then add (4) 1/4"-20X3" screws horizontal through the wood stuffed tubes into the center of the steel tube. **See Figure 14**

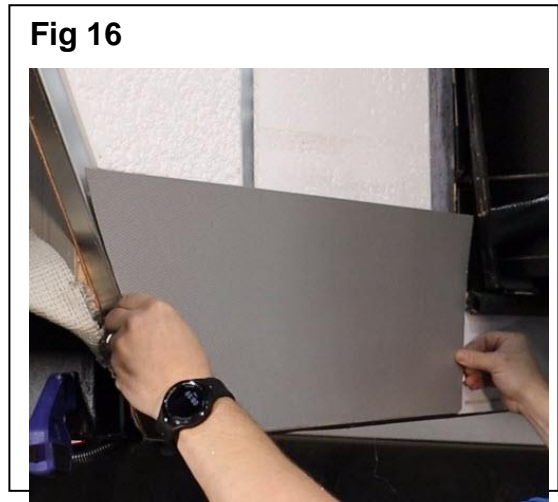
Cut the aluminum skirt metal to fit from the slideout opening to the front of the sidewall and down to the bottom of the sidewall tube. Be sure the metal will cover the 2x6 boards that will go in for the repair. **See Figure 16**

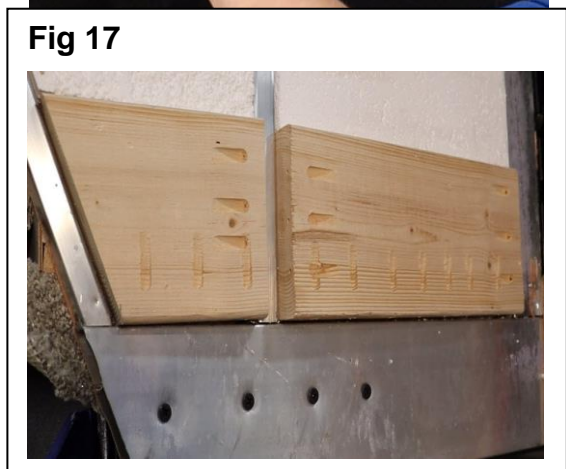
Pocket drill each 2 x 6 and sand both sides of the skirt metal and all aluminum studs with 80 grit sand paper. Using a grinder, remove previously used adhesive from the remaining aluminum framing in preparation for a clean surface to re-adhere to. **See Figure 17**

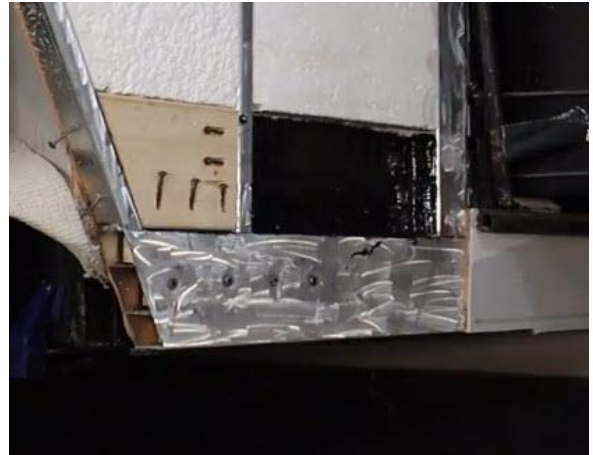
Fig 18

Prep the area using the adhesive the 2 Part Epoxy KRV # 207257 and cover the area with a 1/8" thick layer, then install the 2"x 6" studs and pocket screw in place with 3" screws. **See Figure 18**

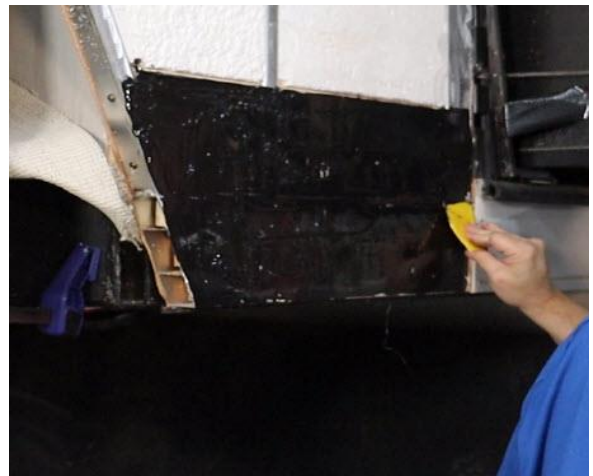
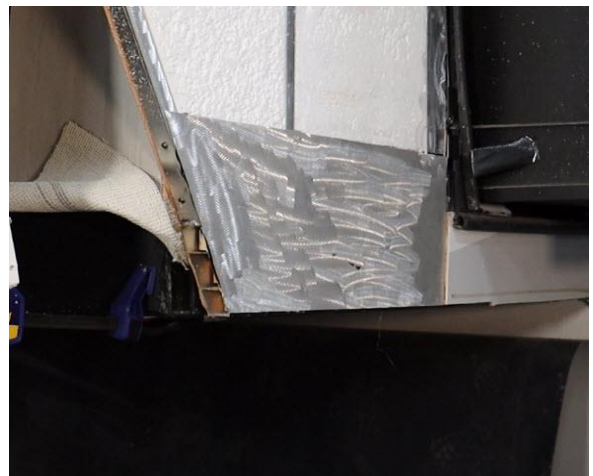
Use the 2 part epoxy again on the aluminum studs and the wood, spread this out in an even layer 1/8" thick and lay the sheet-metal on top of this press firmly and we recommend to staple to hold in place. If you use screws for this step, unless you countersink them you will have to remove them once the epoxy has cured. **See Figure 19 and Figure 20**

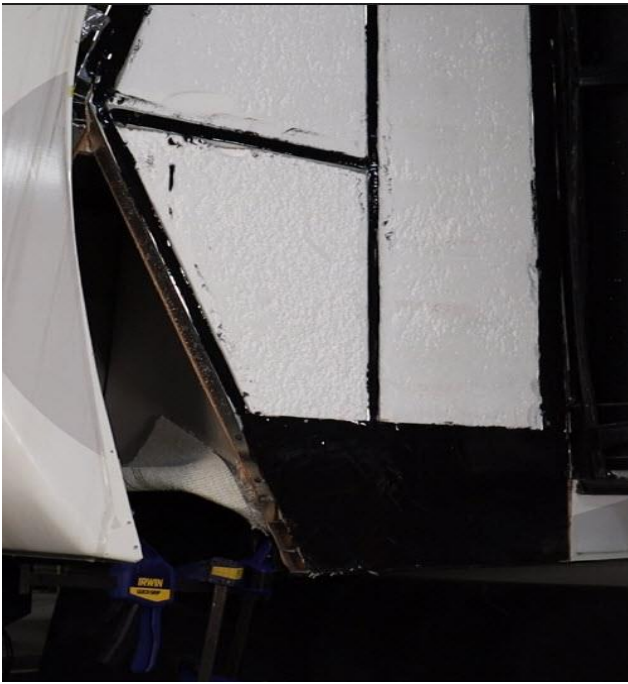
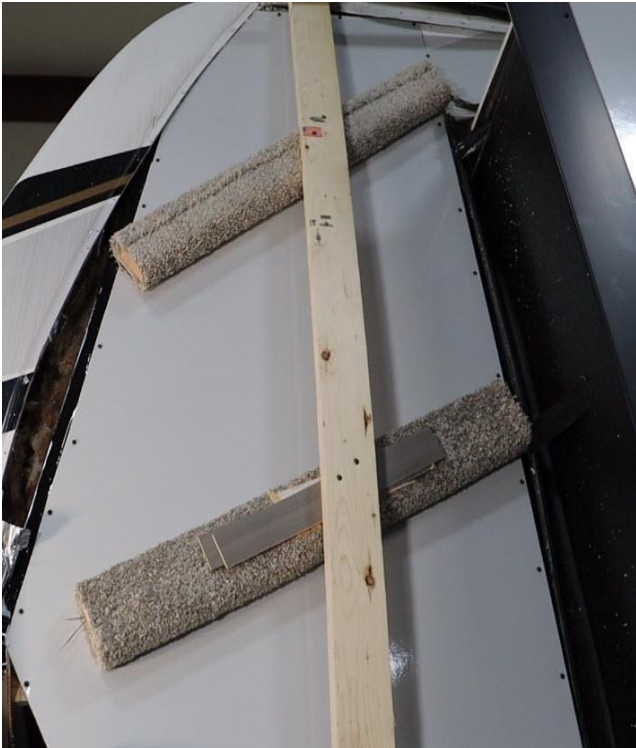
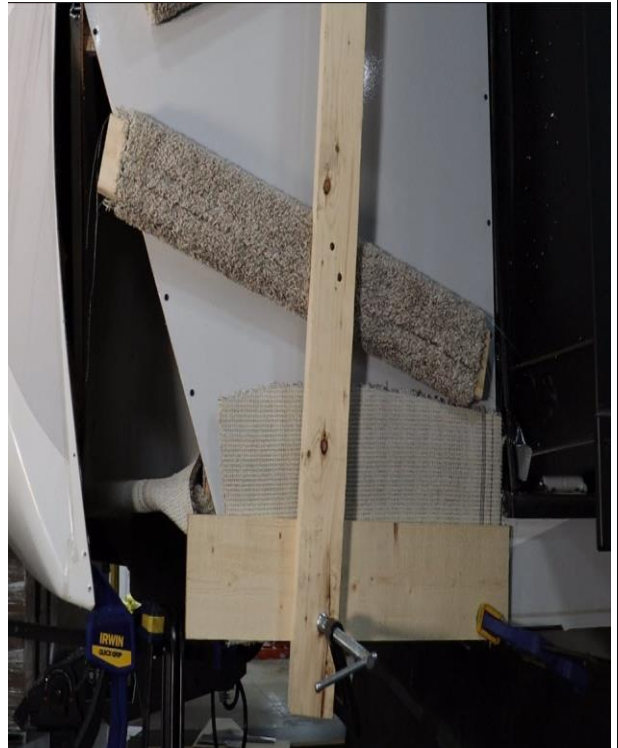
Use the 2 part epoxy again on the aluminum studs, spread this out in an even layer 1/8" thick. **See Figure 21** Then use the Lavanture adhesive KRV# 346665 on the Styrofoam, spread this out in an even layer 1/8" thick. **See Figure 22** Install the new filon in place and add screws to front filon perimeter, the slideout opening perimeter and at the top, the bottom will have to be clamped. Clean off any glue now so it does not dry on the filon. Brace from top to bottom using 2x4's and carpet and allow to dry overnight. **See Figure 23 and Figure 24**

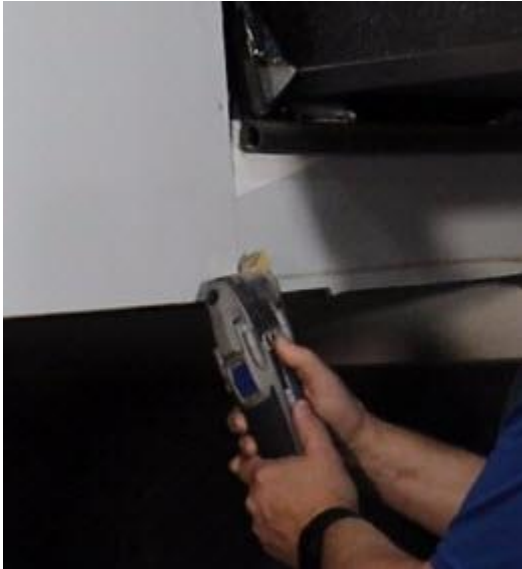
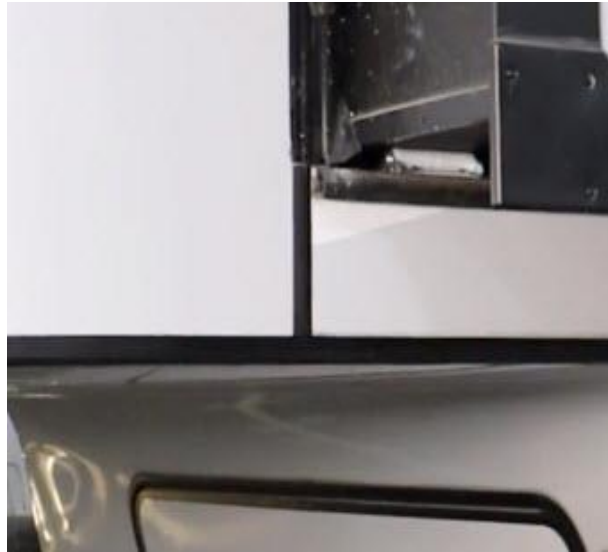
The next day remove the bracing. Remove all the screws used on the edges. Inspect the filon at the edges and trim any excess sidewall skin if necessary. Recut the expansion joints to have the room to then install both top and bottom expansion joint covers with silicone. **See Figure 25 and Figure 26**
