Preliminary Information

PIP5948 Whine Noise Coming From The Transmission

Brand:	Model:	Model Years:	VIN:		Engine:	Transmissions:
			from	to		
Chevrolet	Colorado	2023	All	All	L3B	N8R MFC
GMC	Canyon	2023	All	All	L3B	N8R MFC

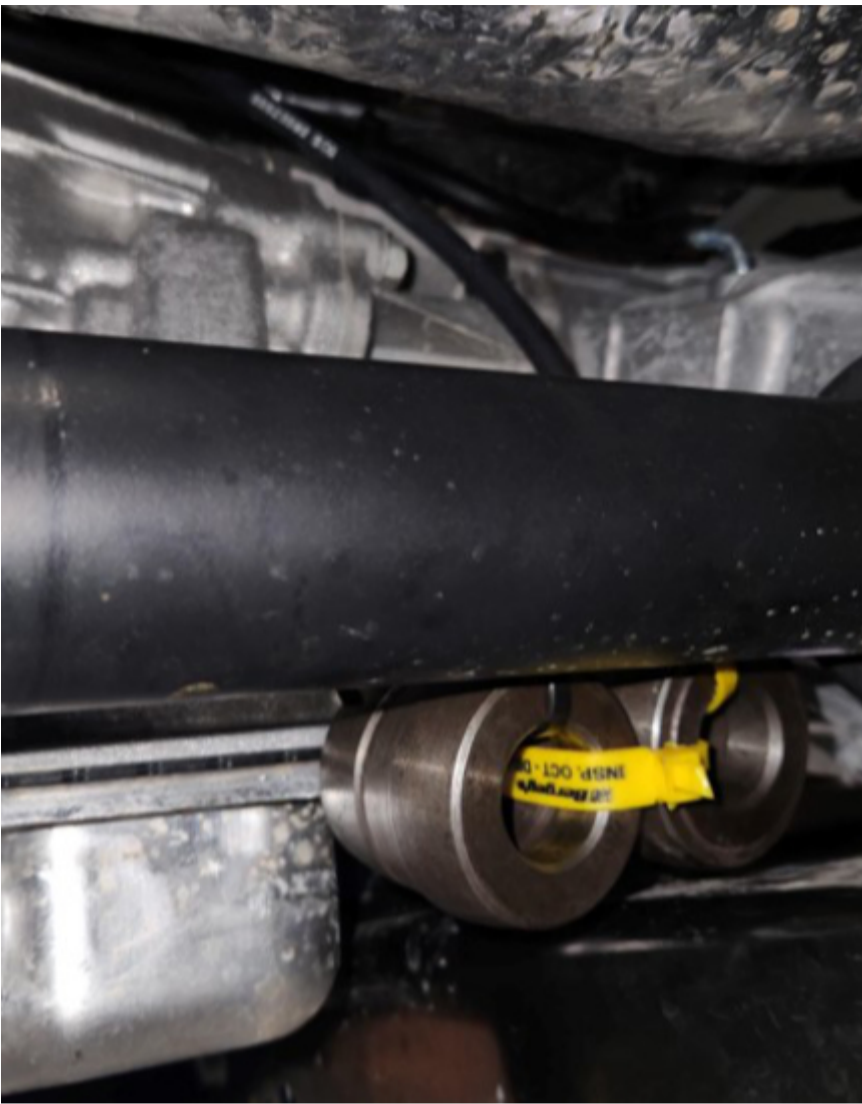
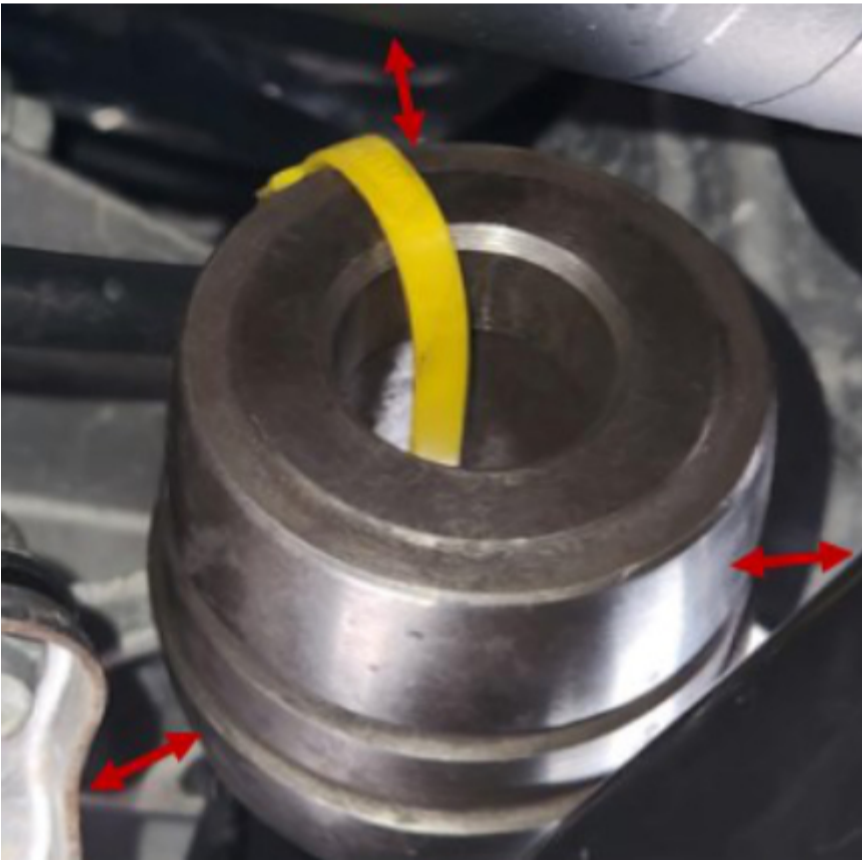
In order to verify this is the concern, the technician should use a heavy-duty zip tie and hang a weight in the location shown below.

Care should be taken to ensure there is no contact at the driveshaft, cross-member, or the transmission assembly.

Please see the pictures Below:

This weight should be at least 1 pound 13 Oz. and the zip tie should be capable of supporting this weight .

Note: It has been found that a cone adapter from the brake lathe works well for this verification.

If this eliminates or reduces the noise, Engineering is aware of the concern and a repair is being determined.

Once the verification has been completed remove the weight from the shift cable.

In the meantime advise the customer this is a known issue and a repair will be available and that the vehicle is safe to drive until the repair becomes available.
