### PIT6078 Front and or Rear Windows Inoperative

Brand:	Model:	Model Years:	VIN:		Engine:	Transmissions:
			from	to		
Chevrolet	Blazer EV	2024	All	All	All	All

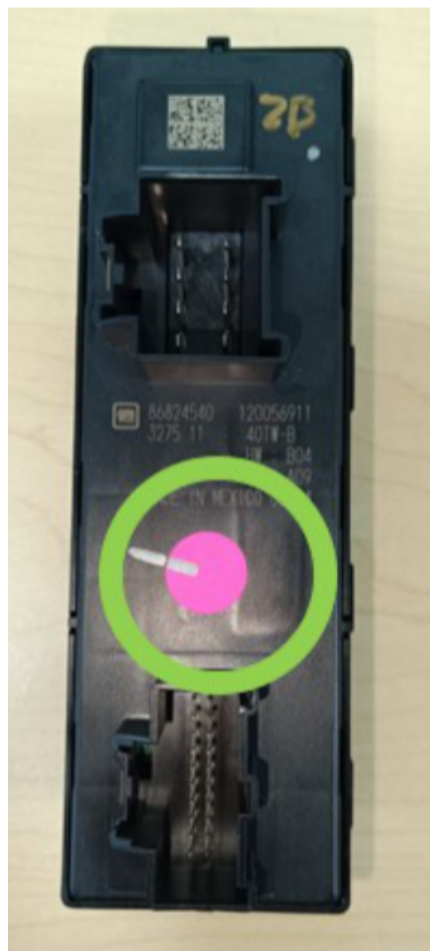
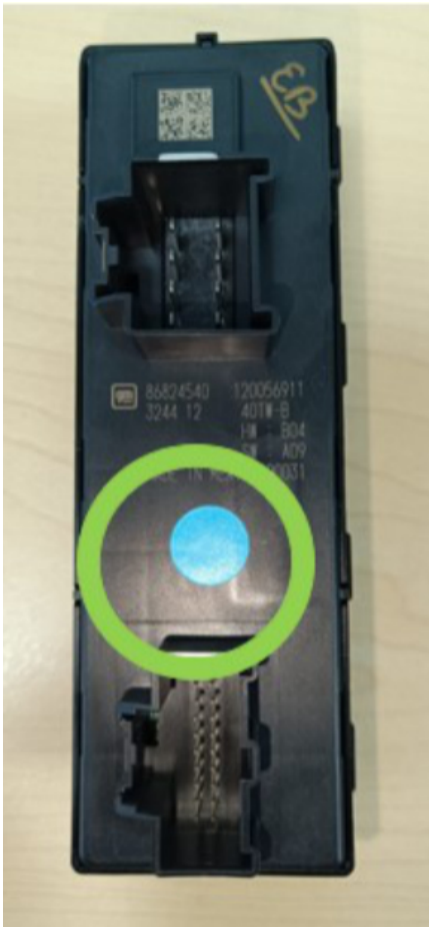
Remove the driver's door trim panel and inspect the window switch for a sticker on the back of the switch. If the switch has a pink or cyan sticker as shown below, test for loose/ bent terminals or circuit faults. If no wiring or terminal concerns are found, the switch may be faulty.

If the switch has no sticker or it has a sticker that is not pink or cyan, replace the window switch.  
Order the replacement switch using EPC. (electronic parts catalog)

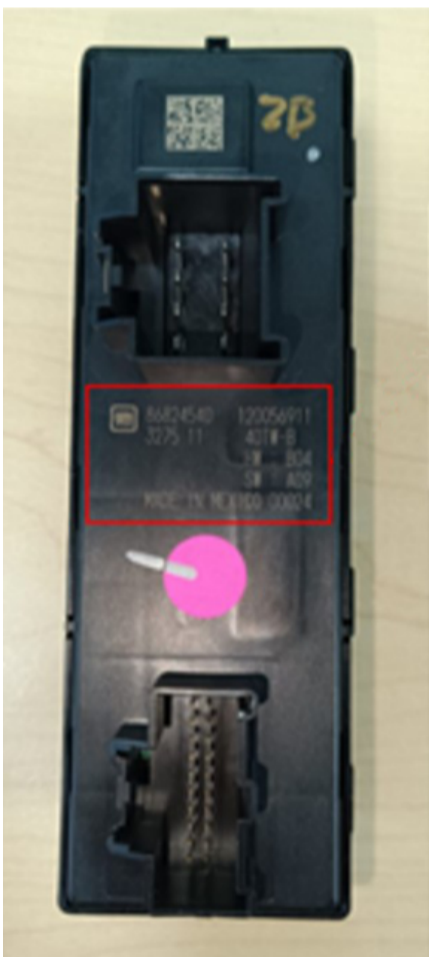
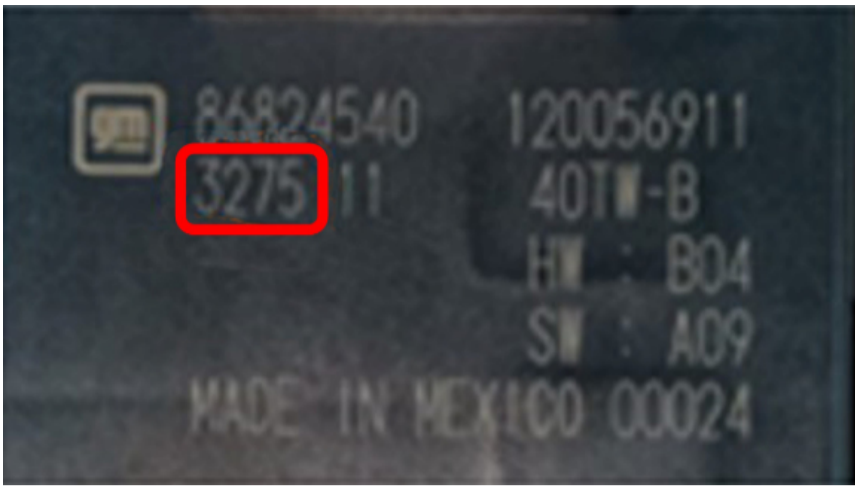
Inspect the Julian date code on the switch.

The date code is located below the part number as shown below.

If the date code is 3156 or 3166 replace the affected switch/s.

Order the replacement switch using EPC. (electronic parts catalog)

If the date code is not 3156 or 3166 test for loose/bent terminals or circuit faults.  
If no wiring or terminal concerns are found, the switch may still be faulty.
