TECHNICAL SERVICE BULLETIN

Classification: RS22-004B	Reference: ITB22-021B	Date: November 2, 2023
------------------------------	--------------------------	---------------------------

SEAT BELT REMINDER SERVICE INFORMATION

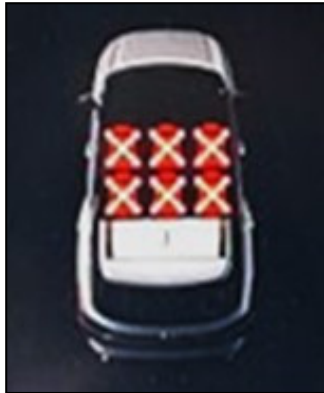
Figure 2

Seat Belt Warning for Rear (Second and Third Row only, with Second Row Bench Seat)

- Red occupant or red exclamation point displays for unbuckled status.
- Grey/green occupant or green check mark displays for buckled status.

- After turning the ignition ON with the vehicle stationary (not moving), the Vehicle Information Display image will display a status of unbuckled (red occupant or red exclamation point) for both a buckled or unbuckled rear seat, as described in **Table 1**.
- The driver has the ability to temporarily dismiss the Visual Indicator through the Vehicle Information Display by scrolling to a different menu.

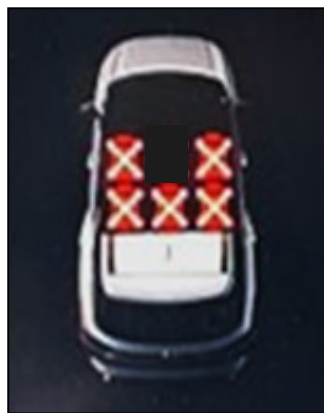
Figure 4

Seat Belt Warning for Rear (Second and Third Row only, with Second Row Bucket Seats)

- Red occupant or red exclamation point displays for unbuckled status.
- Grey/green occupant or green check mark displays for buckled status.
