Technical product information

Topic	During the Pre Delivery Inspection (PDI) the high voltage coolant level is not at maximum (Between minimum and maximum)
Market area	Australia E04 Bentley rest Asia and Australia (6E04),China 796 VW Import Comp. Ltd (Vico), Beijing (6796),Germany E02 Bentley rest Europe (6E02),Japan E03 Bentley Japan (6E03),United Arab Emirates E06 Bentley Middle East and Africa (6E06),United Kingdom E01 Bentley UK (6E01),United States E05 Bentley USA and rest America (6E05)
Brand	Bentley
Transaction No.	2072251/1
Level	EH
Status	Approval
Release date

Bentayga Hybrid

New Flying Spur Hybrid

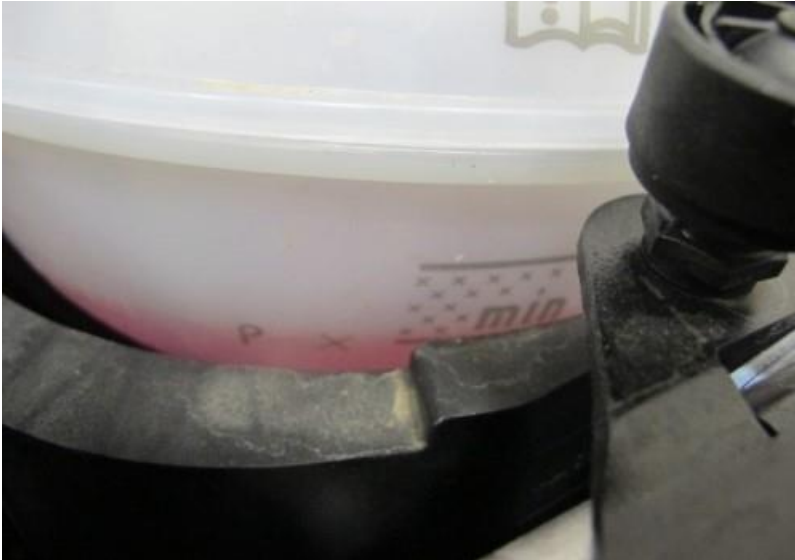
During the Pre Delivery Inspection (PDI) the high voltage coolant level is not at maximum (between minimum and maximum) as shown in Figure 1

The high voltage coolant fill procedure which is conducted during the manufacturing process has been improved to ensure the high voltage coolant system is filled to the maximum mark, however the coolant level may reduce slightly during transportation

- 1) Take a photograph of the low coolant level before top up (Figure 1)
- 2) If the coolant level is **between the minimum and maximum mark** the high voltage coolant system should be topped up to the maximum mark - Refer to Rep.Gr 19
- 3) Take a photograph of the coolant level after top up (Figure 2)
