Bulletin No.: PIC6289D Published date: 11/29/2023

PIC6289D Noise from Exhaust Valves

Brand:	Model:	Model Years:	VIN:		Engine	Transmissions:
			from	to	Engine:	Transmissions.
Chevrolet	Camaro	2016 - 2024	All	All	LGX, LT1, LT4	All

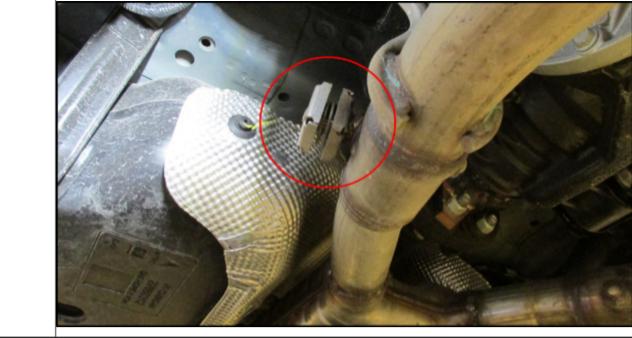
Mechanically Operated Exhaust Valve

Involved Region or Country	United States, Canada, Mexico, United Kingdom, Sweden
Condition	Some customers may comment on a Check Engine Light (CEL) or an exhaust noise. Upon further inspection, dealership technicians may find a P12FD or a P12F0 set.
Cause	P12F0 set. This concern may be caused by an exhaust actuator that was installed but the learn procedure was not completed. This concern will occur on new vehicles with low mileage, or on vehicles that recently had service work done to the exhaust system. Note: This PIC is intended only for electronically controlled exhaust valves. Some vehicles are equipped with Passive Exhaust Valves (PEVs) that are purely mechanical in nature. They are spring operated and they are not able to be externally controlled. Photos of each type of valve can be seen in the two photos below: Electronically Operated Exhaust Valve

Dealership technicians are to relearn the Cylinder Deactivation Valves using GDS2 to resolve this concern.

These valves are also referred to as the Active Fuel Management (AFM) valves. They are located before, or in front of, the muffler. Do not replace any parts for this concern.
