## INVERTER WIRING PREP

| <b>Bulletin #(s):</b> | 23-125 | <b>Make(s):</b> | Jayco |

| <b>Incident:</b> | Inverter prep is not installed |
| <b>Affected Units:</b> | 2024 Jayco Eagle HT FW |

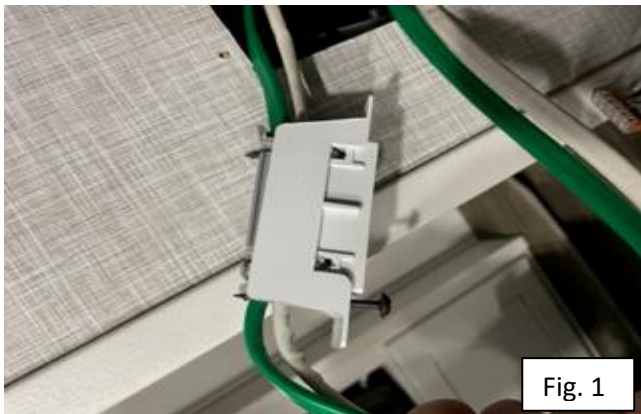
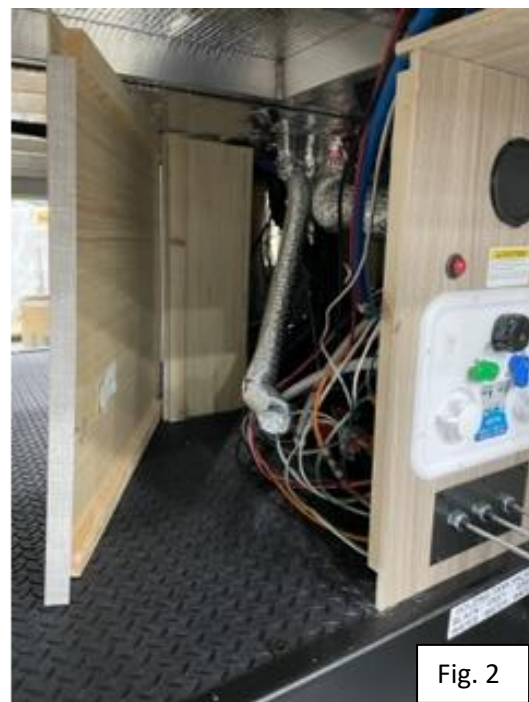
1. Ensure main breaker at converter is flipped in the “off” position and the unit is unplugged from shore power.
2. Go inside coach and remove converter by removing the cover and then all 4 screws securing the converter with a #2 square bit.
3. Find the blank receptacle containing two 14-2 green wires and two 14-2 white wires. Remove the green wires from the blank receptacle. **Figures 1 and 2**

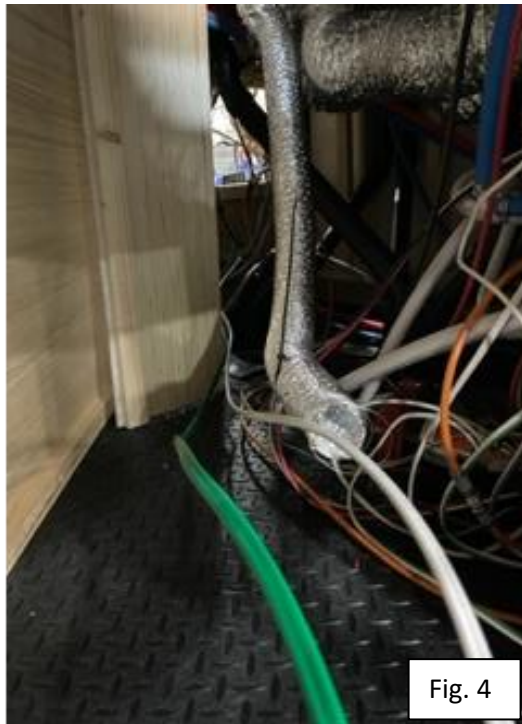
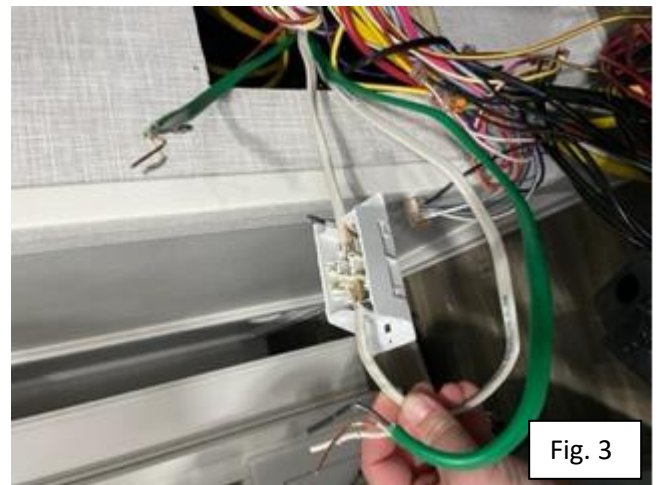
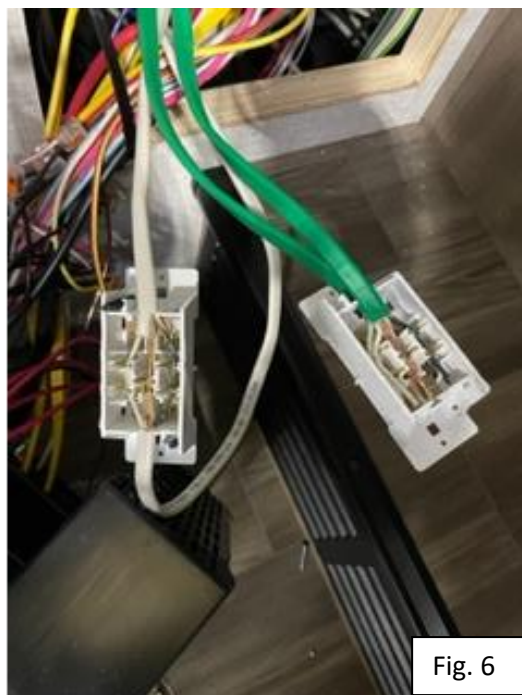
Feed a new green 14-2 wire and a new white 14-2 wire back into the basement where the inverter is desired to be installed (recommended to go under the basement floor in the pass through storage). (Figures 3-5)

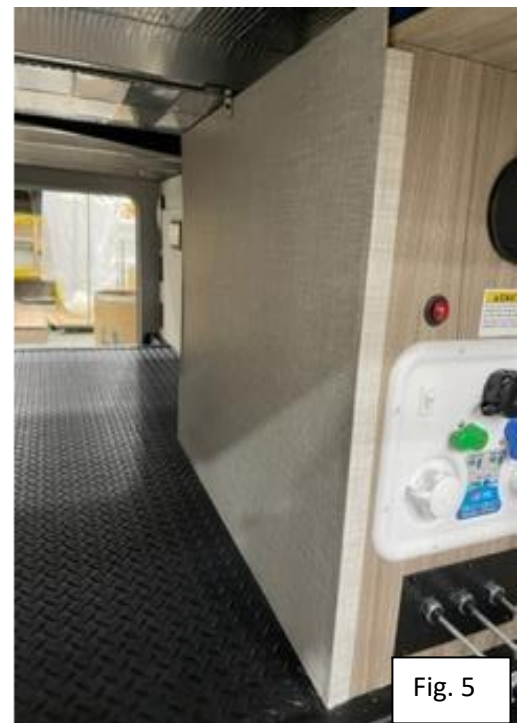
4. Install the new white wire in the existing blank recept and resecure. (Figure 6)

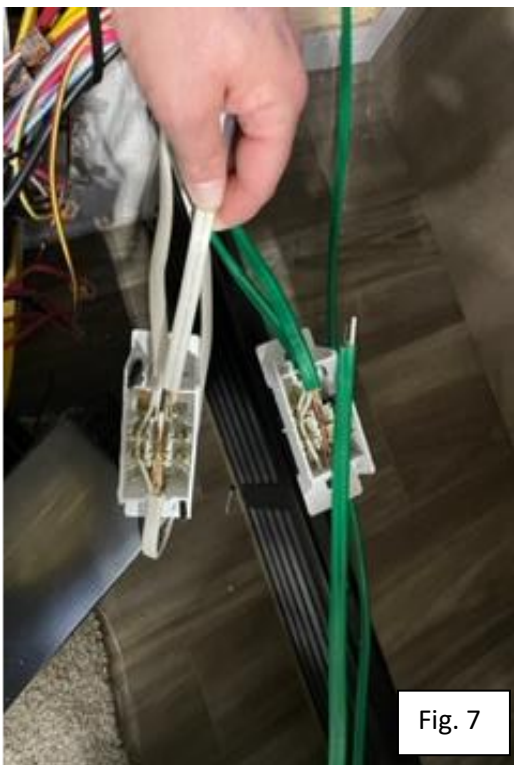
5. Install the new green wire in a new blank recept with the two green wires that were removed in step 3. **Figure 7**
6. The green wire in the pass through is the “out” for the inverter and the white wire is the “in” on the inverter. Reinstall the converter.
