STAR ONLINE PUBLICATION

Case Number: S238A000044

Symptom/Vehicle Issue: Radio Display Blank Screen, Vertical Lines On The Display Or Radio Screen Freezing

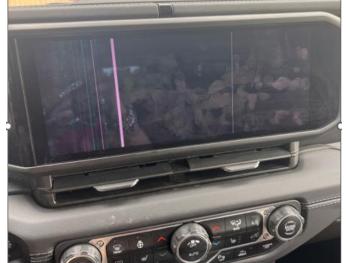
Fig 1 Fig 2

Discussion: Customer complains the radio display is a Blank Screen, vertical Lines on the display or radio screen freezing. This is a known issue and Engineering is investigating into this. Perform a hard radio reset. Push and hold the Volume/Power knob for 10 seconds till the radio resets. Then leave vehicle key on/running outside for 15 minutes to recover by its own. See pictures for reference. Rear View Camera is not impacted by this issue. RVC will display properly.

Do not replace radio for this concern. Replacement radios will perform the same.
