## Case Number: S2308000121

**Symptom/Vehicle Issue:** Check Engine Lamp (CEL) On, Diagnostic Trouble Codes (DTCs) P0245, P2AB8

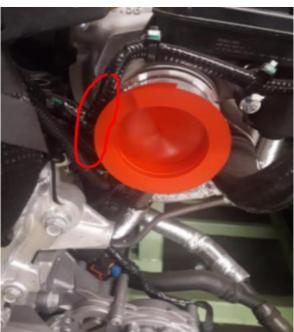
**Repair Procedures Index**

**Diagnostic Procedure:** Inspect the engine harness between the turbo and intake air hose for any signs of pinching or chaffing. Repair any damaged circuits as illustrated in Service Library (SL) > Splicing and Repair Guidelines > Repair Procedure Index > North America - Repair
