STAR ONLINE PUBLICATION

Case Number: S2308000141

Symptom/Vehicle Issue: Park Brake Warning Lamp Illuminated and Flashing, Cluster Warning Message to “Service Park Brake”

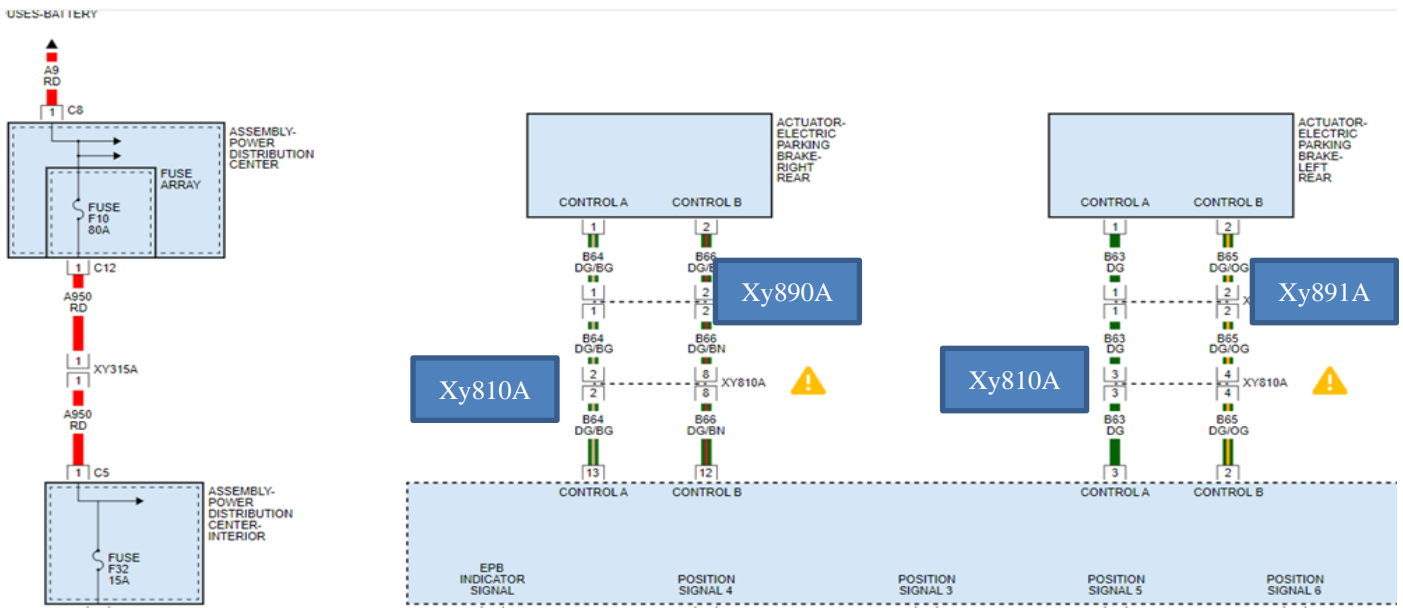
Fig 1

Customer Complaint/Technician Observation: The owner complains the park brake warning lamp is on and is flashing. The Instrument Panel Cluster (IPC) may display a “Service Park Brake” Message on some vehicles. The technician observed the Diagnostic Trouble Codes (DTCs)

C060B-00 or C0610-00 Left or Right Park Brake Actuator Control Circuit/Open
C060D-00 or C0612-00 Left or Right Park Brake Actuator Control Circuit High
C10EA-00 Left Park Brake Actuator.

Repair Procedure: Verify all connections are secure using the push-pull-push method looking for any Terminal Pushouts or Spread terminals at the component actuator, inline connectors Xy890A, Xy891A, Xy810A or the Module Brake System Control as needed Fig 1, 2, 3.

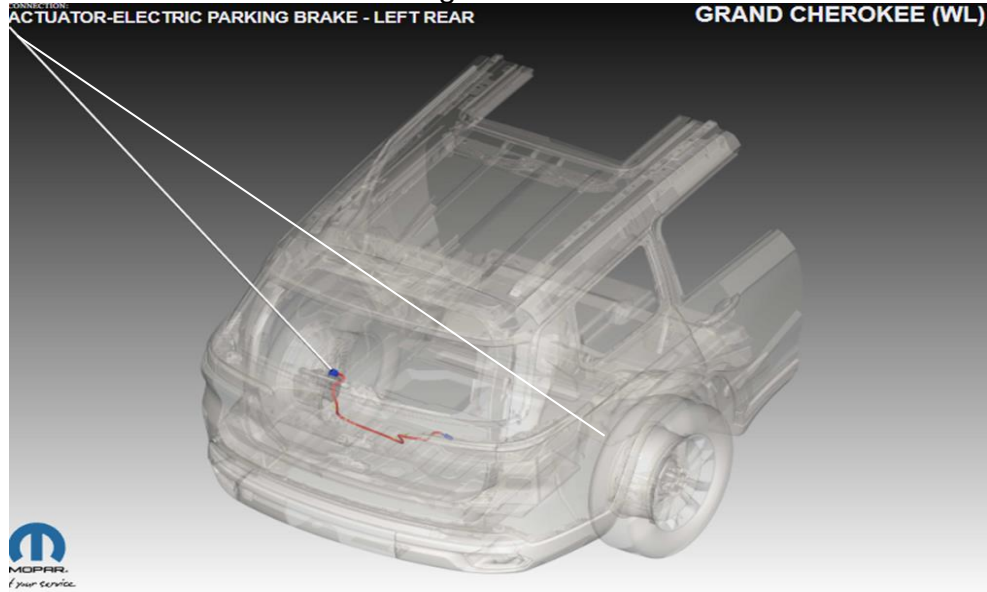
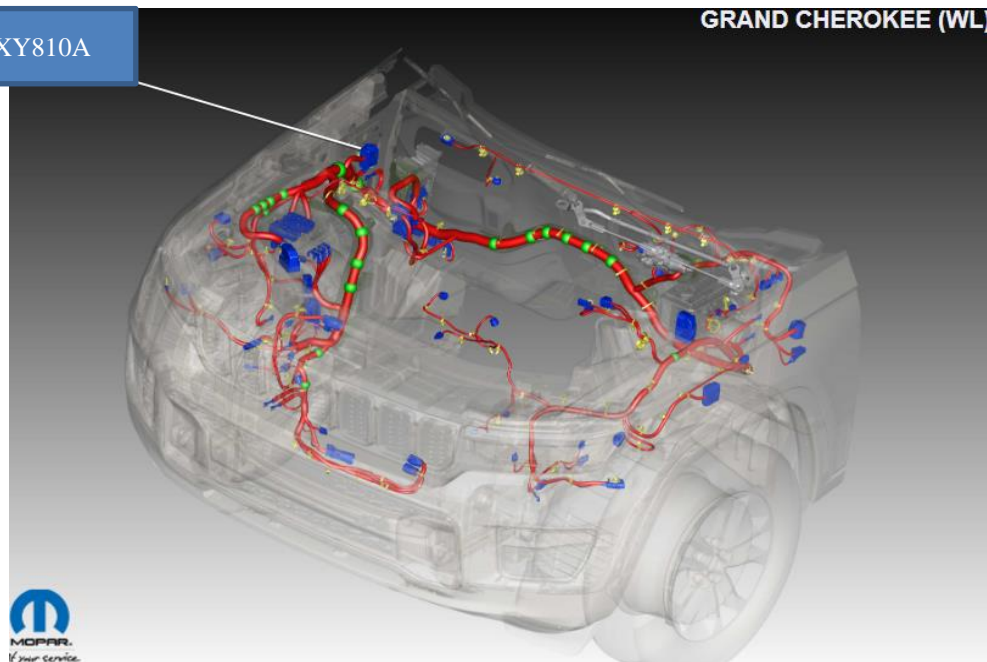
Fig 2

Left or Right rear actuators

XY810A

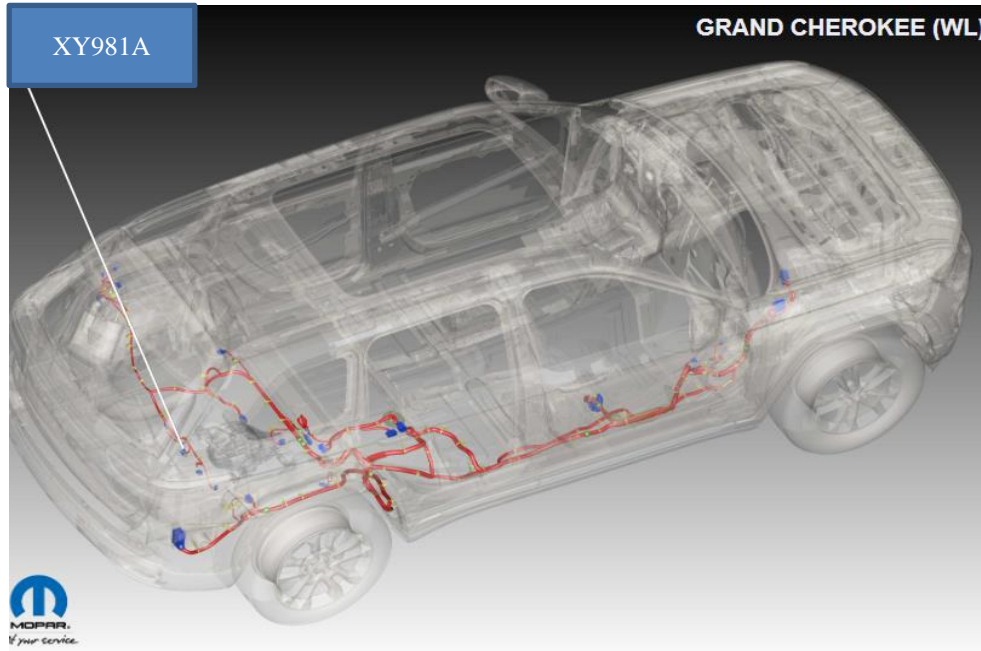
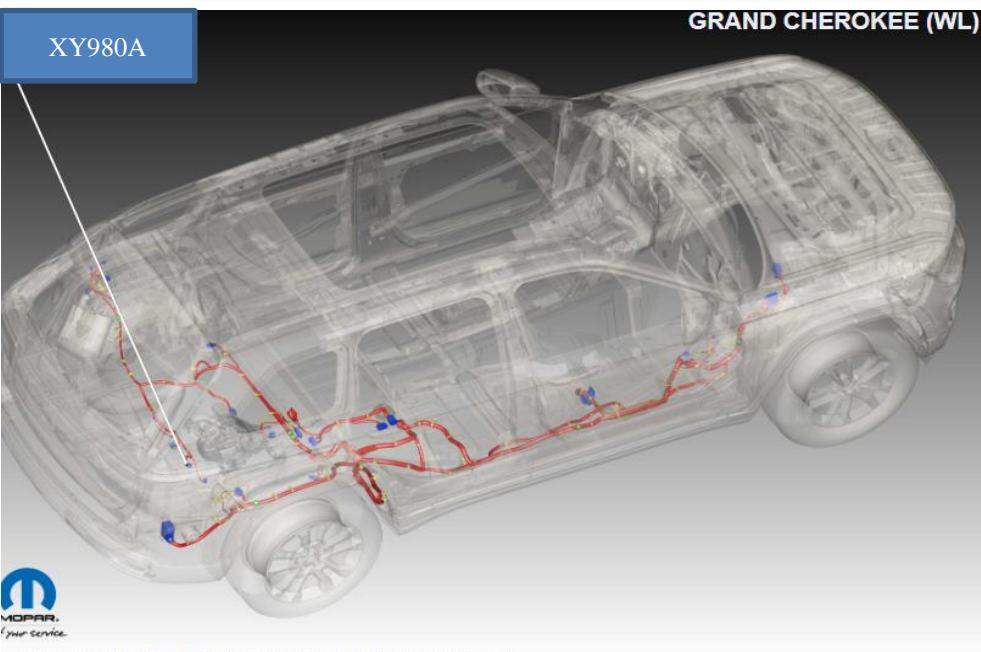
Fig 3

NOTE: This Harness Assembly is a COMPOSITE depicting all available options. Some connectors may not be present on vehicle.
