Bulletin No.: PIT6078A

### PIT6078A Front and or Rear Windows Inoperative

Brand:	Model:	Model Years:	VIN:		Engine:	Transmissions:
			from	to		
Chevrolet	Blazer EV	2024	All	All	All	All

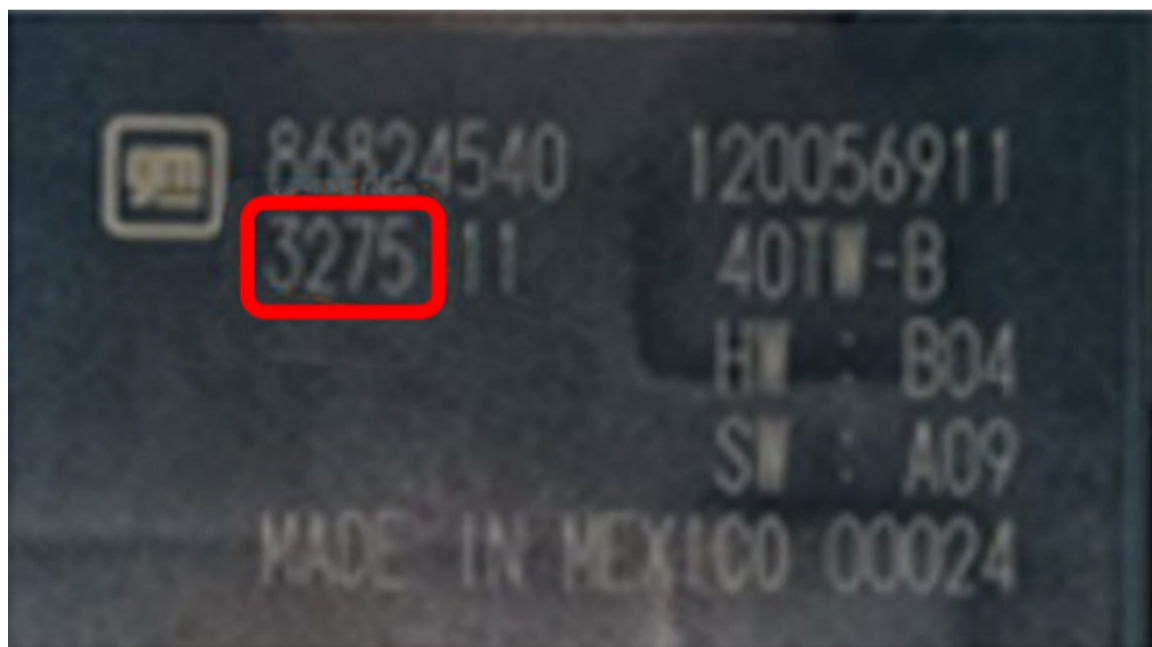
Remove the driver's door trim panel and inspect the Julian date code on the driver's window switch.

The Julian date code is located below the part number (see illustration below of front switch).

If the date code is 3245 or lower replace the switch.

If the date code is 3246 or higher follow SI diagnostics.

The date code is located below the part number as shown above.

The rear switch is configured differently than the front which is shown above. The date code is still below the part number but is above the GM logo instead of next to it.
