HUSQVARNA TECHNICAL BULLETIN HTB2401 - USA

JANUARY 16, 2024

START/STOP SWITCH REPLACEMENT

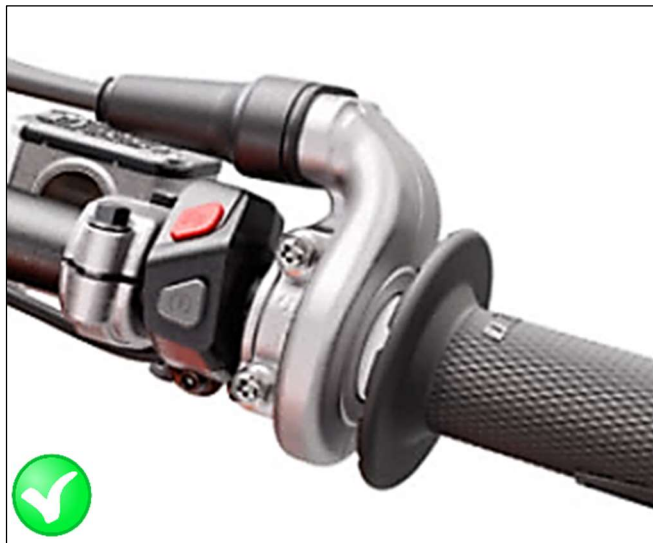
Fig. 1 – New Start/Stop Switch #A46011074000

1. Remove the headlight mask, throttle housing and grip.
2. Replace the original start/stop switch with the new replacement start/stop switch using part number **A46011074000**.
3. Reinstall the throttle housing (torque 5 Nm), grip and headlight mask.
4. Destroy the original start/stop switch by cutting the wires and take a photo of it so you can attach it to the TI warranty claim (Fig. 3).
5. Submit the TI warranty claim with the photo of the destroyed start/stop switch.

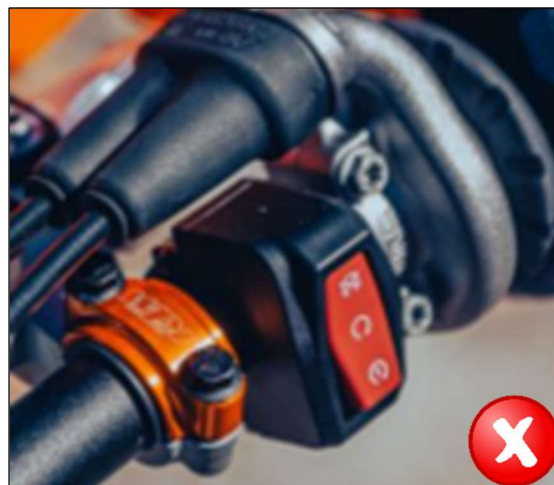
On motorcycles with the currently installed start/stop switch (p.n. A49011074000), there may be problems with the motorcycle starting automatically.

Fig. 2 – Old Start/Stop Switch #A49011074000

For this reason, the start/stop switch (p.n. A49011074000) installed on affected motorcycles must be replaced with a different version (p.n. A46011074000).

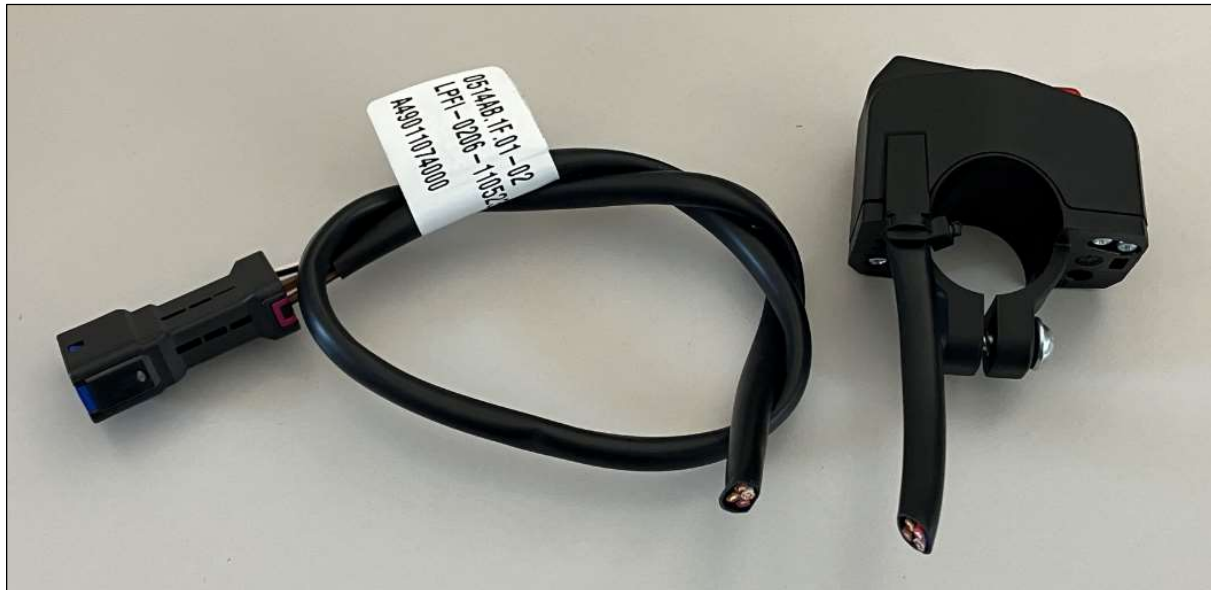
Fig. 3 – Destroy the original start/stop switch, take a photo of it and attach the photo to the claim before submitting.

Replaced start/stop switches #A49011074000 must be stored for at least 6 months and must NOT be disposed of before the 6 month storage time period. A photo of the replaced and destroyed switch (see Fig. 3) must be attached to each TI warranty claim.
