Service Alert

Subject: TRANSMISSION DESIGN CHANGE (PART SUPERSESSION)	Service Alert No.: SA-002/24
	Last Issued : 01/10/2024

2024 CX-90 (H3T)

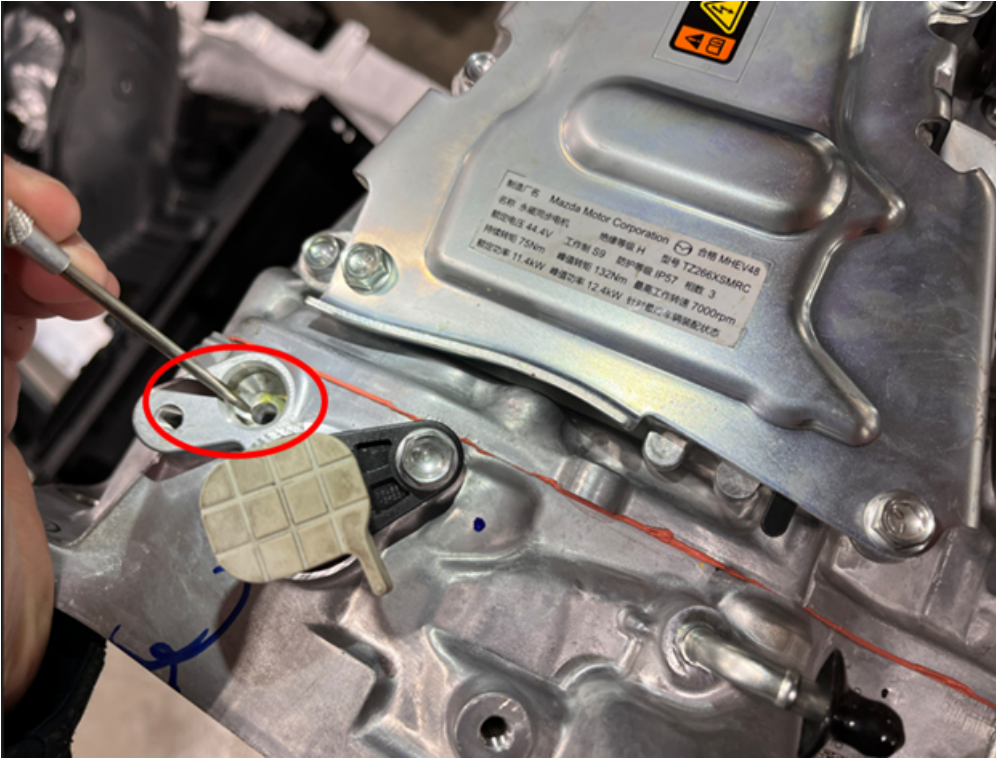
Original Design (Transmission Hole Drilled)

Old design originally required a coolant line running to the top of the bell housing, the new design has omitted the hole and need for the coolant line.

The new/superseded design can be used in place of the old/original design and the coolant hose is no longer needed to be used.
