January 24, 2024

Version 4

Warranty Extension: 2016-2021 Civic A/C Compressor Shaft Seal Leak (1.5T, 2.0, 2.0T)

Supersedes 23-039, dated September 28, 2023, to revise the information.

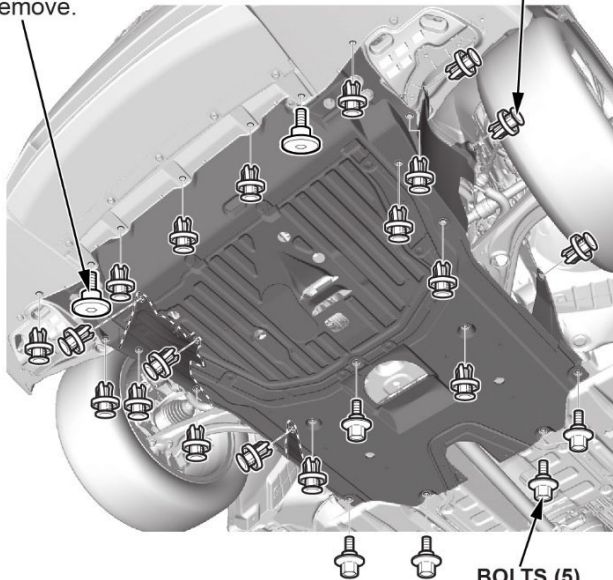
1. Remove the right-front tire.
2. Remove the engine undercover.

SCREWS (2)
9.3 N.m (6.9 lb-ft)
Remove.

CLIPS (19)
Remove.

BOLTS (5)
9.3 N.m (6.9 lb-ft)
Remove.

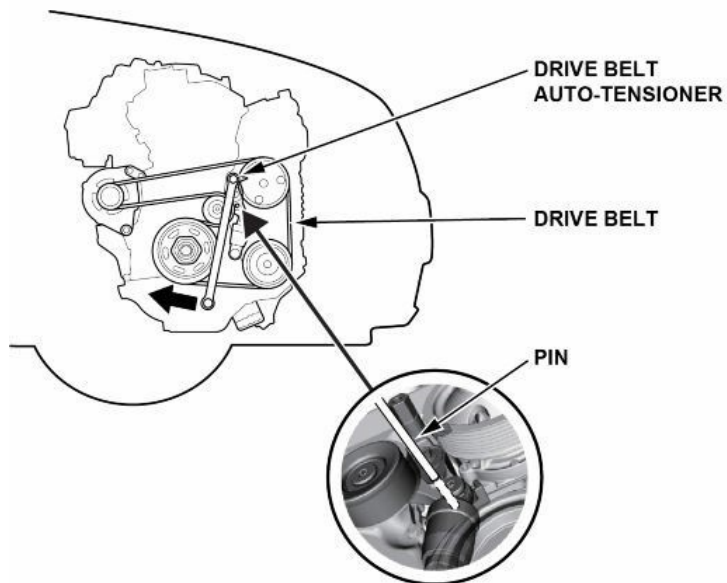
3. Remove the drive belt.

NOTE: This is a hydraulic type auto-tensioner so turn the wrench slowly for at least **3 seconds**.

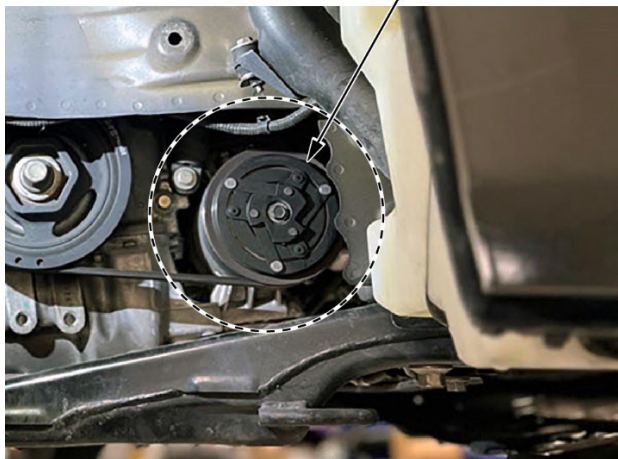
4. Inspect for oil on the armature plate surface of the compressor.

NOTE: If any oil is stuck to the armature plate surface of the compressor, then proceed to the repair procedure.

Inspect for oil.

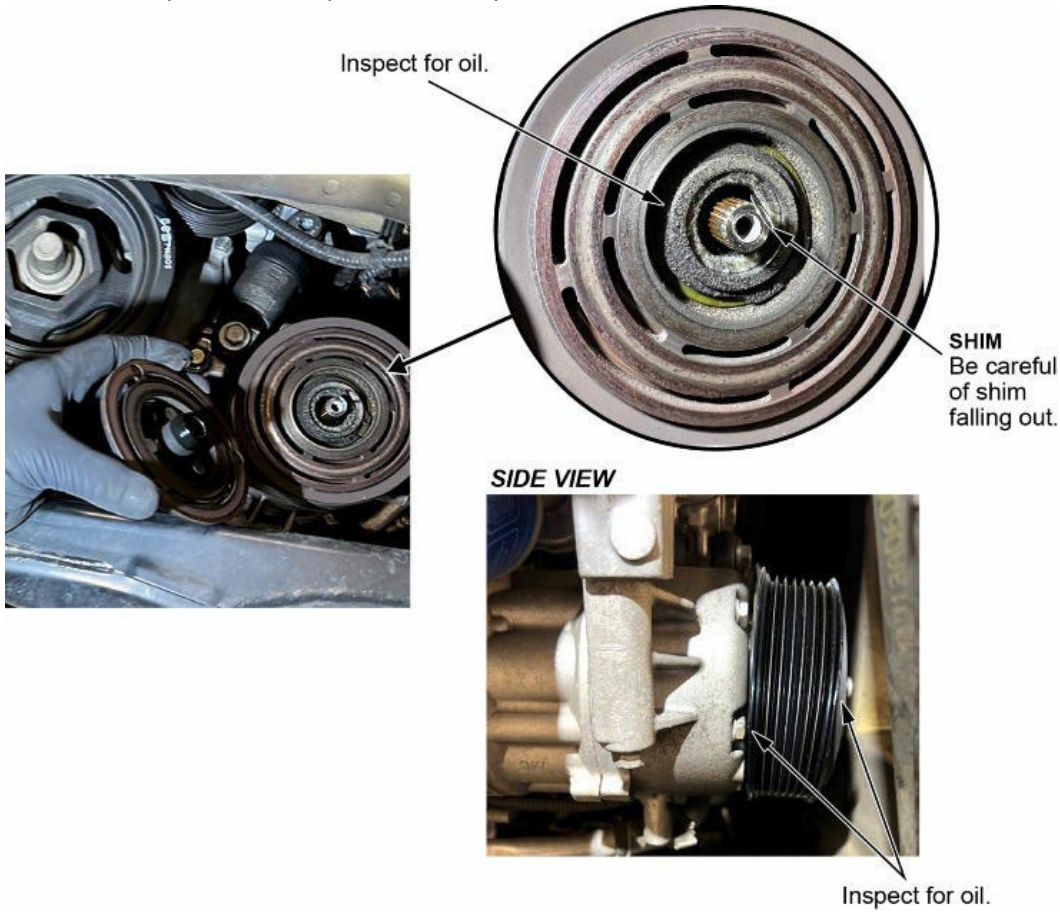
5. If no oil is noticed, leave the compressor on the vehicle. Remove the center hub bolt and armature plate from the compressor. Then, inspect both for oil.

- If oil is present on the armature plate, then proceed to the repair procedure.
- If no oil is present, then proceed to step 6.

Examples of dry and oily armature assemblies.

Rotor	Hub	Rotor	Hub
Dry	Dry	Oily	Oily

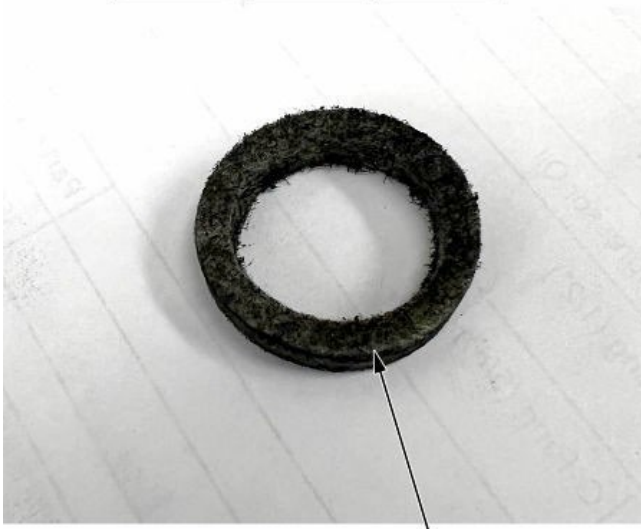
6. Remove the felt washer from the compressor and gently place it on a clean sheet of copier paper.

NOTE: If oil transfers from the felt washer to the paper after **10 seconds**, proceed to the repair procedure. If not, proceed to step 7.

Observe for excess oil.

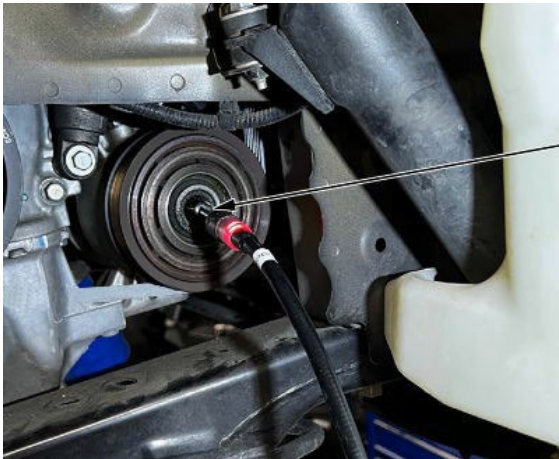
SNOUT OF
COMPRESSOR

7. Using a calibrated leak detector, check for a leak.

- Use the leak detector for at least **five minutes** around the snout of the compressor.
- The longer an A/C compressor has not been ran, the better chance you will have at detecting a leak.
- A higher vehicle engine temperature produces more accurate results.
- If a leak is detected, proceed to the repair procedure.

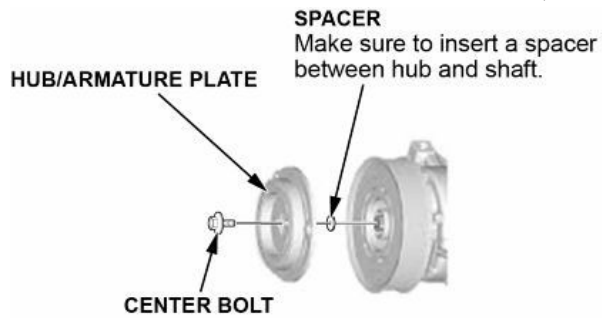
8. If no oil or leak is found, reassemble the hub/armature plate with the original bolt and torque to **(17 N·m or 13 lb-ft)**.

- Verify that the armature plate and pulley rotate smoothly and independently.
- Measure the clearance between the pulley and armature plate all the way around. If clearance is not within specified limits, remove the armature plate and add/or remove shims as needed.
- Clearance: **0.30–0.60mm (0.012–0.024in)**
- Shims are available in three sizes: **0.3mm, 0.4mm, 0.5mm.**

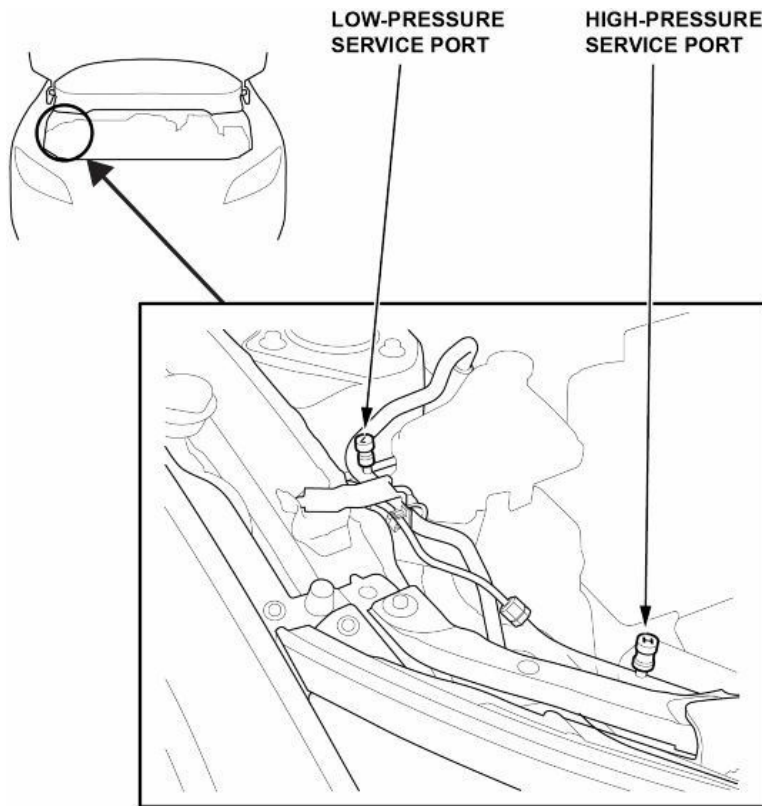
1. Connect an A/C recover/recycle/recharge machine to both the high-pressure service port and the low-pressure service port. Follow the equipment's manufacturer instructions.

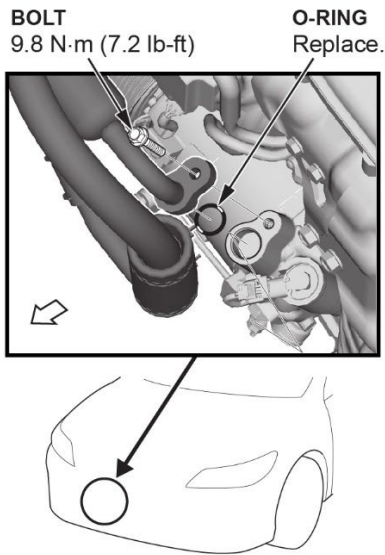
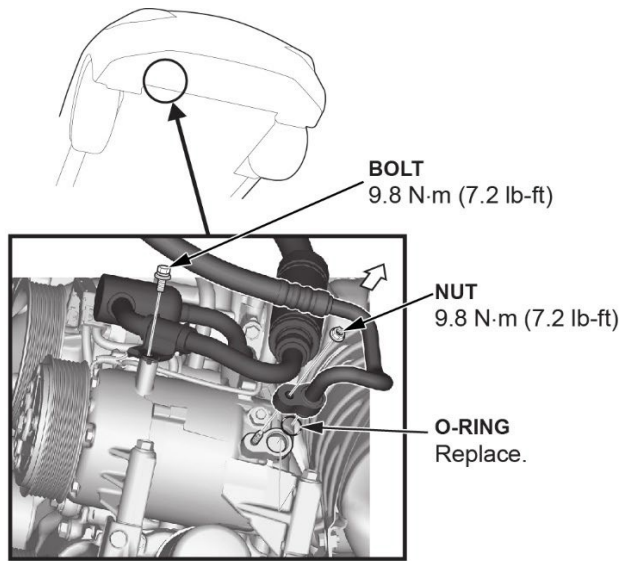
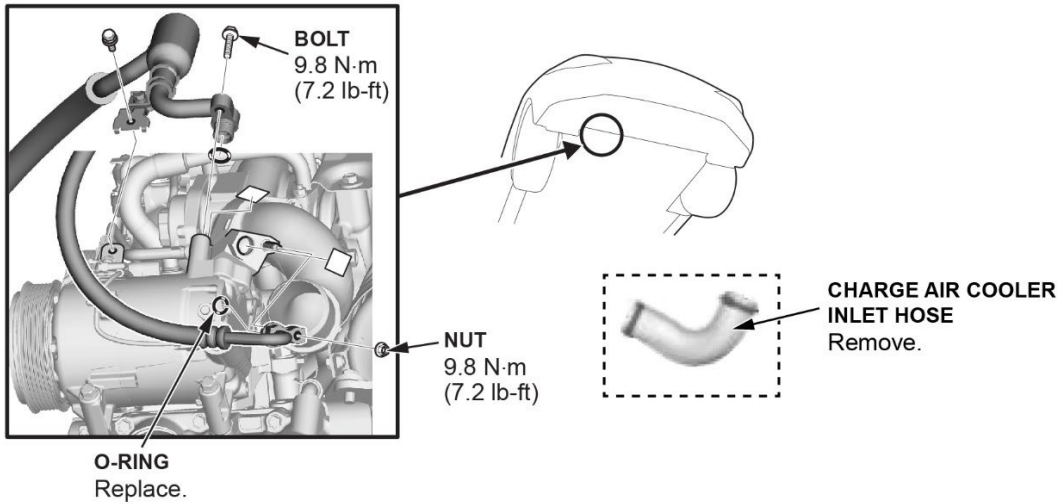
TYPE R

3. Disconnect the discharge and suction hoses.

- Use the port plugs in the seal assembly kit to immediately seal the ports after disconnection. This avoids moisture and dust contamination from entering the air conditioning compressor. Installing an A/C compressor into a contaminated system can result in premature A/C compressor failure.
- For the Type-R Models only: remove the charge air cooler inlet hose and A/C condenser fan shroud.

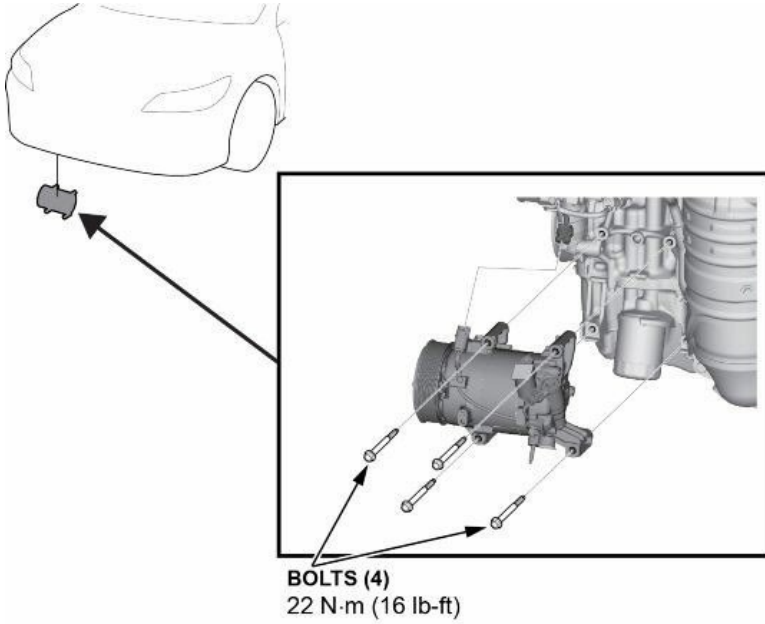
4. Remove the A/C compressor.

NOTE: Be careful not to damage the radiator fins while removing the A/C compressor.

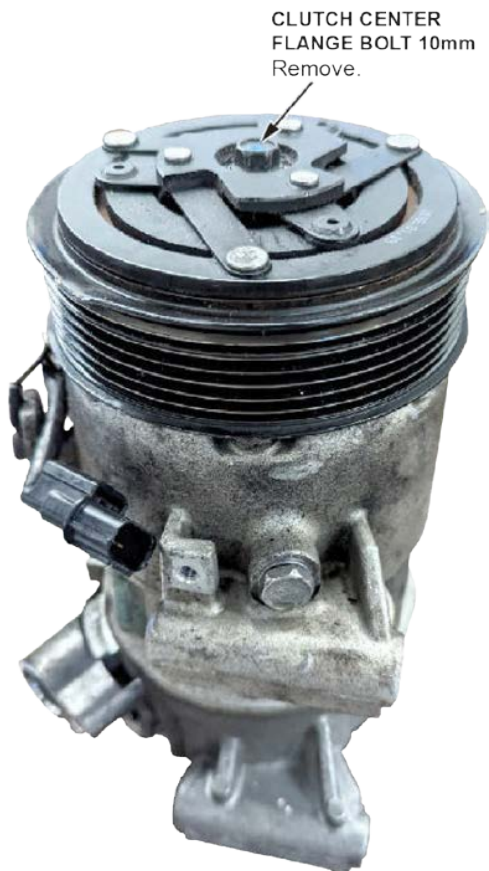
5. If not already removed, remove the center hub bolt (10 mm), tightened at 17 N·m (13 lb-ft).

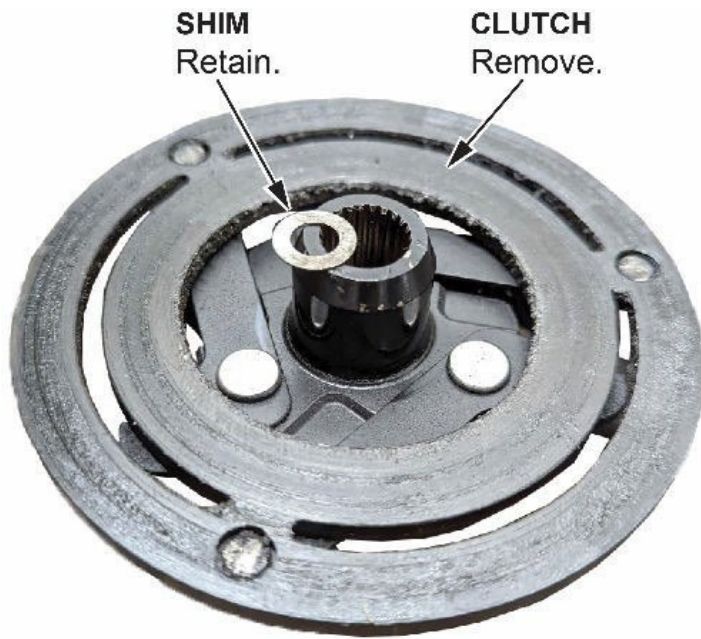
6. If not already removed, remove the clutch, carefully, to not drop/lose any shims (usually 1–2 shims).

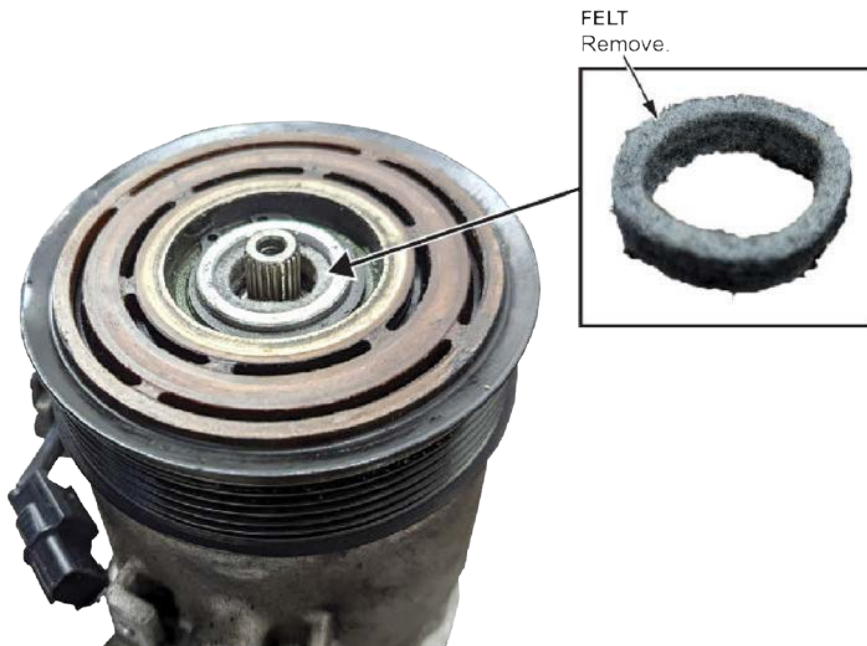
7. If not already removed, use a pick and remove the felt washer.

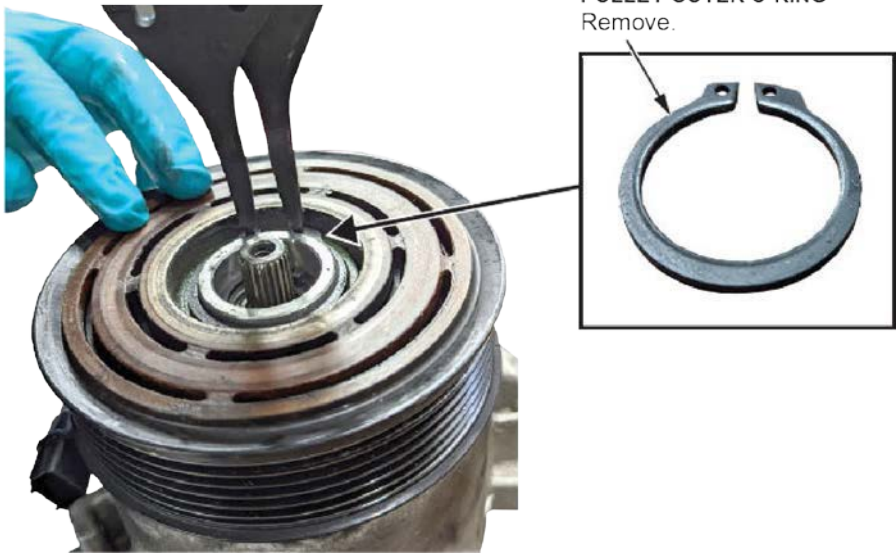
8. Remove the outer pulley C-ring.

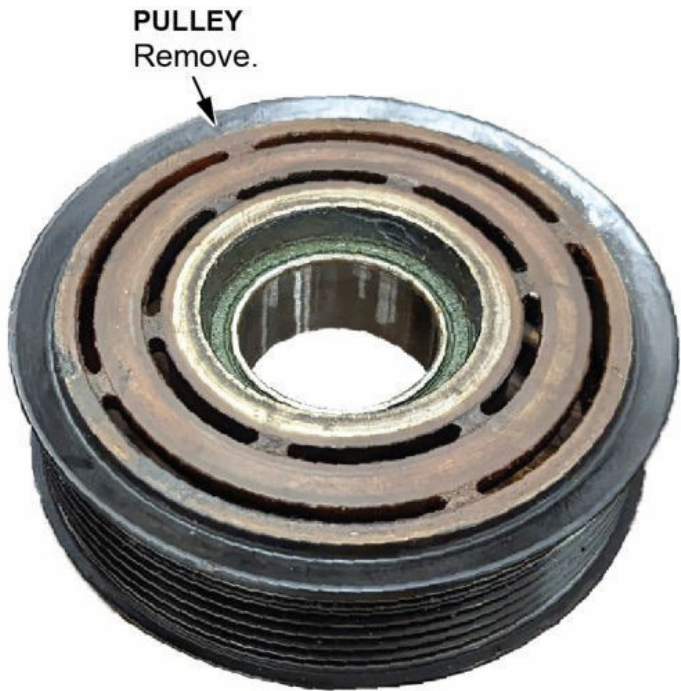
9. Remove the pulley.

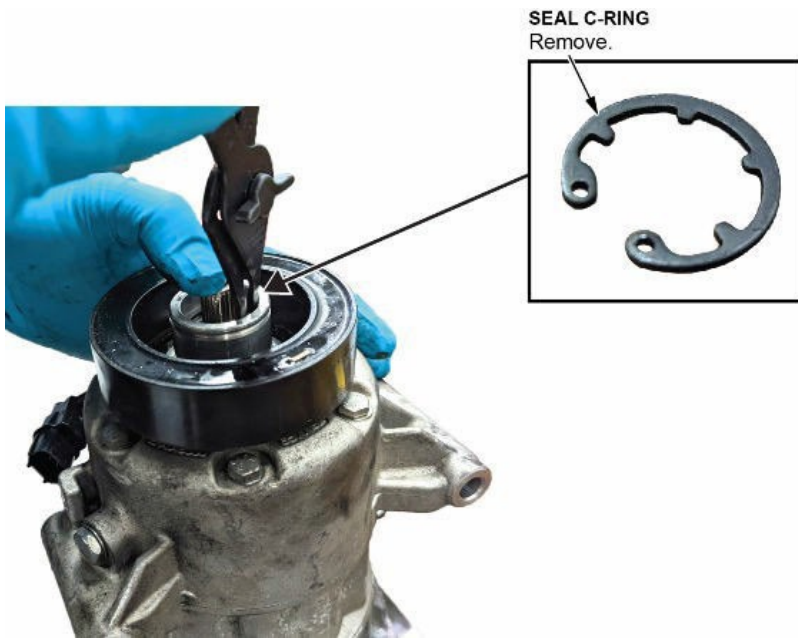
10. Remove the seal C-ring.

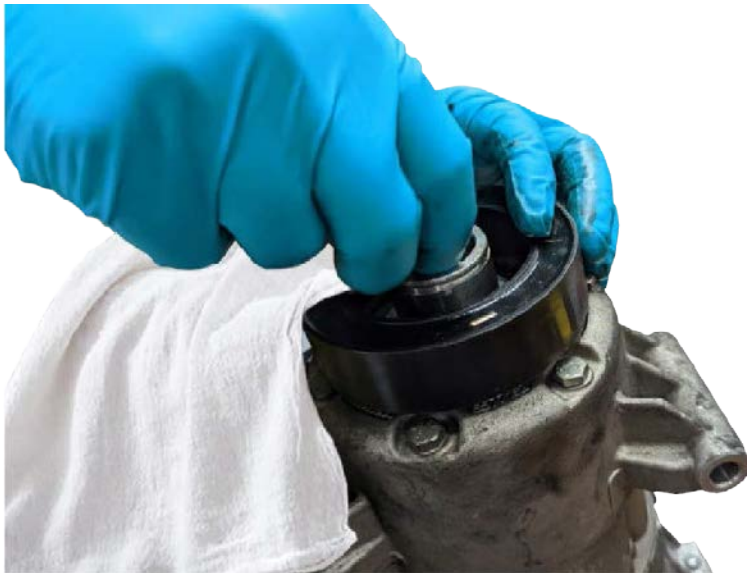
11. Thoroughly clean the bore and shaft with a lint free cloth.

NOTE: Do not use compressed air. The bore needs to be very clean as to prevent debris from entering the compressor once the seal is removed. Failure to remove all debris will result in a future failure.

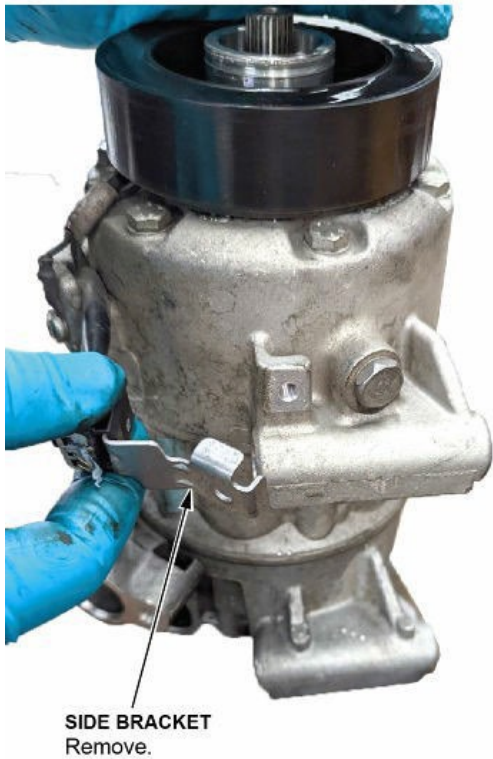
12. Remove the side bracket.

1.5L ONLY

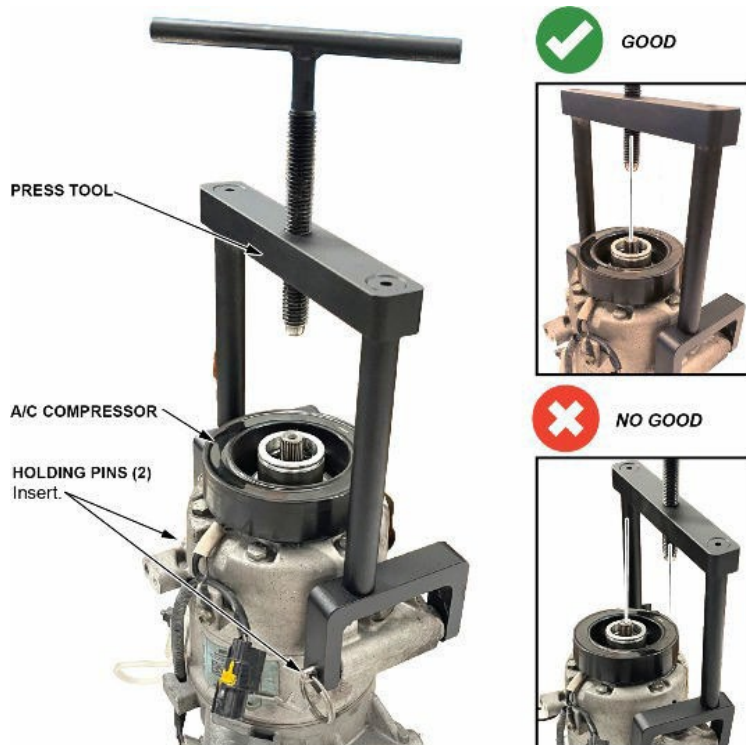
13. Place the press tool onto the A/C compressor and insert (2) holding pins. Make sure the press tool installs where the press shaft and compressor shaft align. The press tool will only align correctly in one orientation. The pins must be all the way through.

NOTE: The part numbers for the press tool are: 1.5T tool: 07AAD-5AAA101, 2.0 tool: 07AAD-5BAA100, and 2.0T tool: 07AAD-5BAA100.

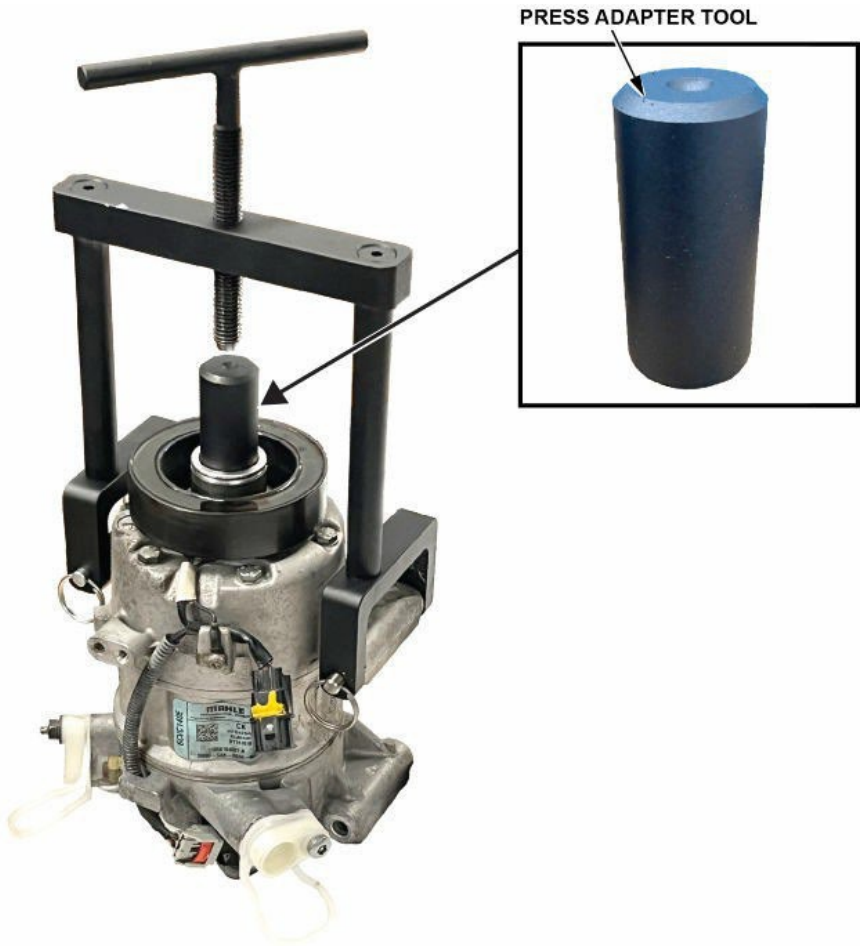
14. Add the press adapter tool.

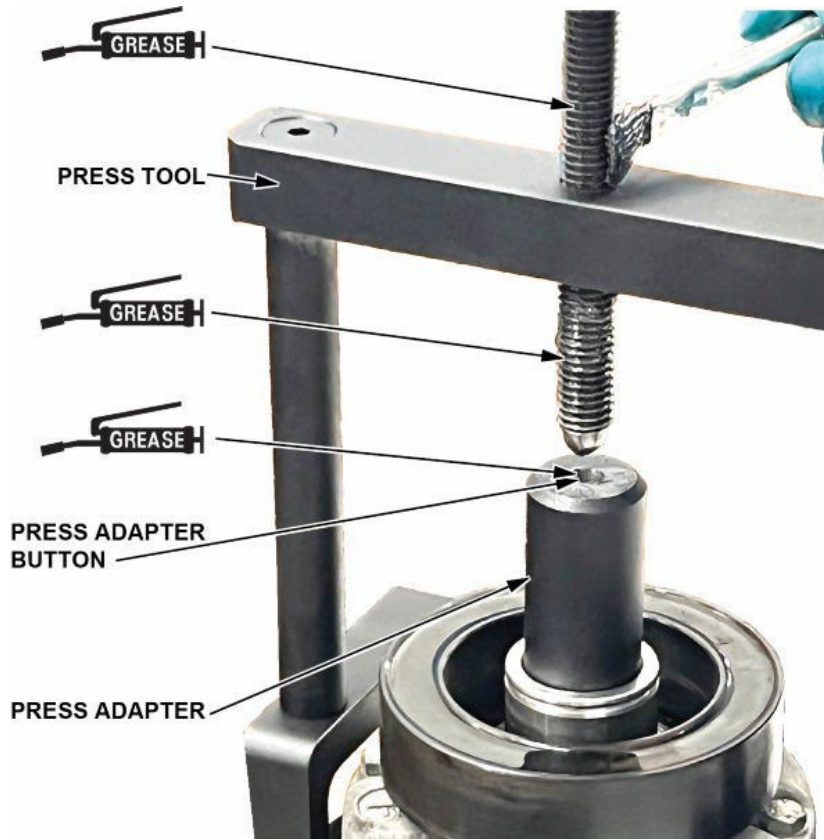
15. Add grease to the press adapter button and press threads.

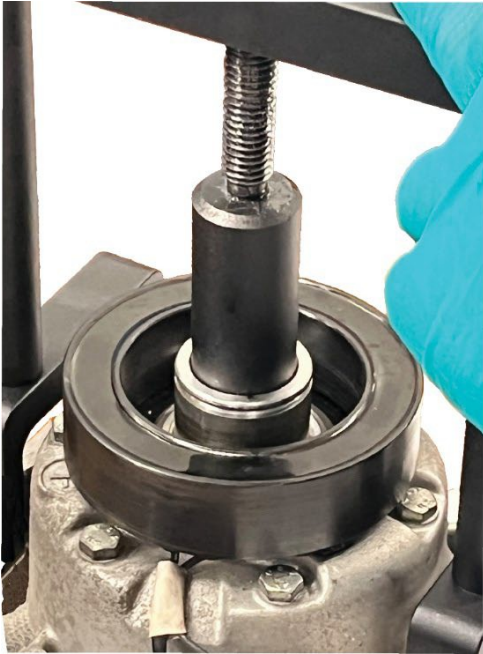
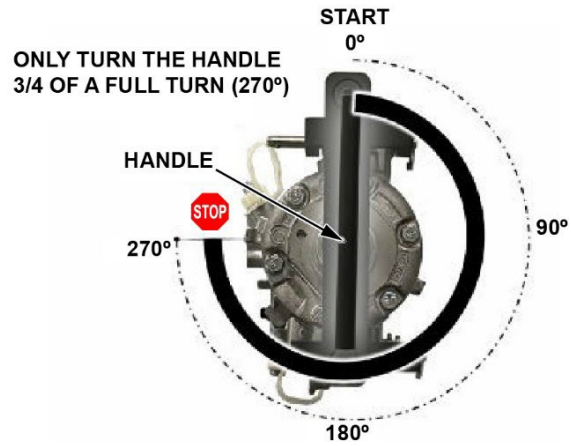
16. Tighten the press until there is no clearance, and then **3/4 turn (270°)**.

- The purpose of this step is to break the compressor shaft seal loose.
- Turning the handle more than **3/4 turn (270°)** can damage the tool and seal making it difficult to remove the compressor shaft seal.

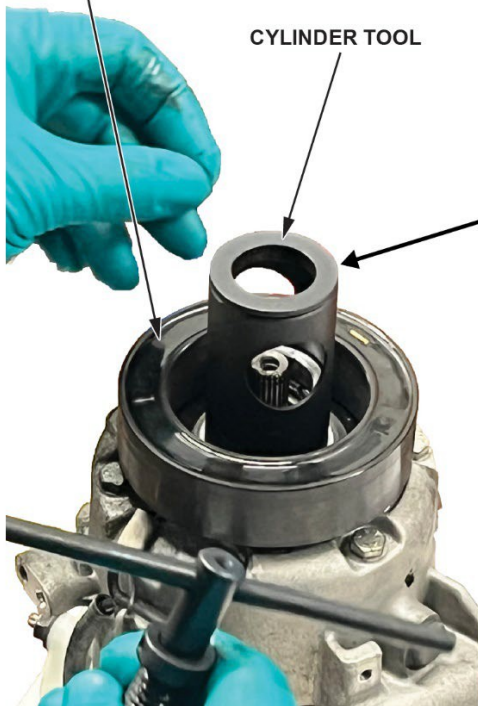
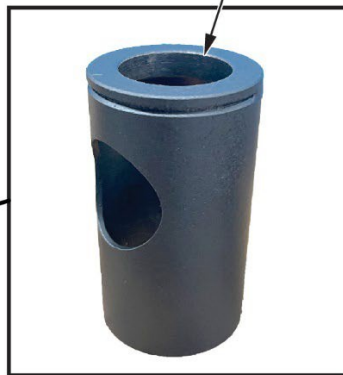
18. Insert the cylinder tool onto the A/C compressor.

A/C COMPRESSOR

CYLINDER TOOL

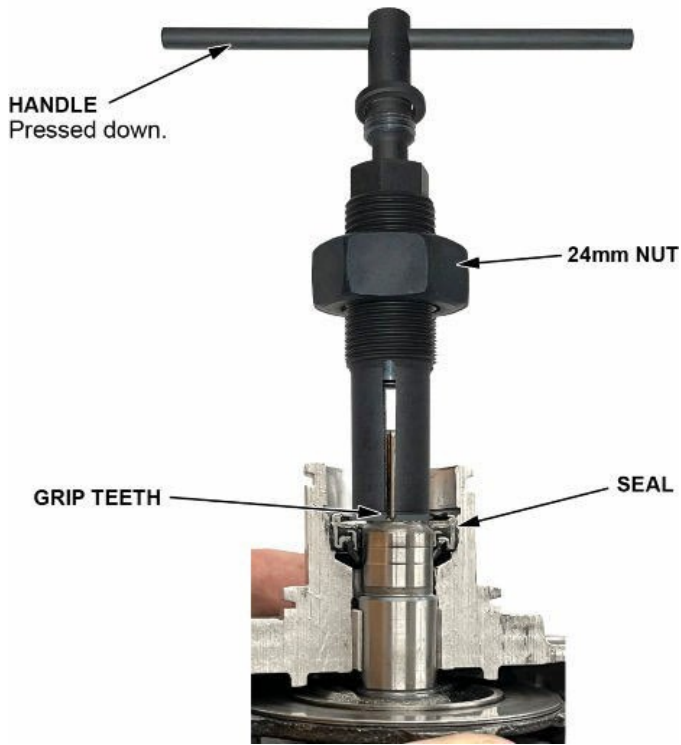
19. Insert the extractor tool, and make sure the **24 mm** nut is positioned towards the top. Look into the cylinder window to align the extractor tool onto the flange and press the handle fully down to grab the seal.

NOTE: The **24 mm** nut will use a **36 mm** wrench.

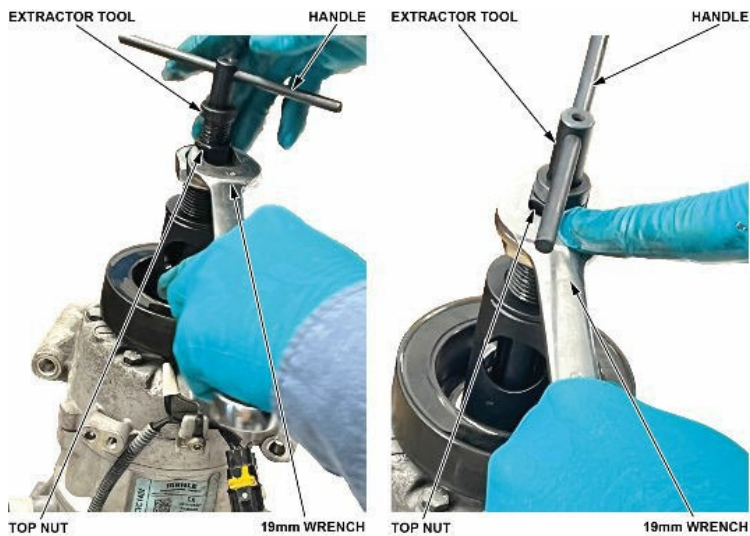
20. Stabilize the extractor tool using a **19 mm** wrench on the top. **Then**, turn the handle clockwise until resistance is felt. Make sure that the space between the **19 mm** wrench and the bottom portion of the extractor tool is minimal.

NOTE: To confirm the extractor is engaged, hold the extractor tool and lift the compressor up.

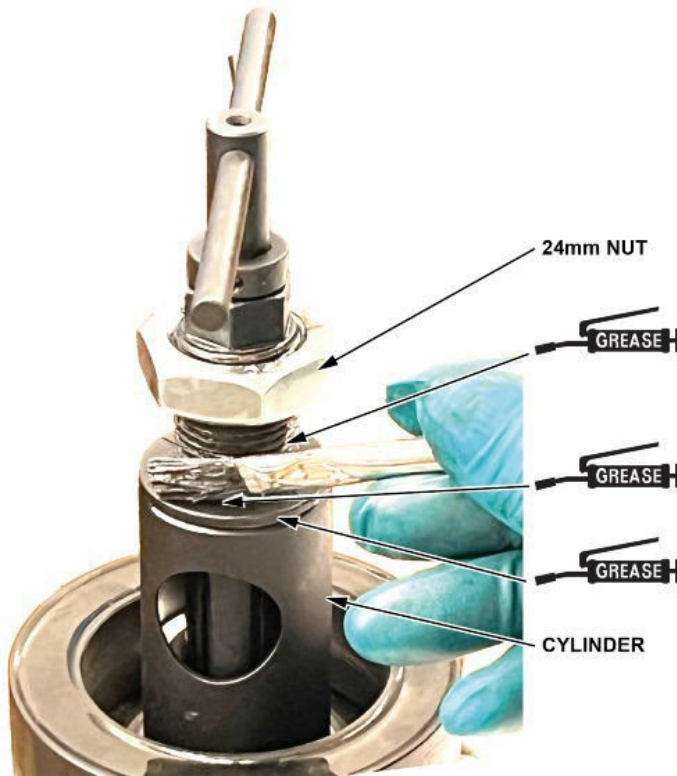
21. Apply grease between the **24 mm** nut and cylinder as well as cylinder top.

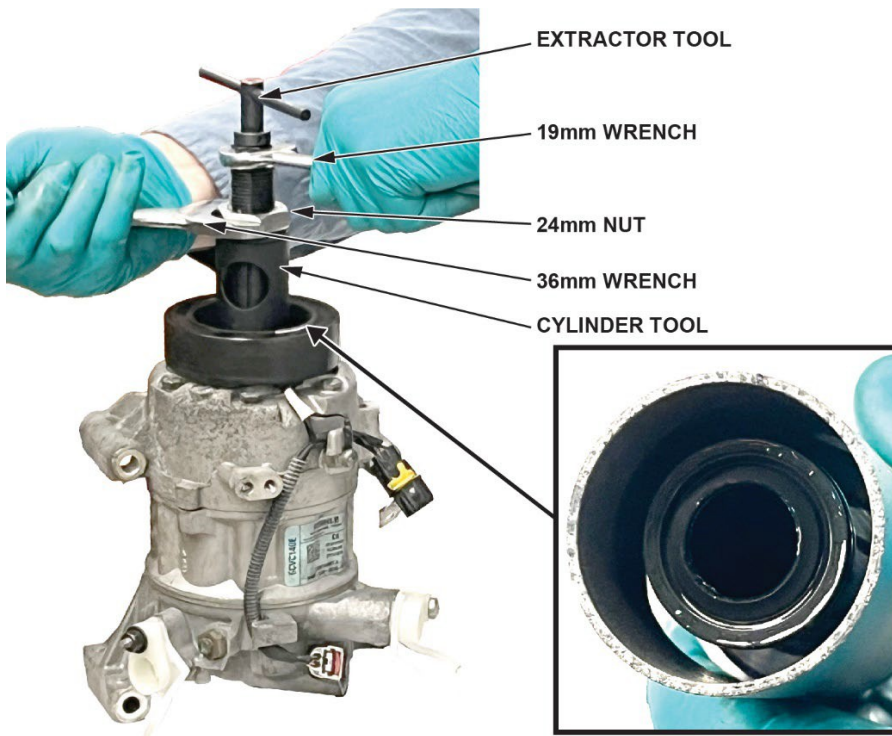
22. With the **19 mm** wrench in place, lower the **24 mm** nut down until it reaches the cylinder. Slowly and carefully adjust until the extractor tool comes out freely with the seal.

- Resistance will be felt while lowering **24 mm** nut and will cease once the seal is extracted.
- If the seal does not come out on the first step, repeat the process starting at step 13.

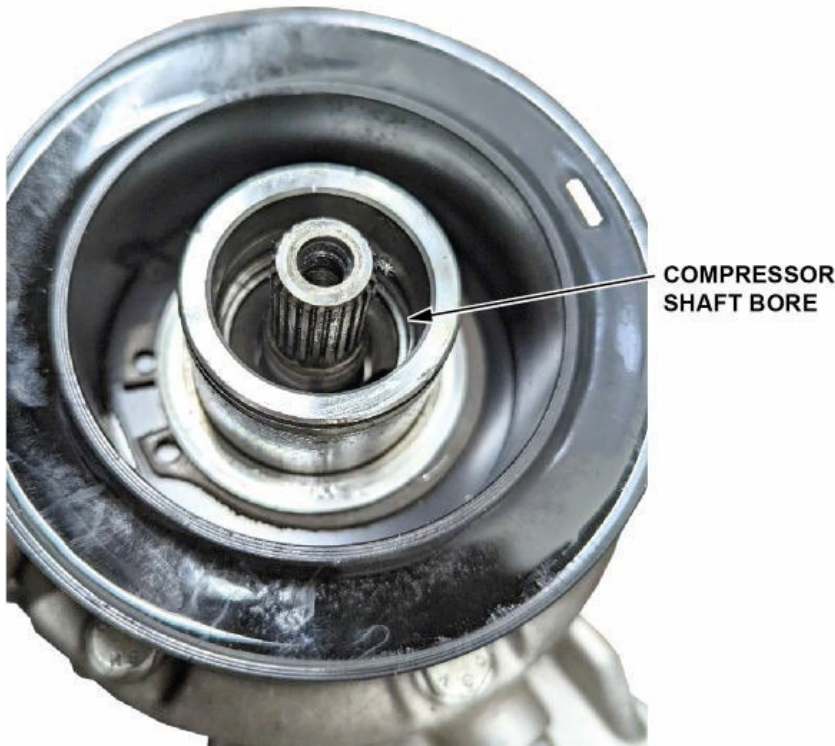
23. Thoroughly clean the bore and shaft with a lint free cloth.

NOTE: Do not use compressed air. The bore needs to be very clean as to prevent debris from entering the compressor once the seal is installed. Failure to remove all debris will result in future failure.

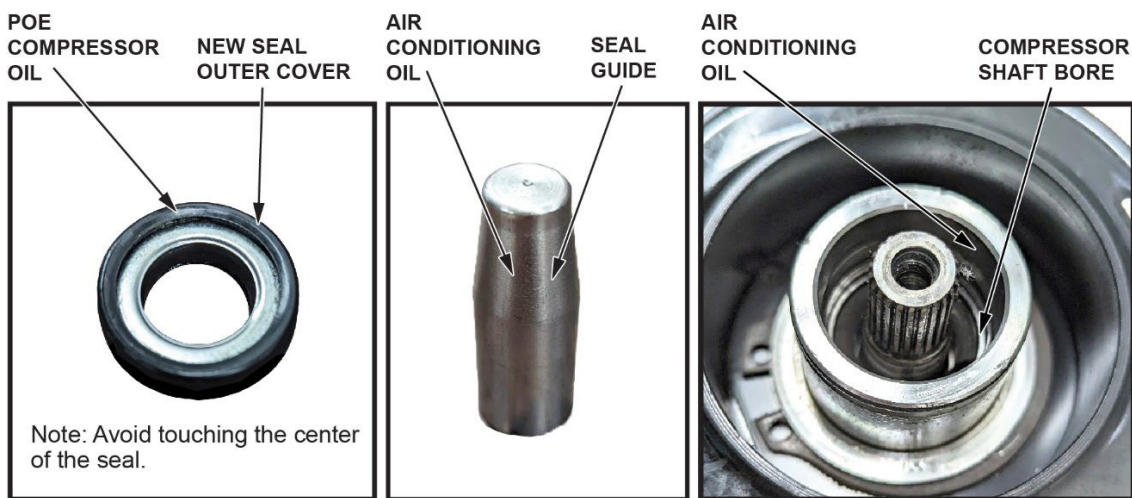
25. Lubricate the new seal outer surface, seal guide, and bore with new POE compressor oil.

- Avoid touching the center of the seal to prevent cross-contamination of the A/C refrigerant system.
- Make sure to clean the surface using clean gloves and with a lint free cloth before lubrication.

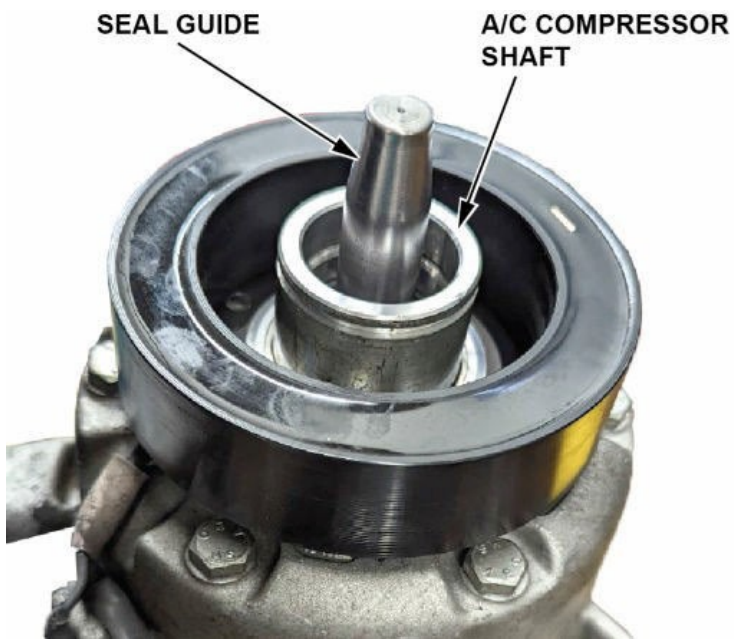
26. Insert the seal guide tool onto A/C compressor shaft.

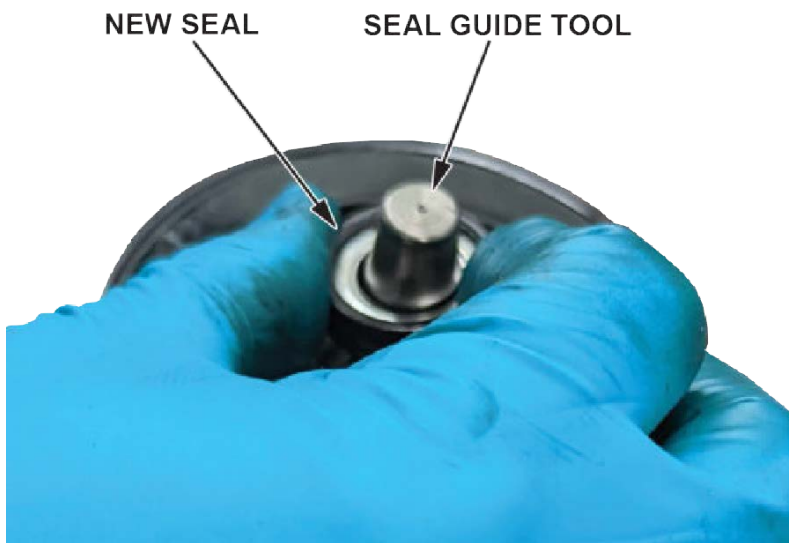
27. Insert the new seal onto the seal guide tool.

NOTE: The seal is directional and must be placed with the metal side upwards as shown below.

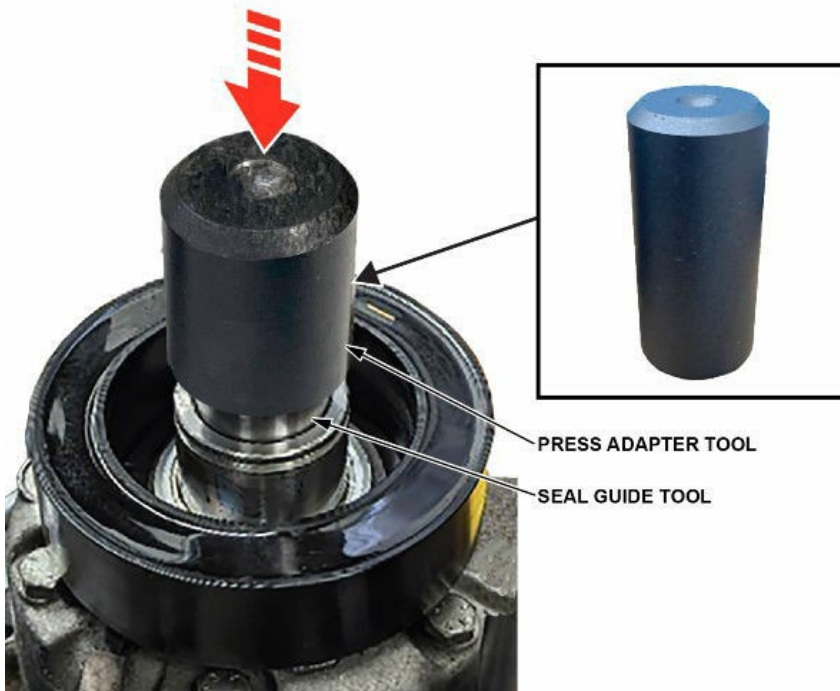
28. Insert the press adapter tool over the seal guide. By hand, press down just enough to seat and install the new seal.
 NOTE: Seat the seal about 5 mm below the top edge of the bore.

Push down.

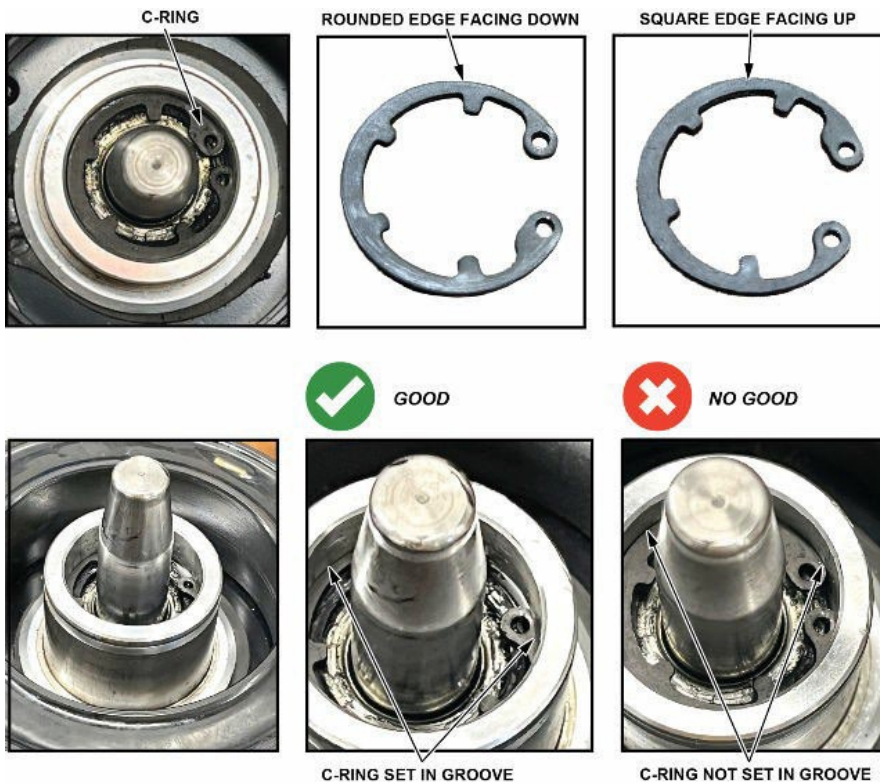
29. Insert the new seal C-ring with the teeth's rounded side pointing down into the bore.

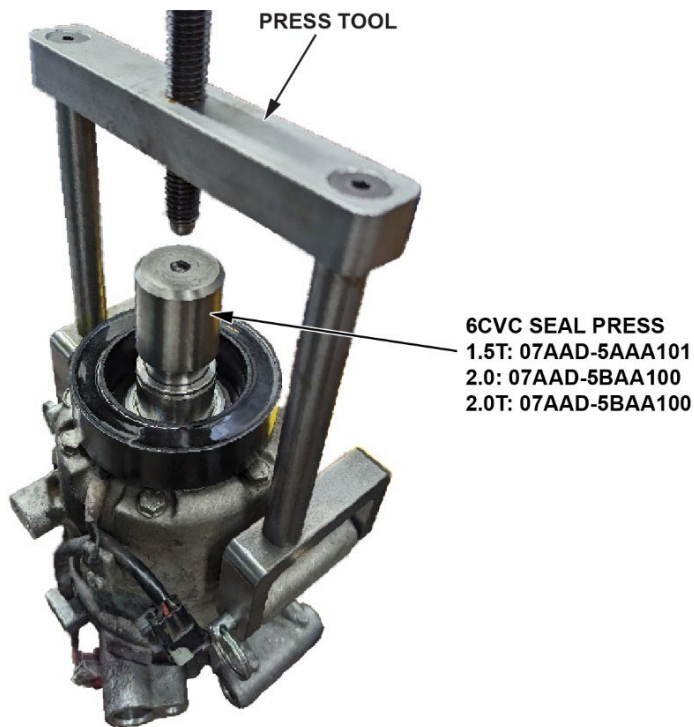
30. Add the press tool.

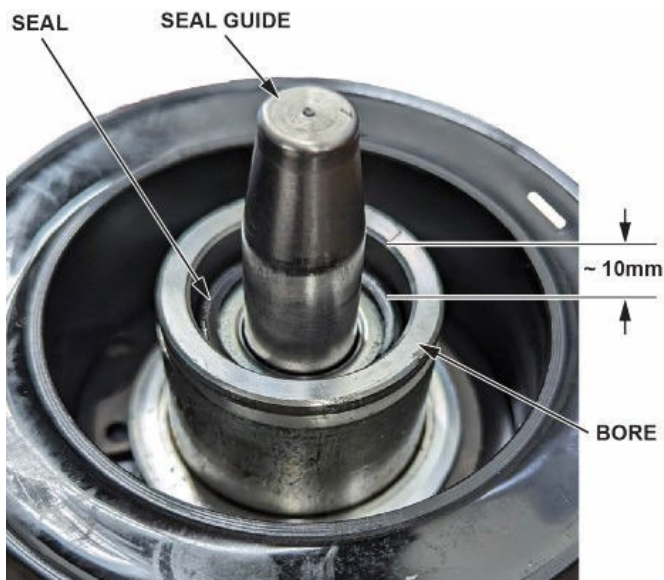
31. Tighten the press by rotating the handle clockwise until it reaches the adapter tool. Slowly and carefully continue to rotate the handle clockwise until the seal is pressed down roughly **10 mm** below the top edge of the bore.

NOTE: Tighten the press until the C-clip is installed into the clip groove. There will be a sound or vibration felt when the C-clip is fully set.
