January 24, 2024

Version 4

Warranty Extension: 2017-22 CR-V A/C Compressor Shaft Seal Leak

Supersedes 23-040, dated September 28, 2023, to revise the information.

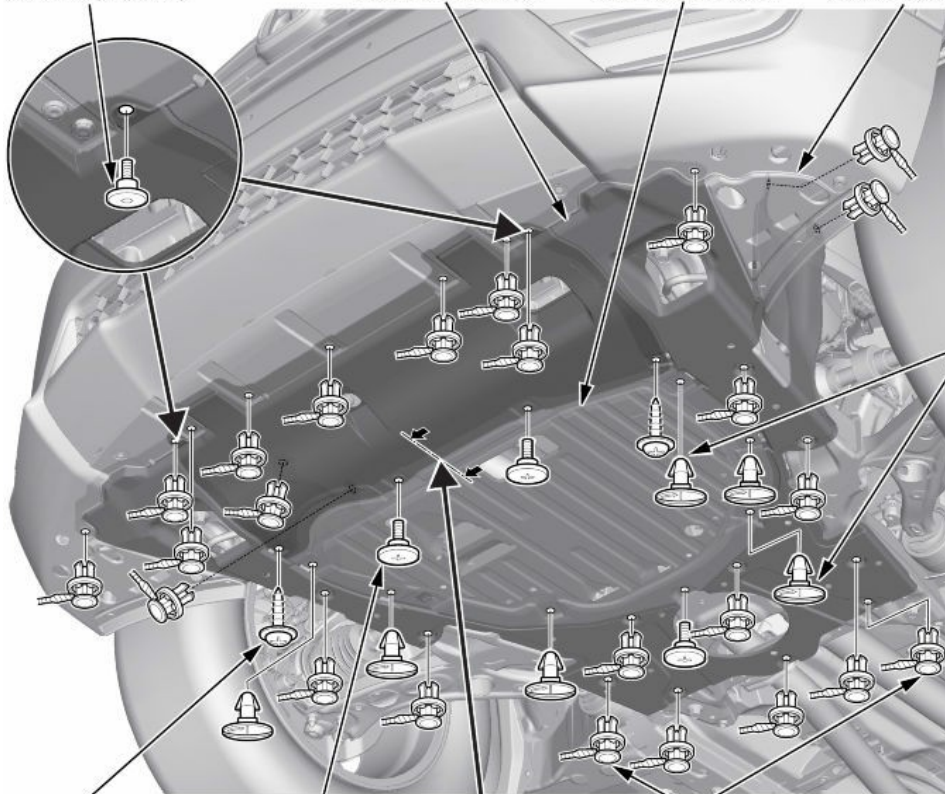
1. Remove the right-front tire.
2. Remove the engine undercover.

**PHILLIPS HEAD
SCREW FASTENERS (2)**
9.4 N-m (6.9 lb-ft)

SCREWS (2)
Remove.

**PHILLIPS HEAD
SCREW FASTENERS (3)**
Remove.

FASTENERS (24)
Remove with small screwdriver.

FASTENERS (6)
Remove.

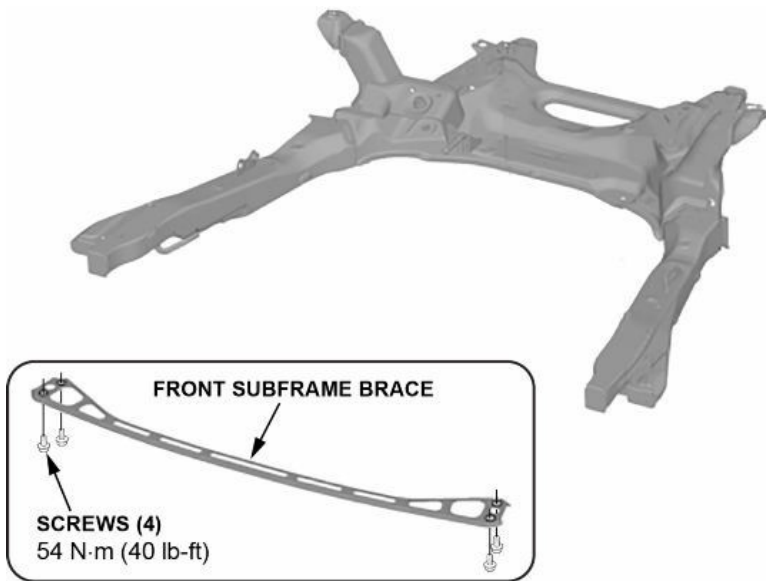
3. Remove the front subframe brace.

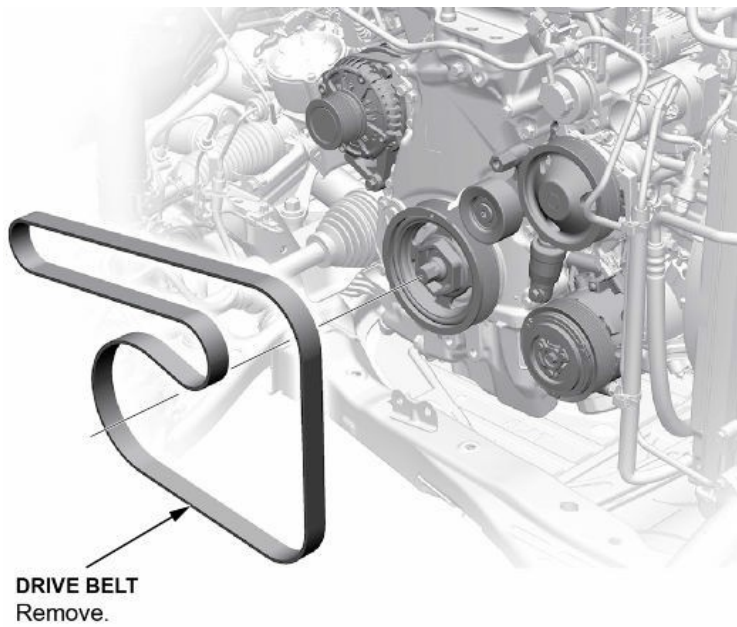
4. Remove the drive belt.

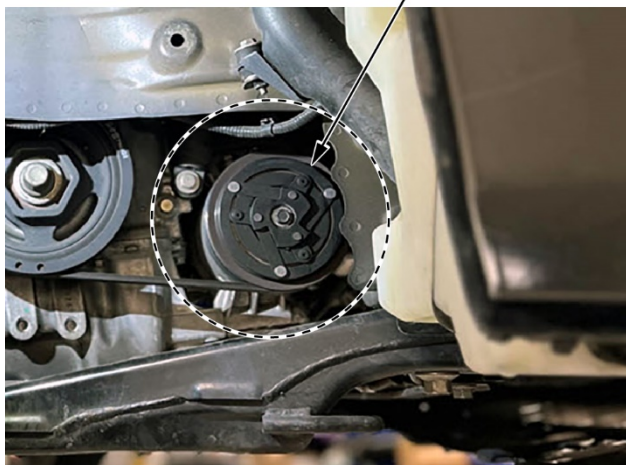
5. Inspect for oil on the armature plate surface of the compressor.

NOTE: If any oil is stuck to the armature plate surface of the compressor, then proceed to the repair procedure.

Inspect for oil.

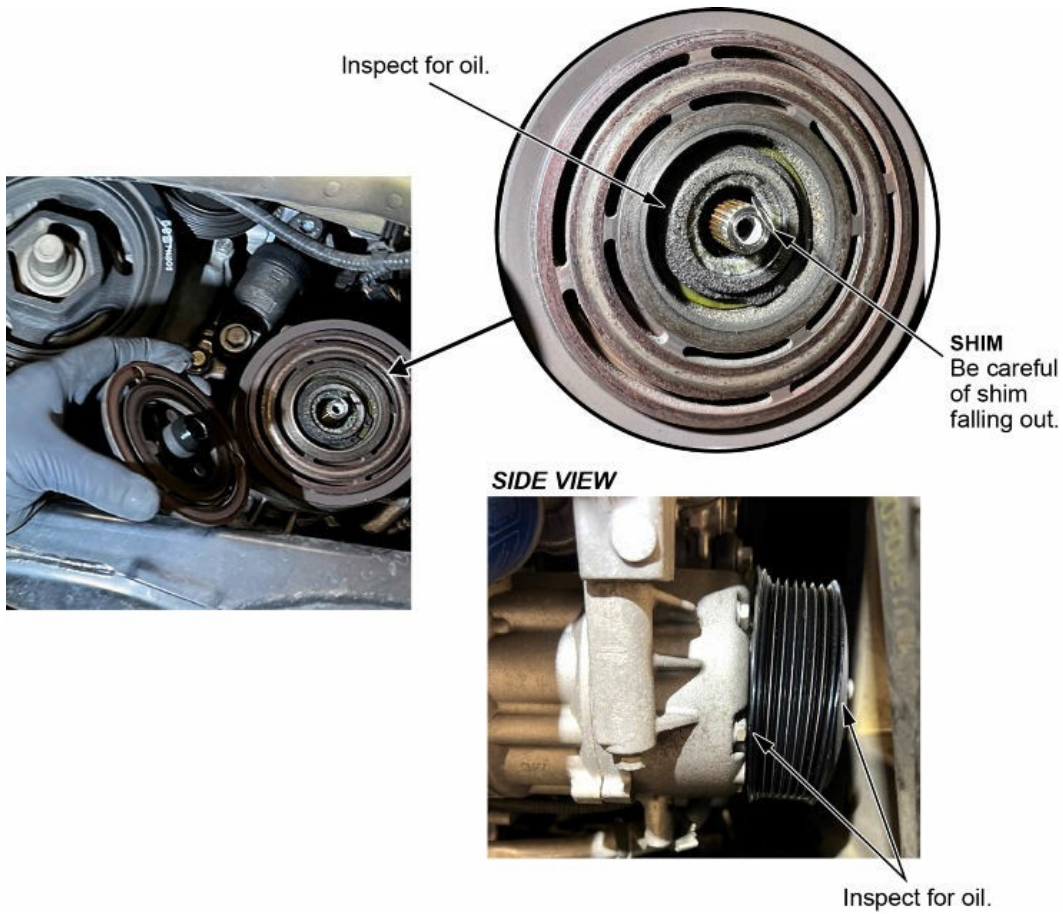
6. If no oil is noticed, leave the compressor on the vehicle. Remove the center hub bolt and armature plate from the compressor. Then, inspect both for oil.

- If oil is present on the hub/armature plate, then proceed to the repair procedure.
- If no oil is present, then proceed to step 7.

Examples of dry and oily clutch assemblies.

Rotor	Hub	Rotor	Hub
Dry	Dry	Oily	Oily

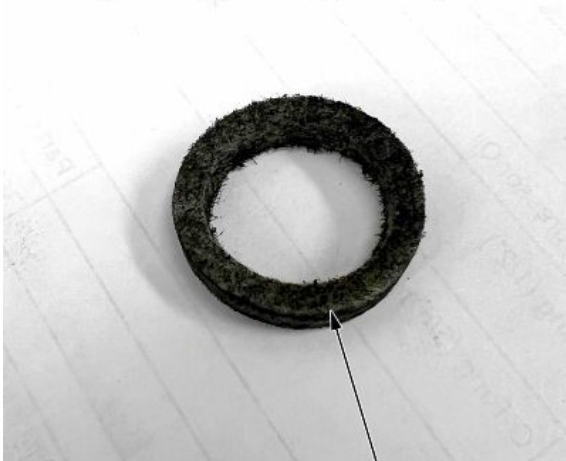
7. Remove the felt washer from the compressor and gently place it on a clean sheet of copier paper.

NOTE: If oil transfers from the felt washer to the paper after **10 seconds**, proceed to the repair procedure. If not, proceed to step 8.

Observe for excess oil.

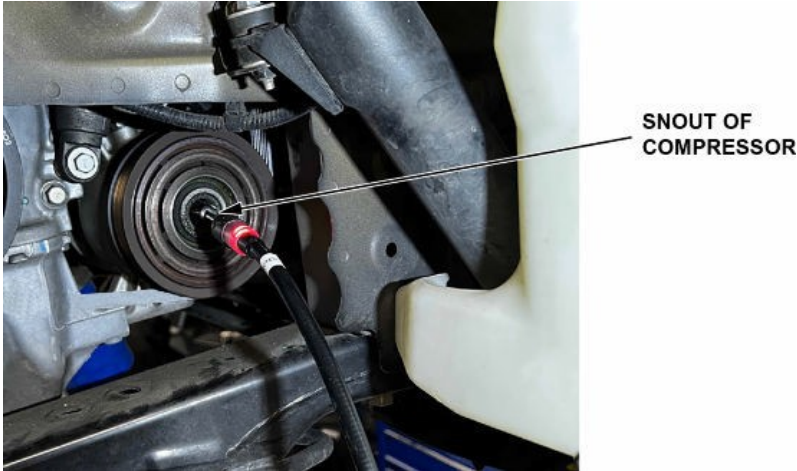
8. Using a calibrated leak detector, check for a leak.

- Use a leak detector for at least **5 minutes** around the snout of the compressor.
- An A/C compressor that has not been engaged will yield better results. The longer the A/C compressor has not been run, the better chance you will have at detecting a leak.
- A higher engine temperature produces more accurate results.
- If a leak is detected, proceed to the repair procedure.

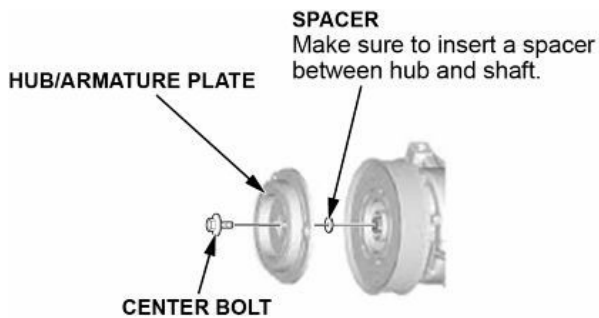
9. If no oil leak is found, reassemble the armature plate with the original bolt and torque to **17 N.m (13 lb-ft)**.

If this is a second time and no leak is found, reassemble the hub/armature plate with a new bolt and torque to **17 N.m (13 lb-ft)**.

- Verify the armature plate and pulley rotate smoothly and independently.
- Measure the clearance between the pulley and armature plate all the way around. If clearance is not within specified limits, remove the armature plate and add/or remove shims as needed.
- Clearance: **0.30–0.60mm (0.012–0.024in)**.
- Shims are available in three sizes: **0.3mm, 0.4mm, 0.5mm**.

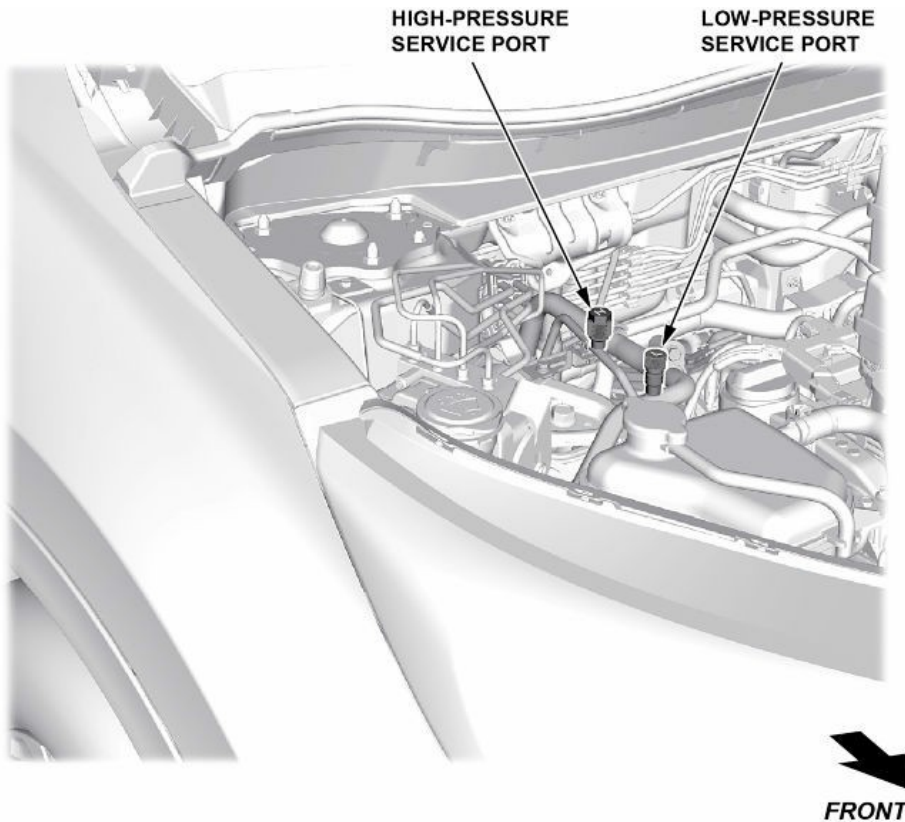
1. Connect an A/C recover/recycle/recharge machine to the high-pressure service port and the low-pressure service port following the equipment manufacturer instructions.

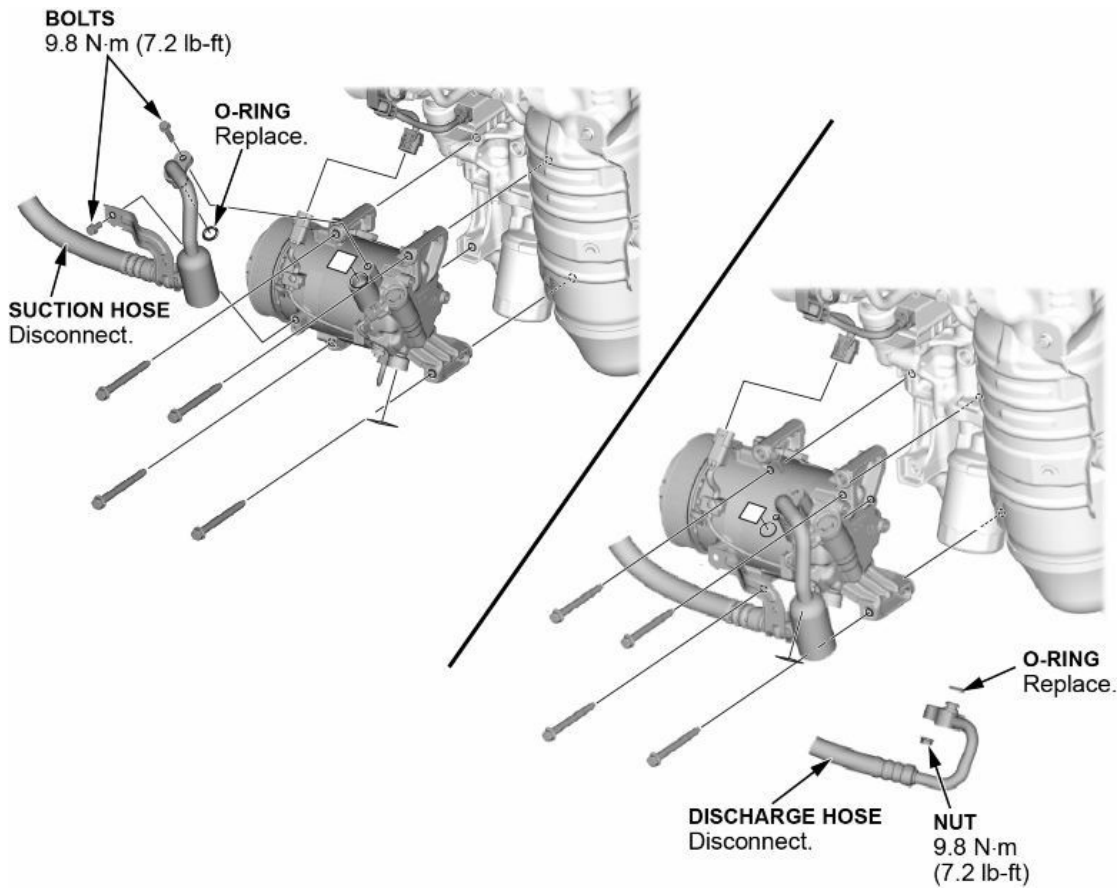
3. Disconnect the discharge and suction hoses.

NOTE: Use the port plugs in the seal assembly kit to immediately seal the ports after disconnection. This avoids moisture and dust contamination from entering the air conditioning compressor. Installing an A/C compressor into a contaminated system can result in premature A/C compressor failure.

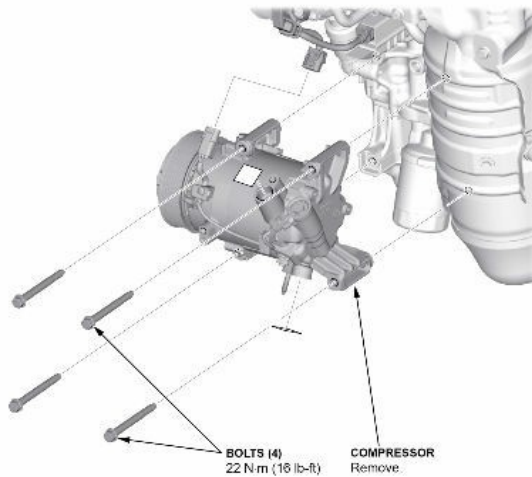
4. Remove the A/C compressor.

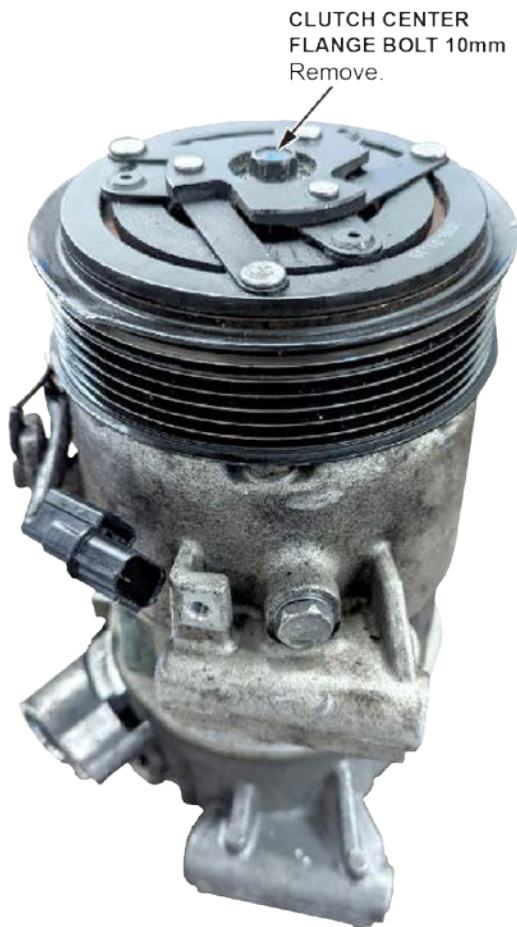
5. If the clutch has not been removed from a previous step, remove the clutch center flange bolt (**17 N.m 13 lb-ft**).

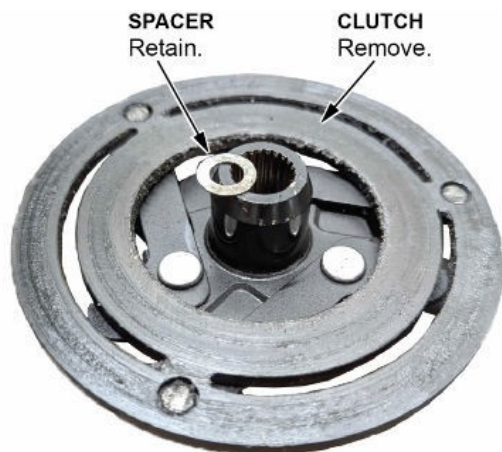
6. If the clutch has not been removed from a previous step, remove the clutch while being careful not to drop/lose any shims (usually 1-2).

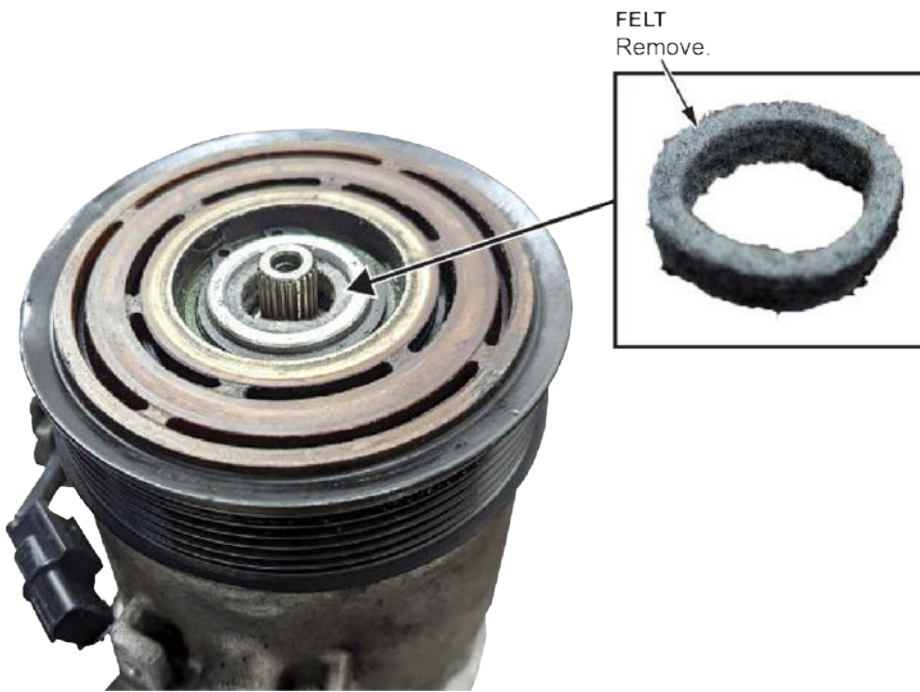
7. If the felt washer has not been removed from a previous step, use a pick to remove the felt washer.

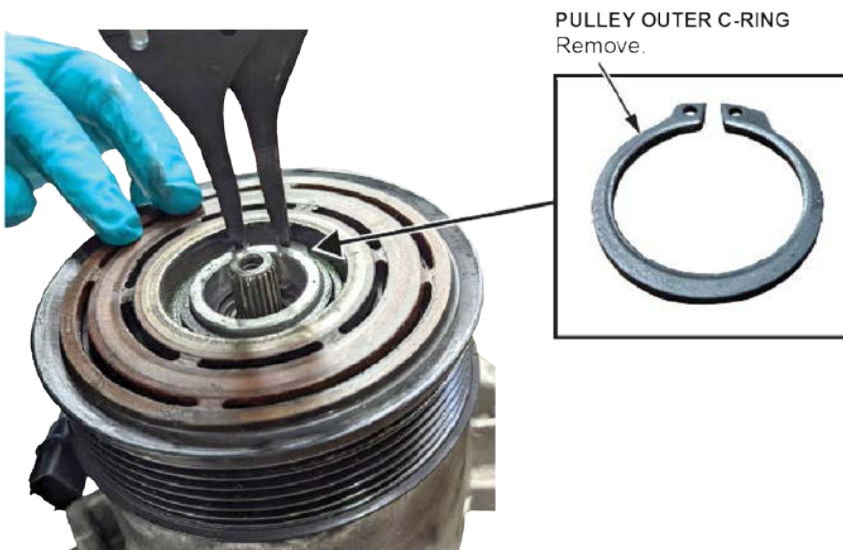
8. Remove the pulley C-ring.

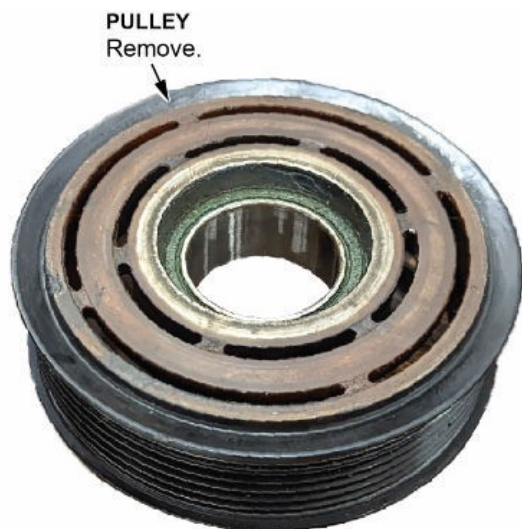
9. Remove the pulley.

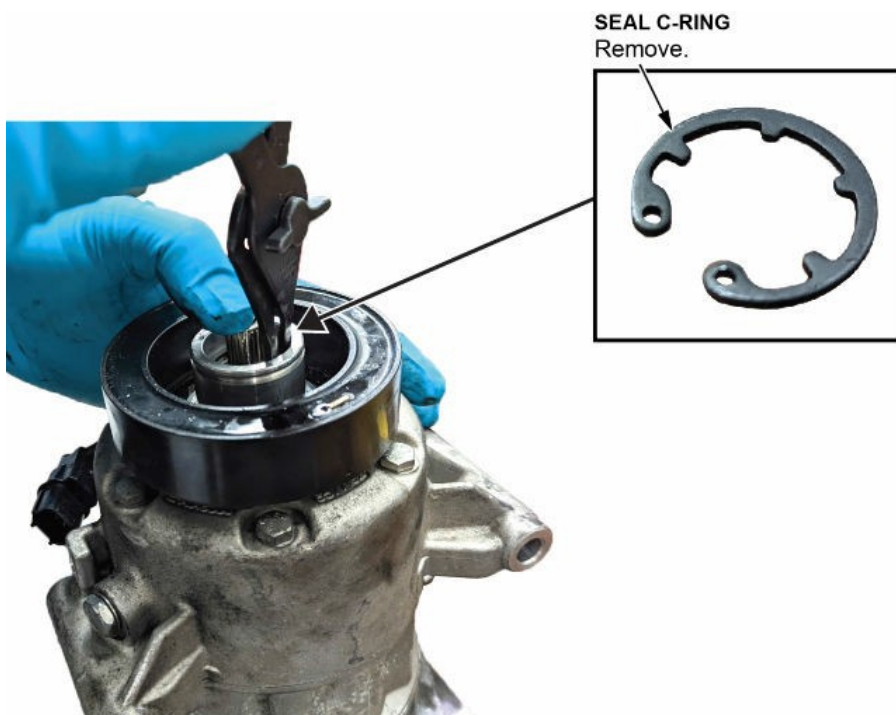
10. Remove the seal C-ring.

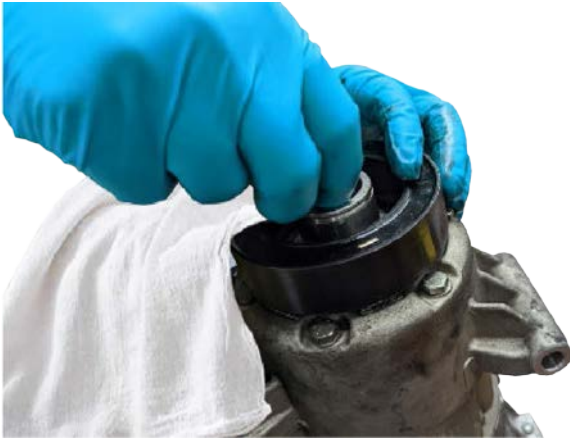
11. Thoroughly clean the bore and shaft with a lint free cloth.

NOTE: Do not use compressed air. The bore needs to be very clean as to prevent debris from entering the compressor once the seal is removed. Failure to remove all debris will result in future failure.

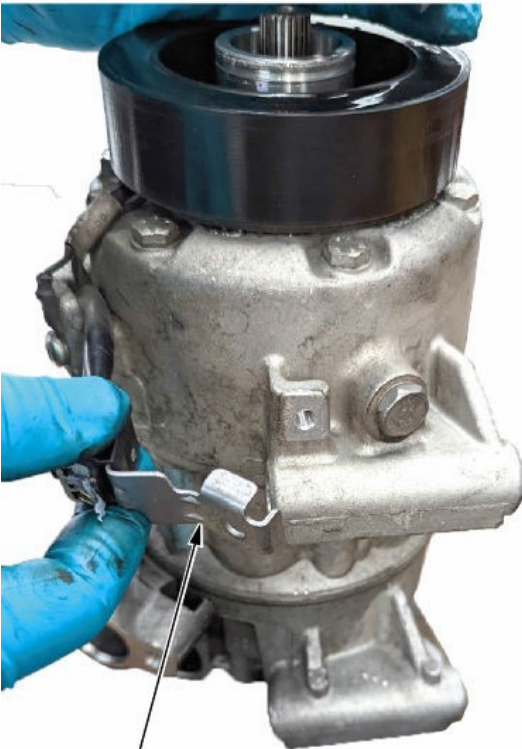
1.5L ONLY

12. Remove the side bracket (1.5L engine only).

SIDE BRACKET
Remove.

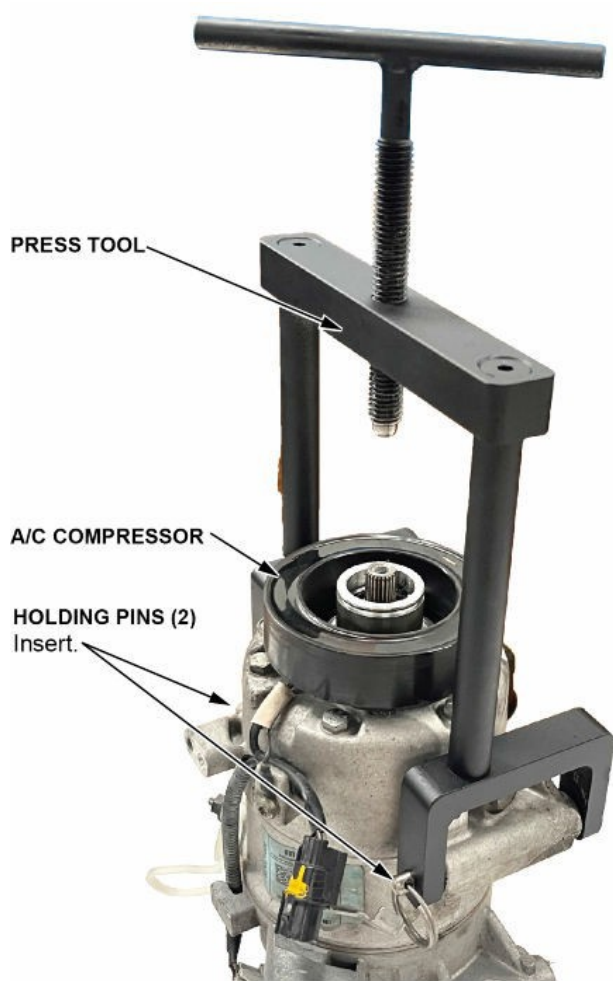
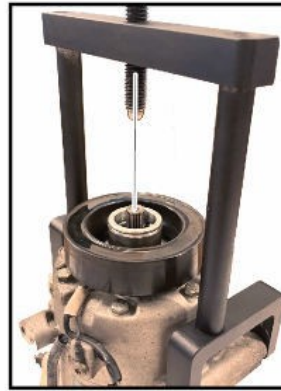
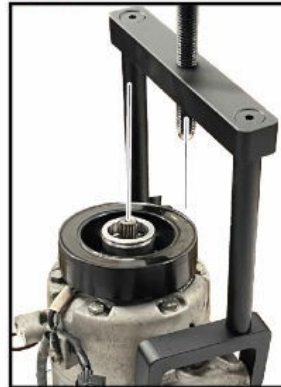
13. Place the press tool onto the A/C compressor and insert the holding pins (2). Make sure the press tool installs where the press shaft should align with compressor shaft. The press tool will only align correctly in one orientation. The pins must go all the way through.

NOTE: The part numbers for the press tool are: 1.5T tool: 07AAD-5AAA101, 2.0 tool: 07AAD-5BAA100, and 2.0T tool: 07AAD-5BAA100.

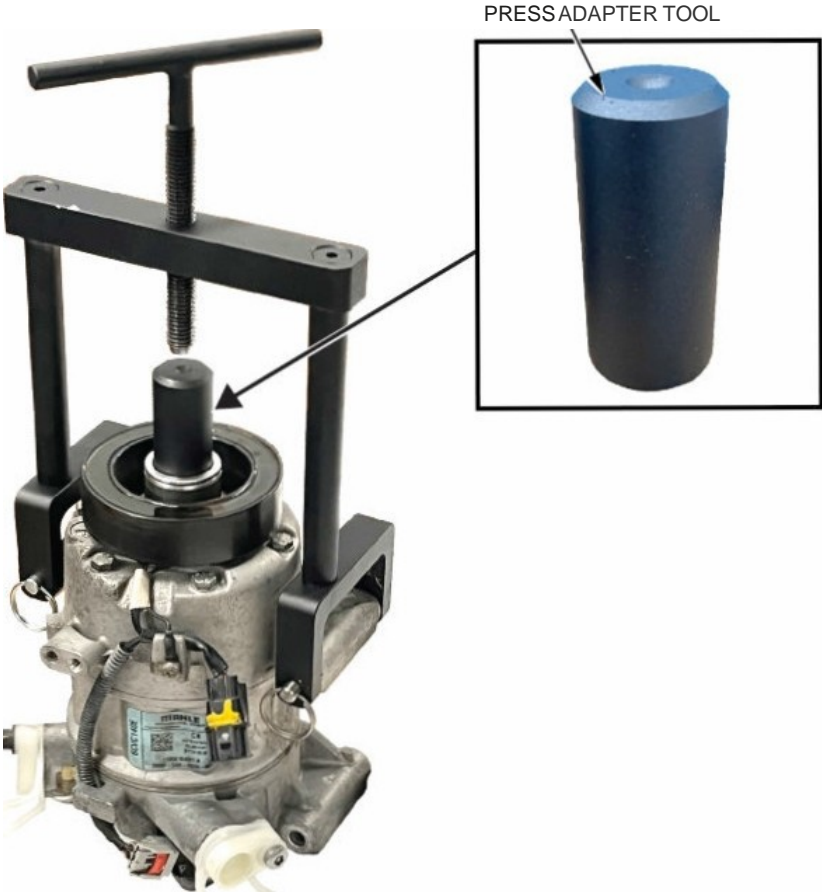
14. Add the press adapter tool.

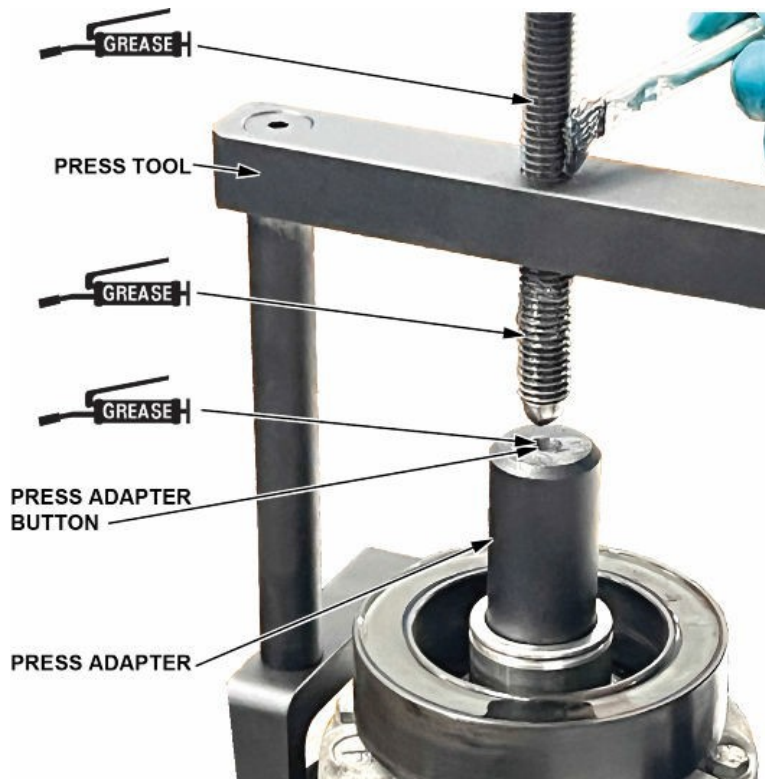
15. Add grease to the press adapter button and press threads.

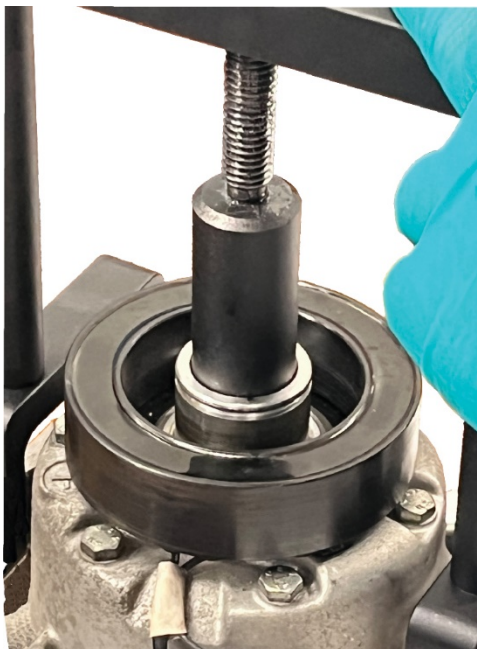
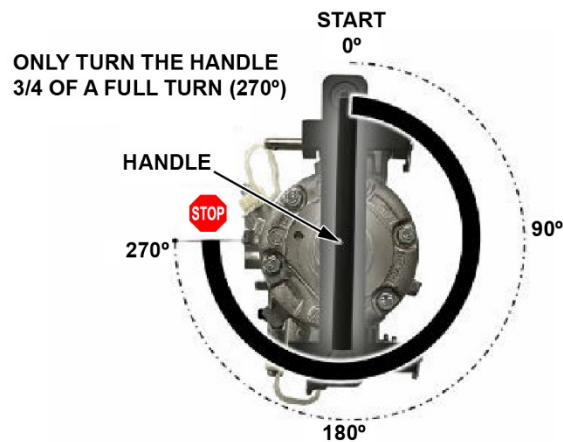
16. Tighten the press until there is no clearance, then **3/4 turn (270°)**.

- The purpose of this step is to break the compressor shaft seal loose.
- Turning the handle more than **3/4 turn (270°)** can damage the tool and seal making it difficult to remove the compressor shaft seal.

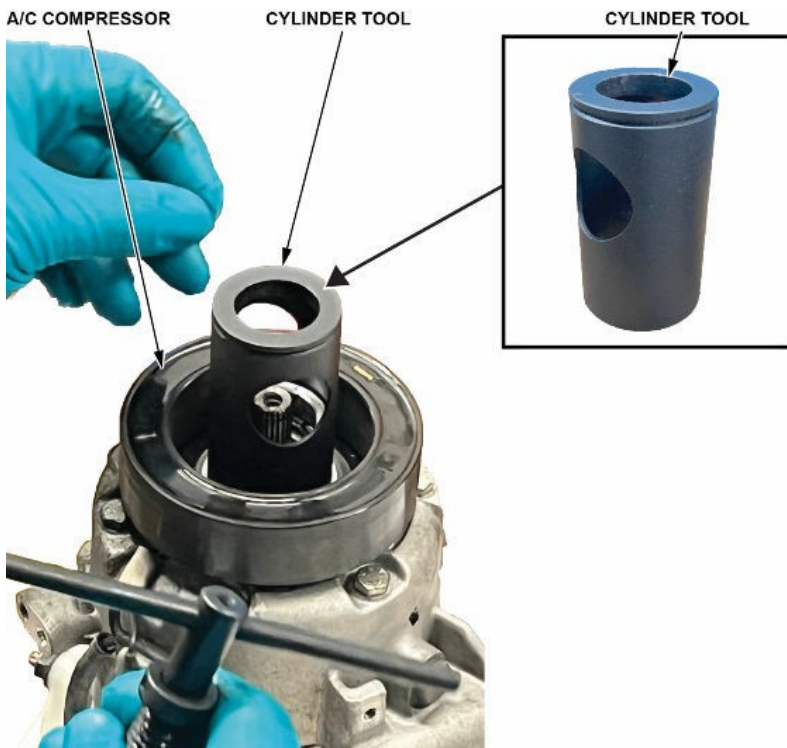
18. Insert the cylinder tool onto the A/C compressor.

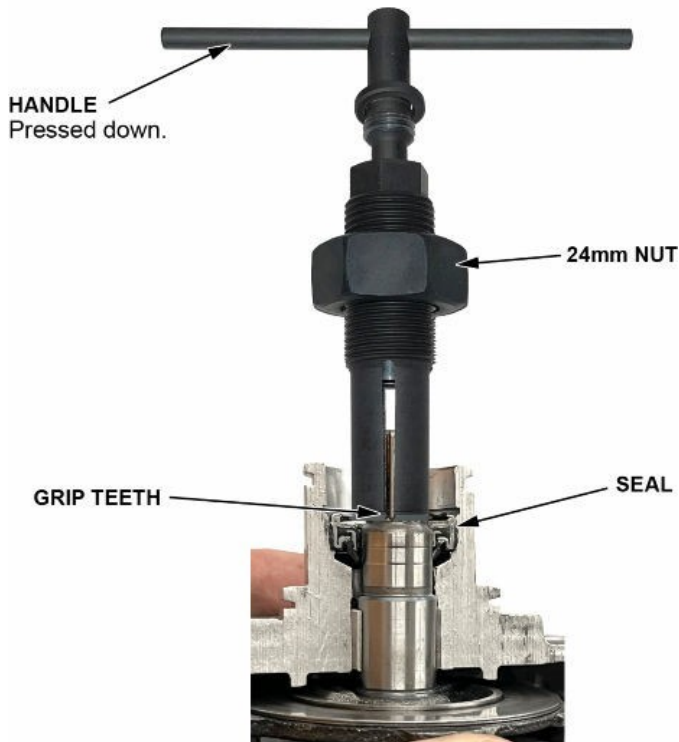
19. Insert the extractor tool, and make sure the **24 mm** nut is positioned towards the top. Look into the cylinder window to align the extractor tool onto the flange and press the handle fully down to grab the seal.

NOTE: The **24 mm** nut will use a **36 mm** wrench.

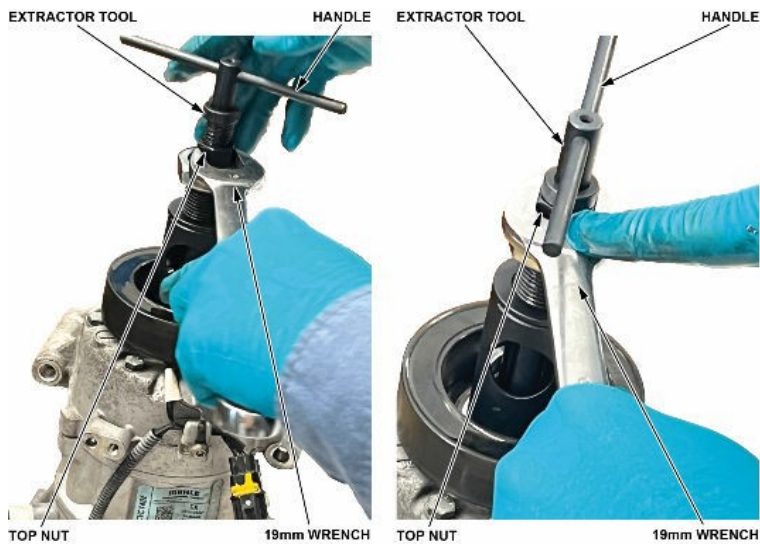
20. Stabilize the extractor tool using a **19 mm** wrench on the top. **Then**, turn the handle clockwise until resistance is felt. Make sure that the space between the **19 mm** wrench and the bottom portion of the extractor tool is minimal.

NOTE: To confirm the extractor is engaged, hold the extractor tool and lift the compressor up.

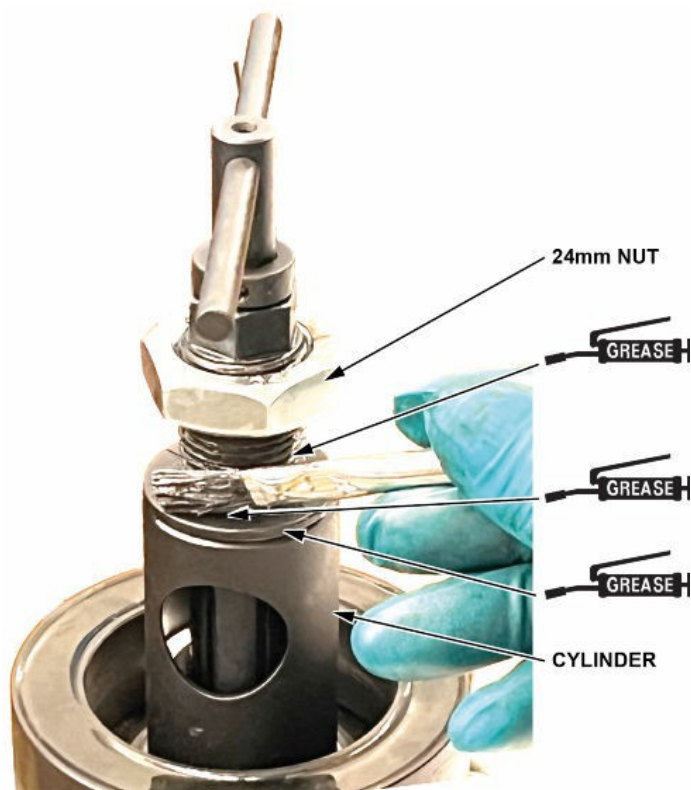
21. Apply grease between the **24 mm** nut and cylinder as well as cylinder top.

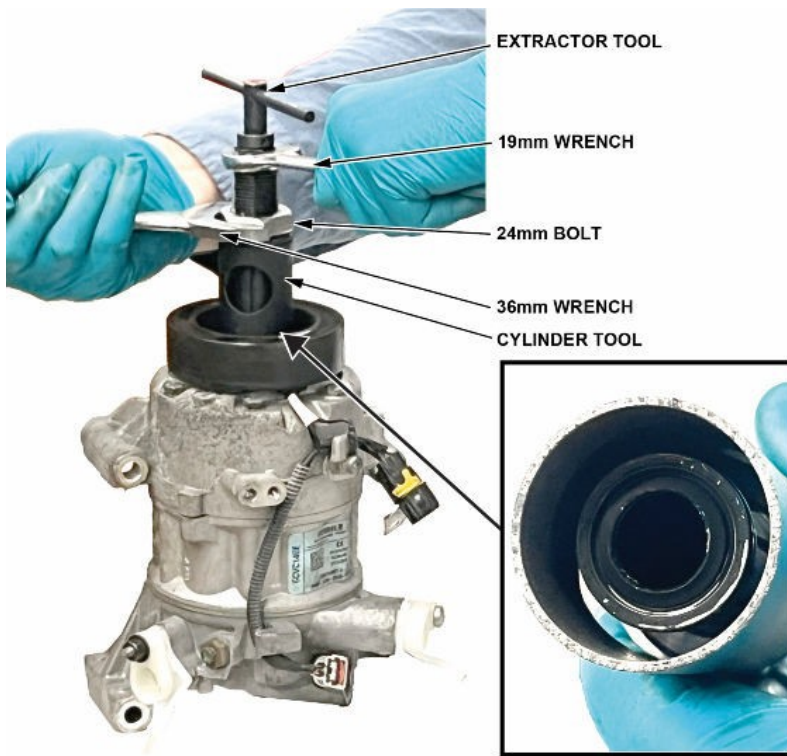
22. With the **19 mm** wrench in place, lower the **24 mm** nut down until it reaches the cylinder. Slowly and carefully adjust until the extractor tool comes out freely with the seal.

- Resistance will be felt while lowering **24 mm** nut and will cease once the seal is extracted.
- If the seal does not come out on the first step, repeat the process starting at step 13.

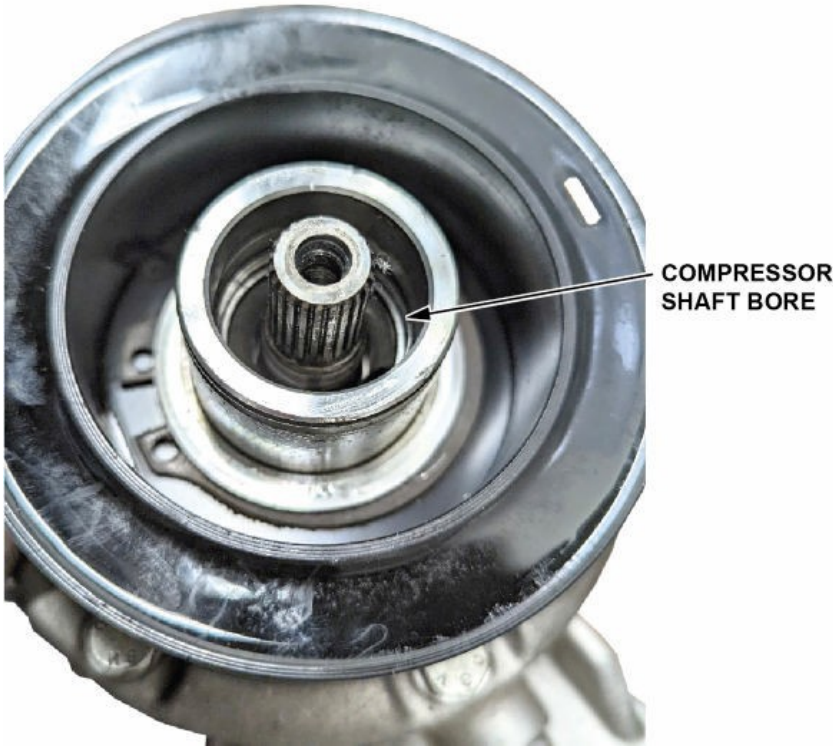
23. Thoroughly clean the bore and shaft with a lint free cloth.

NOTE: Do not use compressed air. The bore needs to be very clean as to prevent debris from entering the compressor once the seal is installed. Failure to remove all debris will result in future failure.

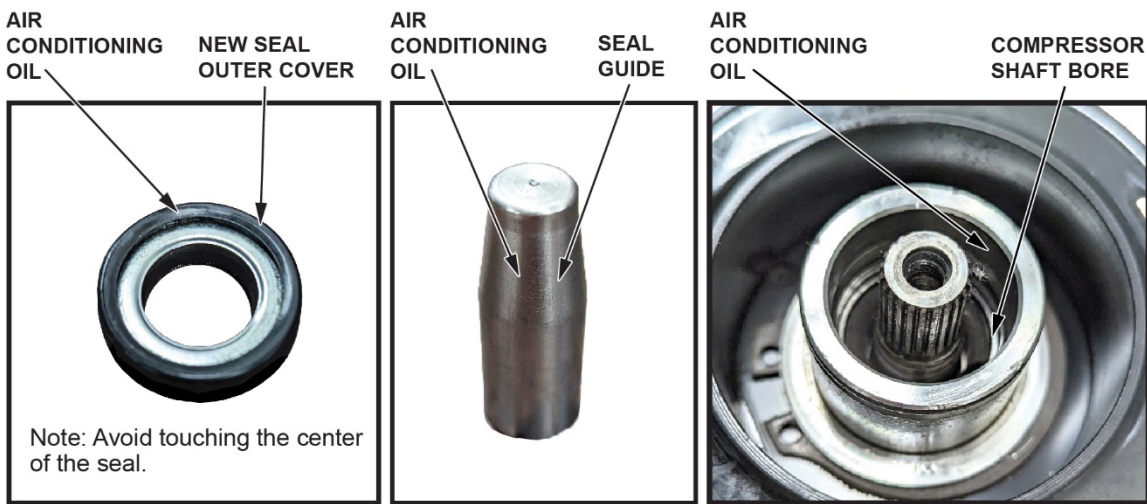
24. Inspect the compressor shaft bore for visible damage; Inspect the seal guide for contamination or damage.

25. Lubricate the new seal outer surface, seal guide, and bore with new POE compressor oil.

- Avoid touching the center of the seal to prevent cross-contamination of the A/C refrigerant system.
- Make sure to clean the surface using clean gloves and with a lint free cloth before lubrication.

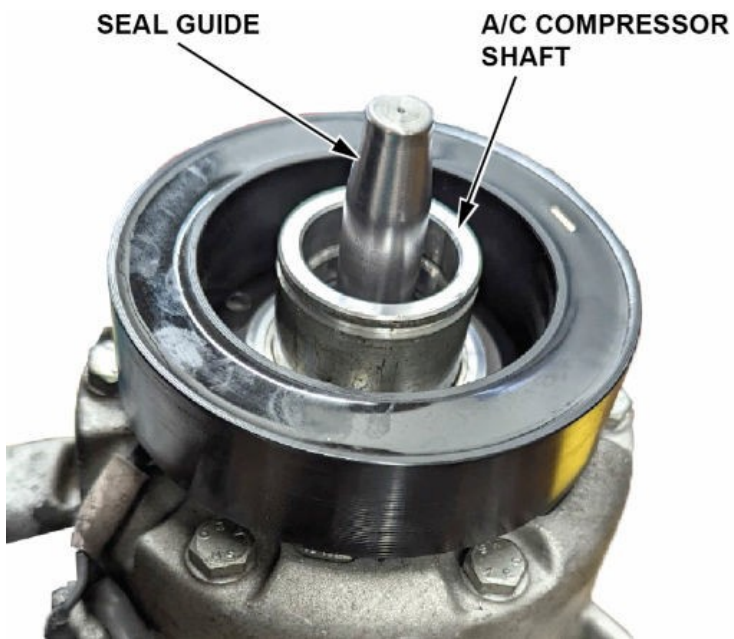
26. Insert the seal guide tool onto A/C compressor shaft.

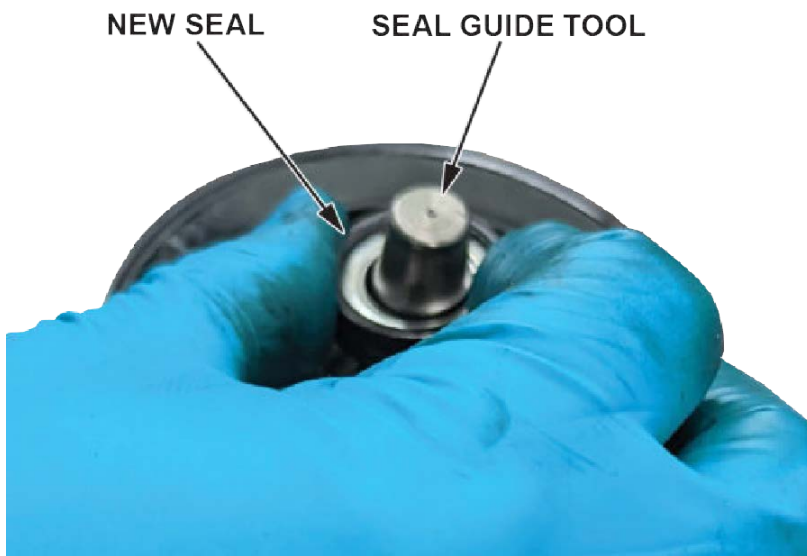
27. Insert the new seal onto the seal guide tool.

NOTE: The seal is directional and must be placed with the metal side upwards as shown below.

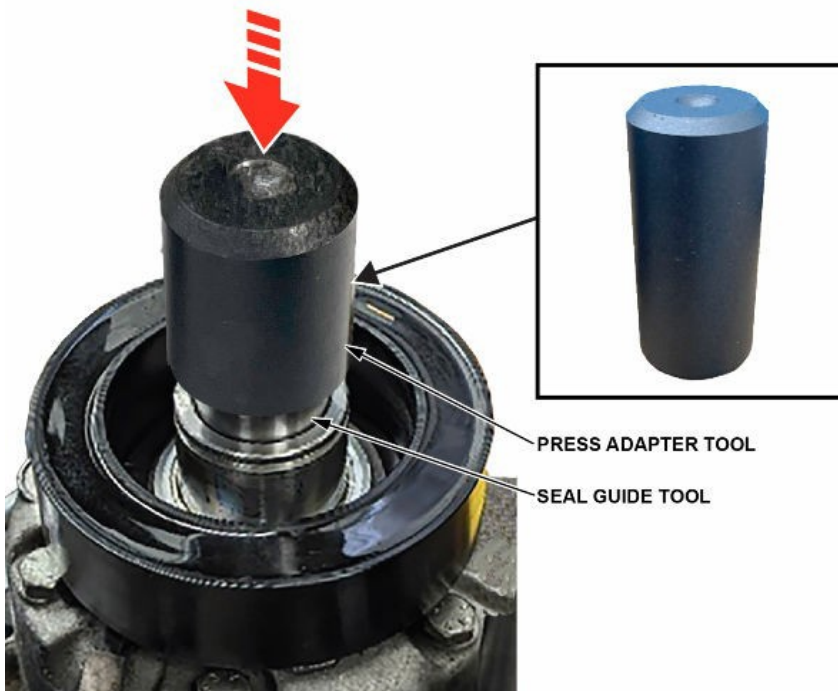
28. Insert the press adapter tool over the seal guide. By hand, press down just enough to seat and install the new seal.
 NOTE: Seat the seal about **5 mm** below the top edge of the bore.

Push down.

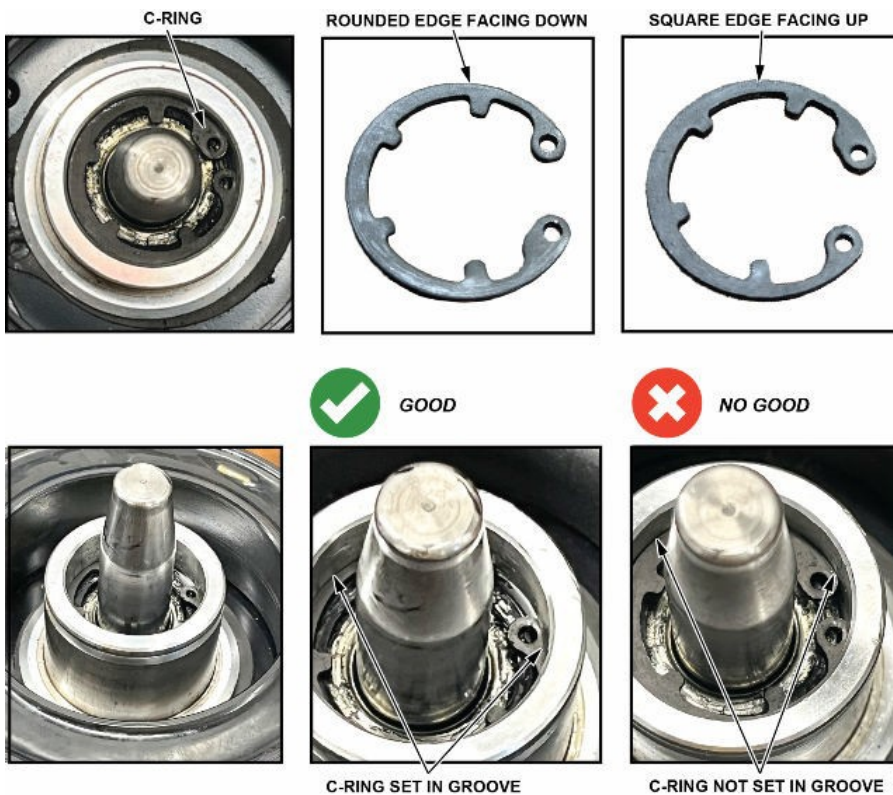
29. Insert the new seal C-ring with the teeth's rounded side pointing down into the bore.

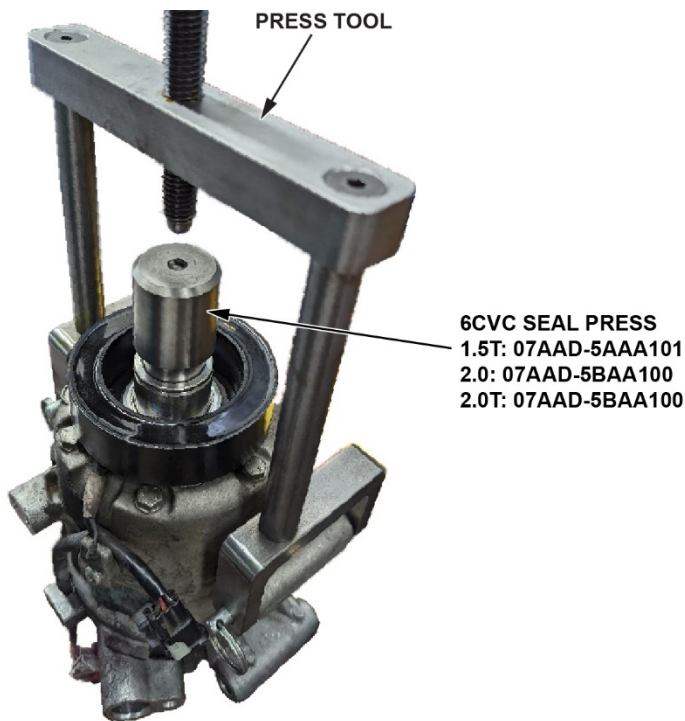
30. Add the press tool.

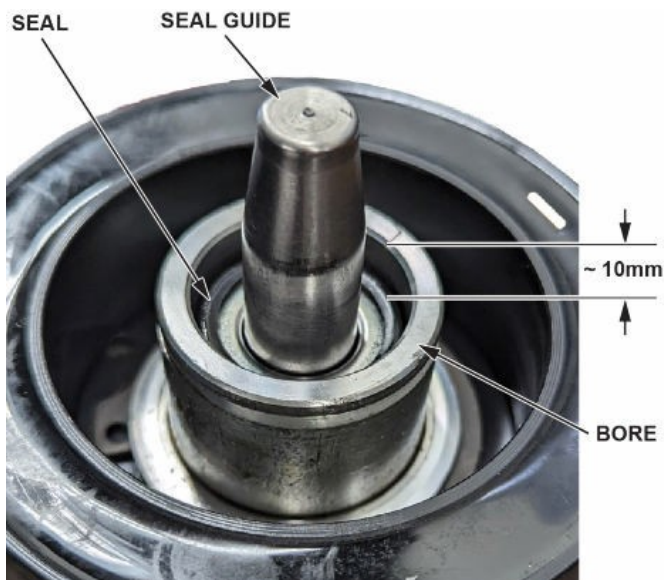
31. Tighten the press by rotating the handle clockwise until it reaches the adapter tool. Slowly and carefully continue to rotate the handle clockwise until the seal is pressed down roughly **10 mm** below the top edge of the bore.

NOTE: Tighten the press until the C-clip is installed into the clip groove. There will be a sound or vibration felt when the C-clip is fully set.
