## Technical product information

<b>Topic</b>	Bentayga - "A" Post Water Deflector - Surface Contamination
<b>Market area</b>	Hongkong-Macau (5HK),Australia E04 Bentley rest Asia and Australia (6E04),China 723 Volkswagen (Anhui) Automotive CO (6723),China 796 VW Import Comp. Ltd (Vico), Beijing (6796),Germany E02 Bentley rest Europe (6E02),Japan E03 Bentley Japan (6E03),Korea, (South) E08 Bentley South Korea (6E08),United Arab Emirates E06 Bentley Middle East and Africa (6E06),United Kingdom E01 Bentley UK (6E01),United States E05 Bentley USA and rest America (6E05)
<b>Brand</b>	Bentley
<b>Transaction No.</b>	2049193/2
<b>Level</b>	EH
<b>Status</b>	Draft
<b>Release date</b>

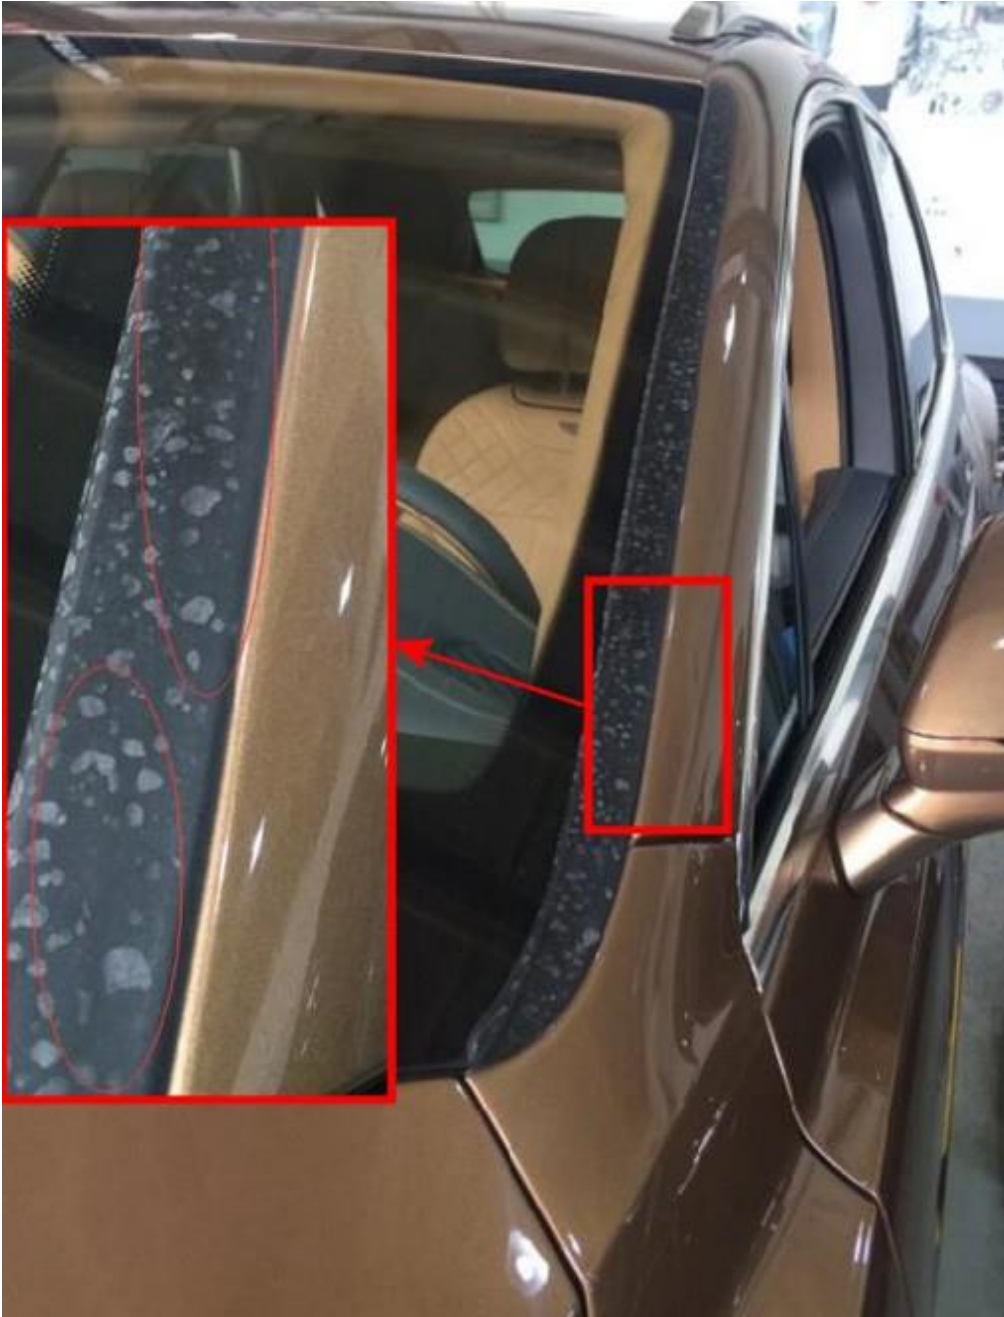
Mottled appearance on "A" post water deflectors.

Surface deposits on "A" post water deflectors cannot be removed by washing with car shampoo.

Surface deposits are caused by UV protection additives contained within the "A" post water deflector migrating to the surface. This migration process is intentionally designed to protect parts from brittleness and ageing, the mottled appearance may occur after a certain length of time and is also dependent on temperature and humidity.

Wash the "A" post water deflectors to remove loose dirt and dust using the Bentley approved car shampoo. The Bentley approved rubber conditioner should then be used to remove deposits and the mottled appearance.
