Technical Service Bulletin

70 Noises from headliner/sunroof area

70 24 87 2038029/9 February 6, 2024. Supersedes Technical Service Bulletin Group 70 number 21-72 dated April 9, 2021 for reasons listed below.

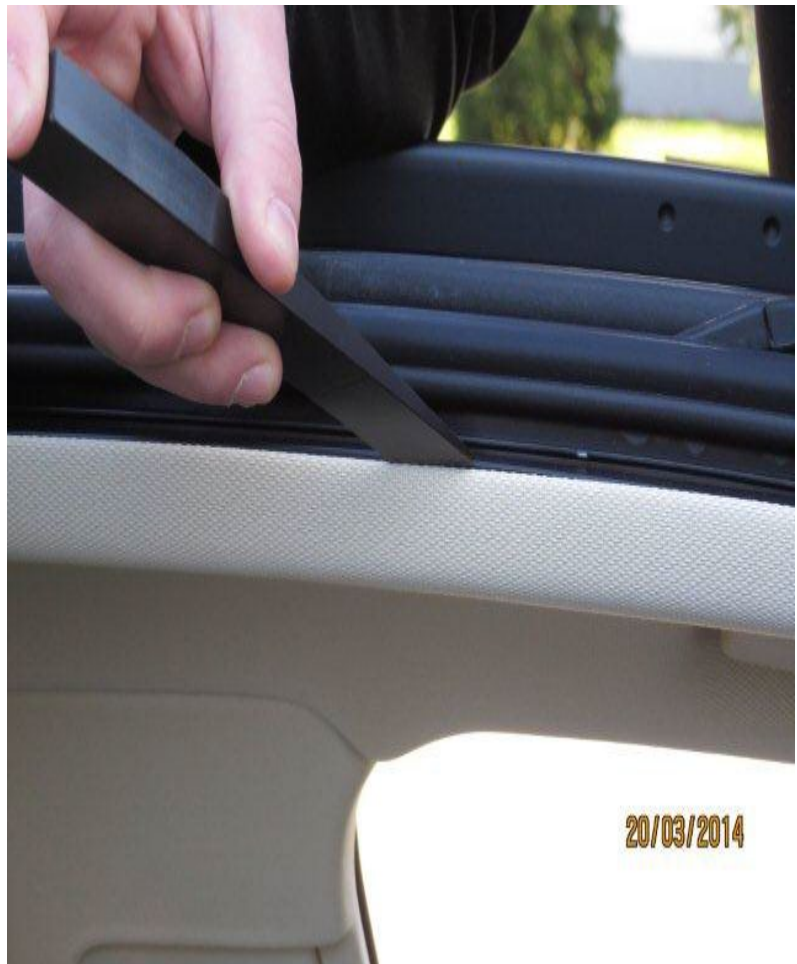
Figure 1. Unclipping the sunroof cover trim frame.

1. Carefully unclip the sunroof cover trim frame and lower the headliner (Figure 1). The headliner does not need to be removed.

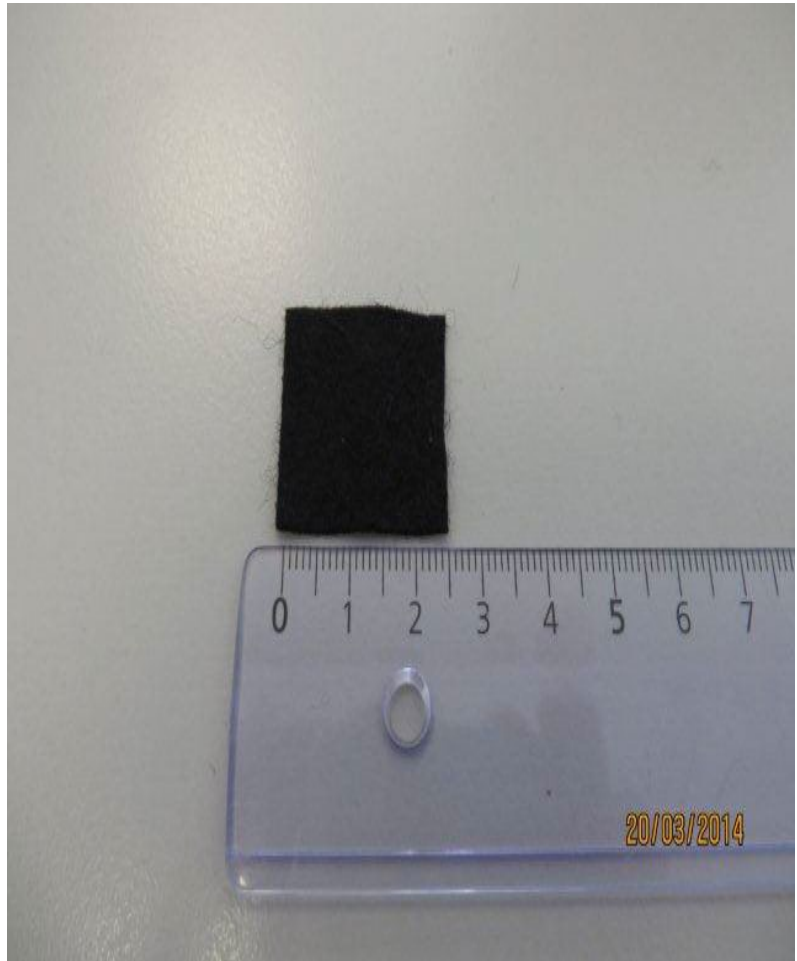
Figure 2. A 25mm section of fleece adhesive tape D 004350A2.

2. The number of retaining clips will vary by model. A piece of dampening tape (webbing adhesive tape D 004350A2) will be applied to each clipping point. Cut pieces of the tape 25mm long (Figure 2).

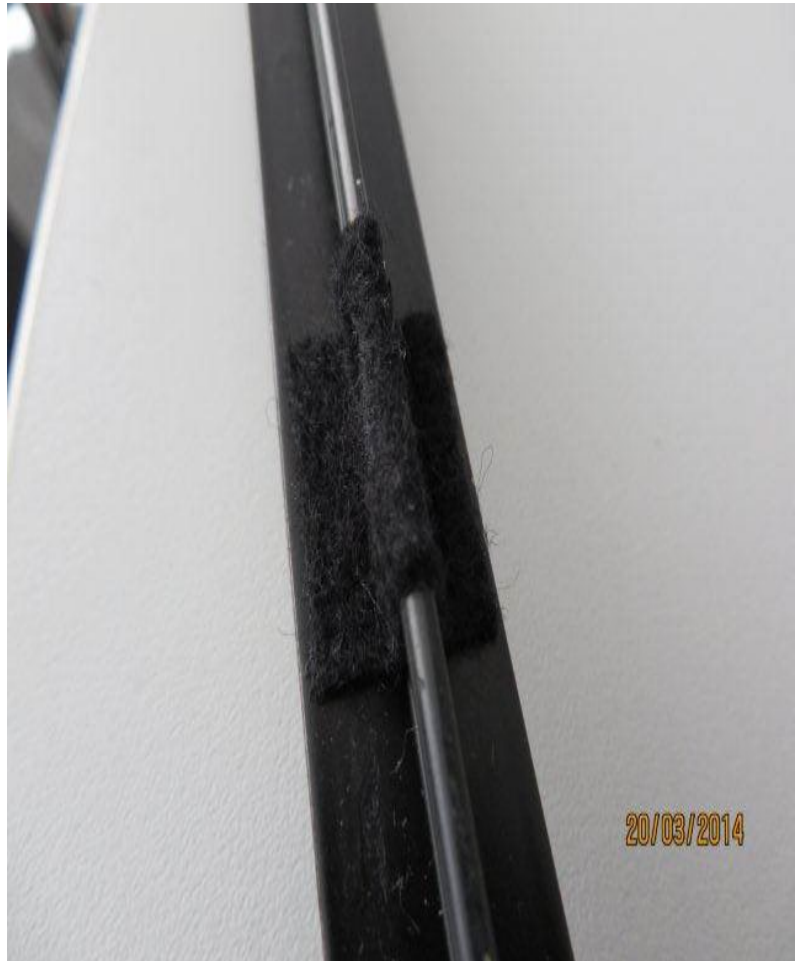
Figure 3. Fleece adhesive tape section applied.

3. Apply the sections of webbing adhesive tape to the sunroof cover trim frame to each clipping point as shown (Figures 3 - 4).

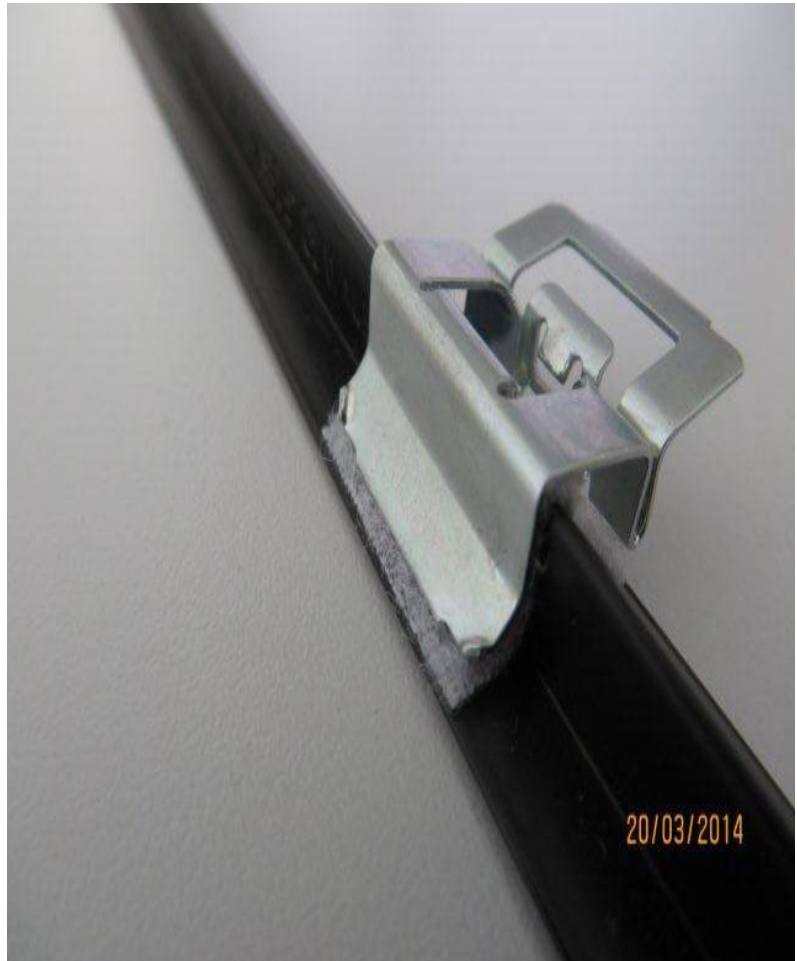
Figure 4. Retaining clip isolated with the fleece adhesive tape.

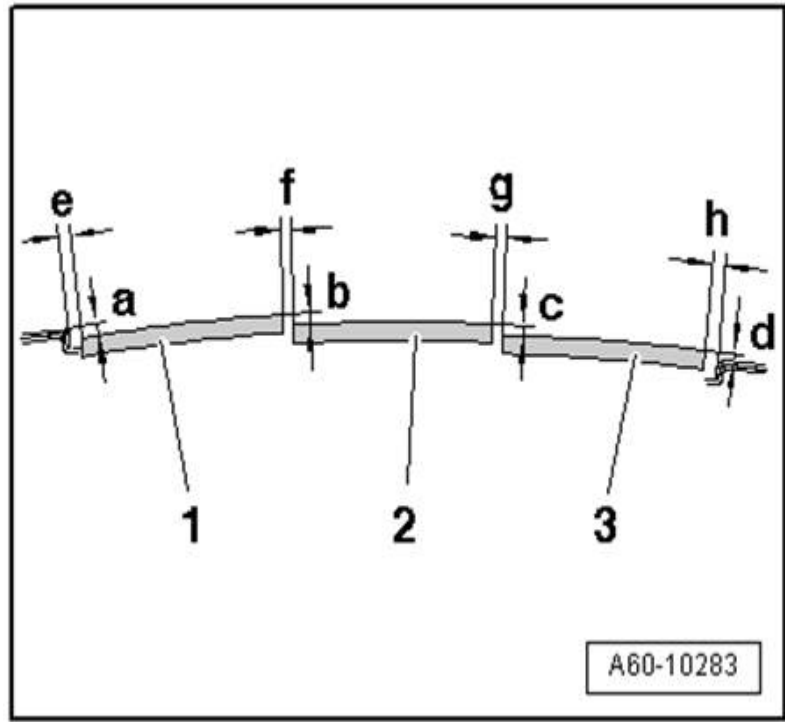
Figure 5. Adjustment of the glass sliding roof panels.

4. Reassemble the components removed for this modification. Ensure that the glass sliding roof panels are adjusted properly according to the repair manual (Figure 5).
