SIB 33 04 24

Service Action: Check Suspension Strut

2024-02-04

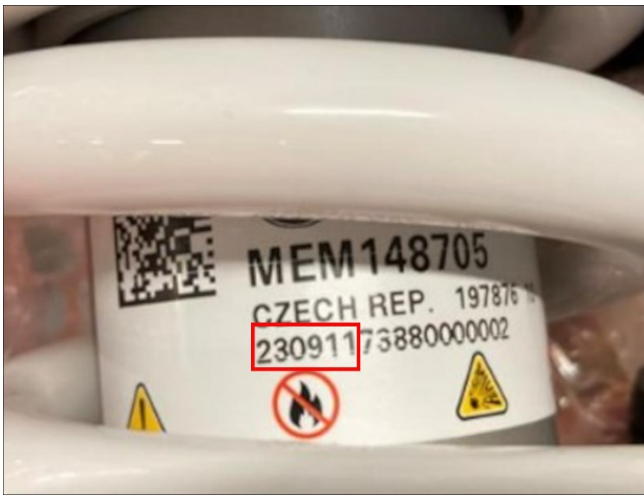
Production date 230814 to 230911:

Suspension strut **must be replaced** if any of these production dates are listed on the strut in the location shown in the above figure;

NOTE: None of the suspension struts **before** or **after** these production dates are affected.

In the case of the K 1600 models and the R 1250 RT, the front and rear ESA suspension strut must be checked and replaced, if necessary.

In the case of the R 1250 R and the R 1250 RS, the rear ESA suspension strut must be checked and replaced, if necessary.
