REFERENCE:	Nova Bus Manuals
SECTION:	01: Body
RS N°:	MQR 7621-2765
EFFECTIVE IN PROD.:	LF63 (2023OC)

SUBJECT:	Headlight Bezel
JUSTIFICATION:	Headlight bezel adjustment screw may interfere with HIVIS frame.

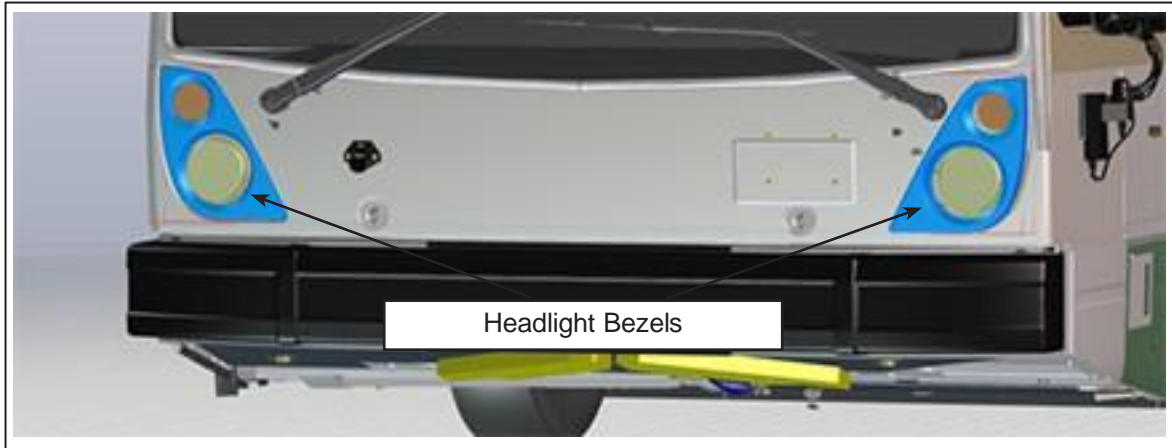
- 1.1. Park the vehicle on an even surface with the transmission on neutral.
- 1.2. Apply the parking brake and set the master control switch to the **stop** position.
- 1.3. Remove the front headlight bezels. See Figure 1.

Figure 1 - Headlight Bezels to Remove

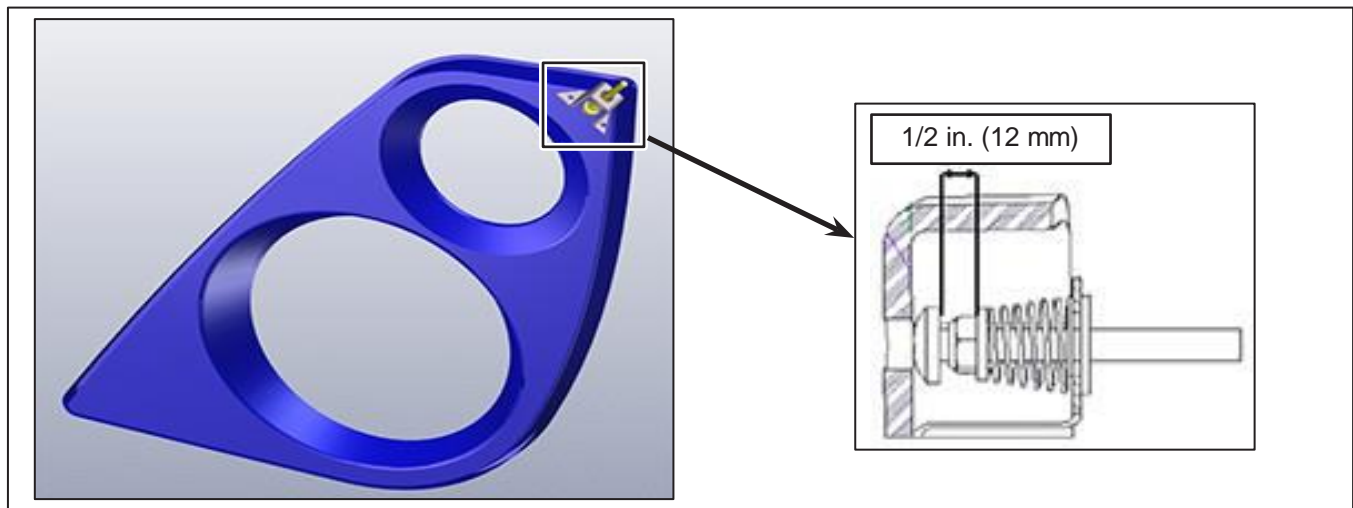
- 1.4. Adjust the gap between the head of the screw and the top of the nut flange on each bezel. See Figure 2.

Figure 2 - Headlight Bezel Screw Adjustment

- 1.5. Install both bezel back to the vehicle.
- 1.6. Return the vehicle in service
