A26/17 - MBUX multimedia system (Head unit) NTG7 - Radio function is not available

Topic number	LI82.60-P-077495
Version	1
Function group	82.60 - Radio, audio, video systems
Date	2/15/24
Validity	NTG7*2 model series 118, 167, 177 and 247 with SA code 521, 525 with software release E329.5 or E330.6
Reason for change

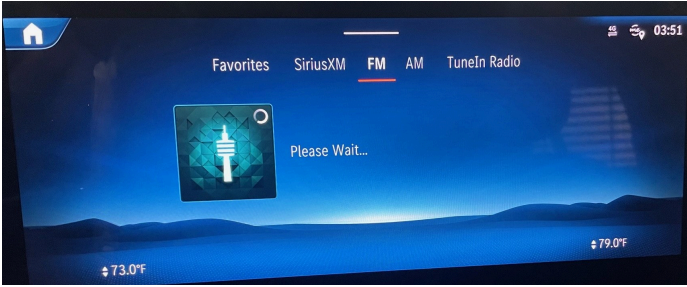
Attachments	
File	Description
LI82.60-P-077495.jpg	Radio screen loading

After clicking on the "Radio" selection function, the radio does not start and instead a permanent loading wheel is displayed. See attached picture for example.

Software version

A26/17 - MBUX multimedia system (Head unit) unit must be replaced. When the head unit is in this condition, a software update will not remedy the situation.
