Bulletin No.: PIT5479F  
Published date: 02/6/2024

### PIT5479F Diagnostic Tip - Perceived Brake Fluid Leak at Caliper Piston Boot

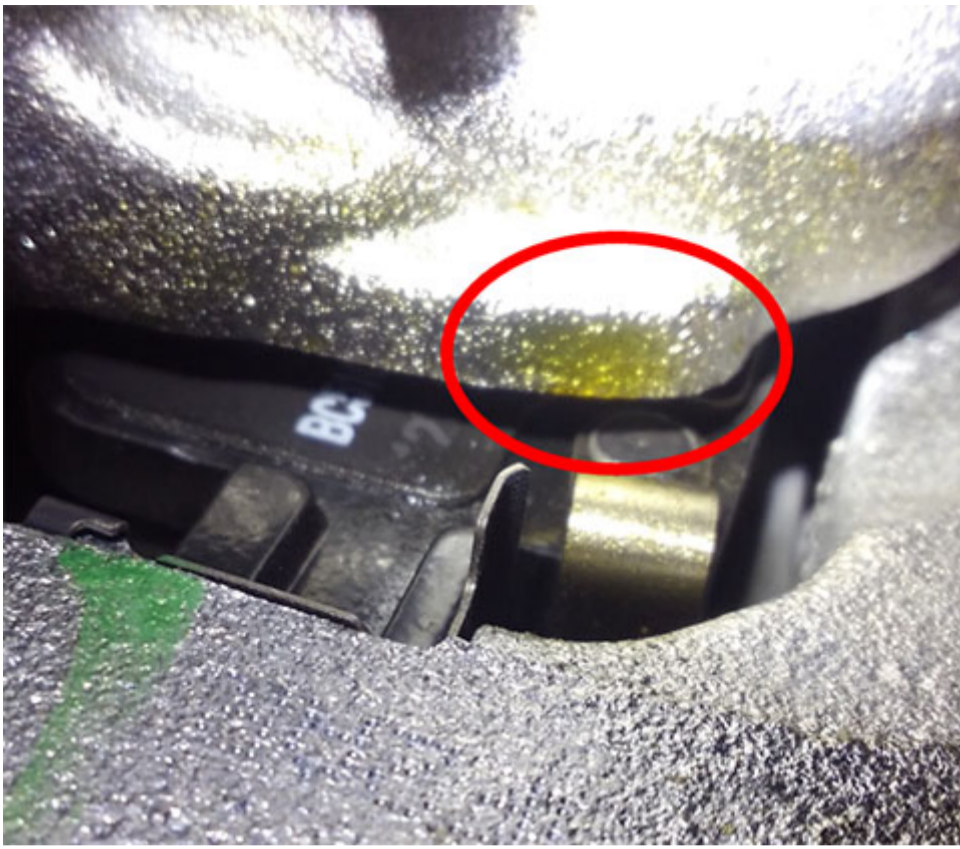
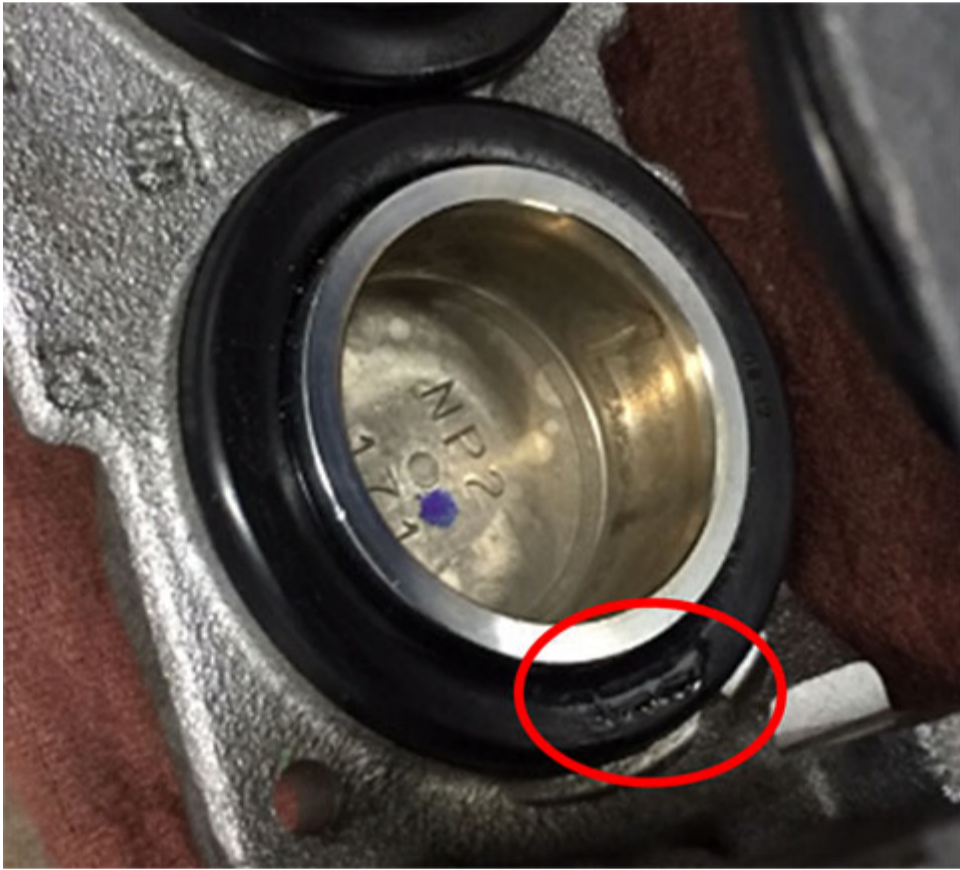
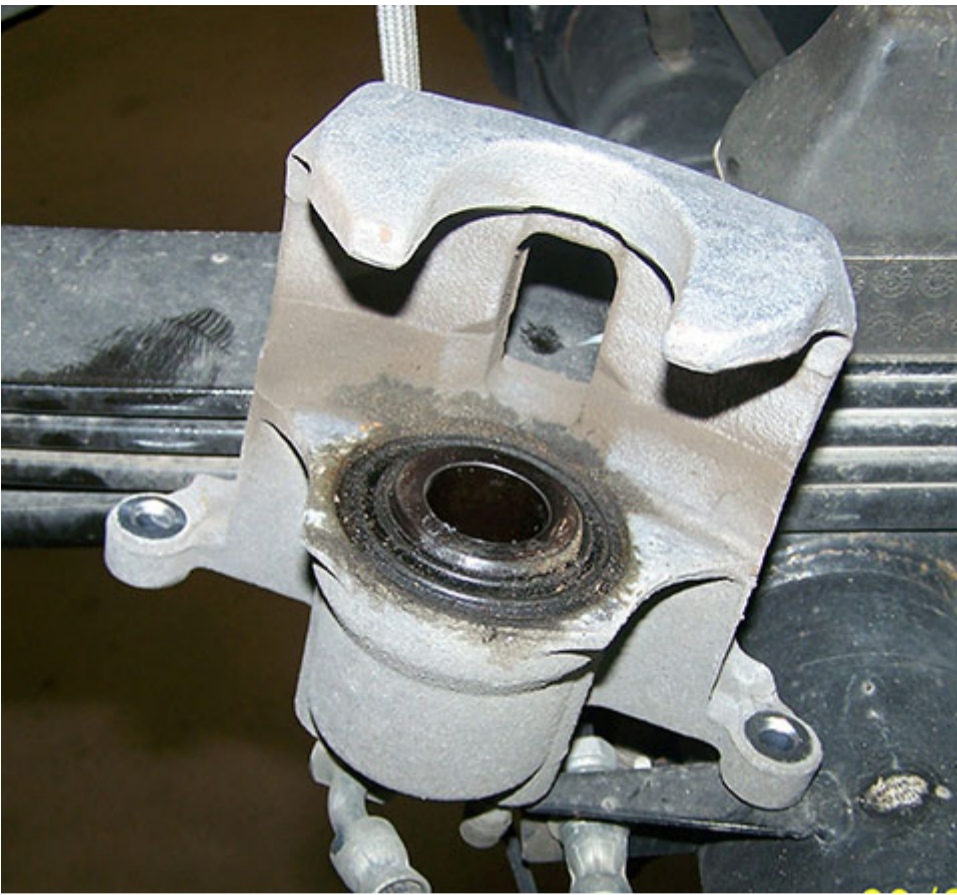
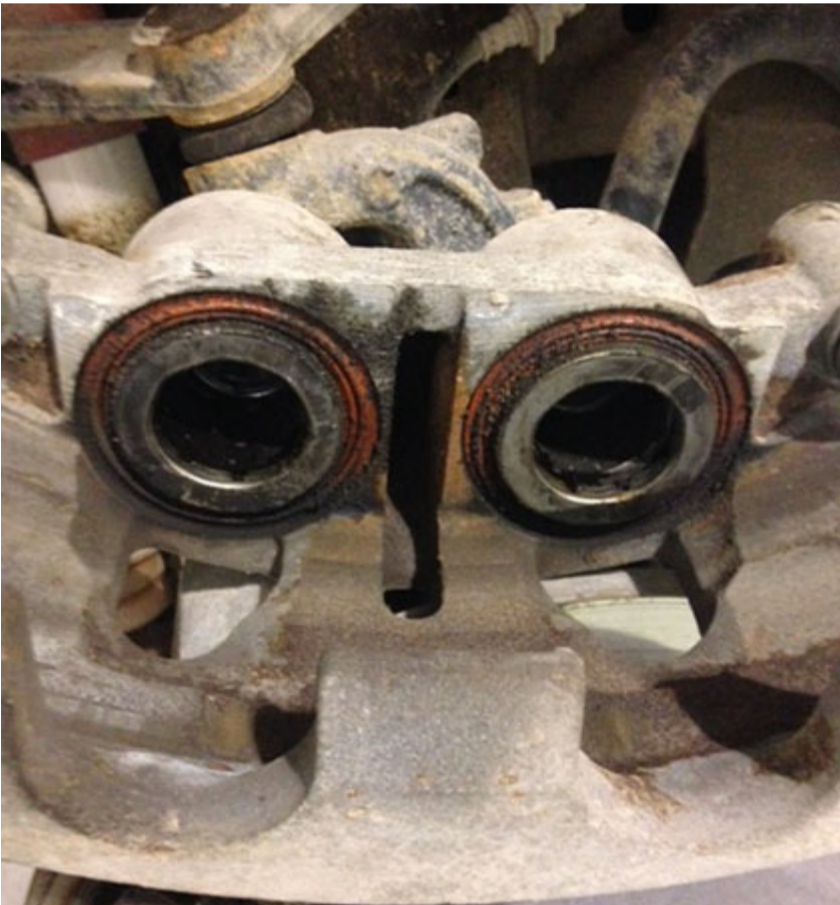
**A technician may comment that, during service, it appears there is fluid leaking from the brake caliper piston area. Shown below are examples of newer low mileage vehicles and older higher mileage vehicles.**

**The substance shown is actually excess assembly grease from the caliper boot and piston installation. This grease can be cleaned off and the rest of the service completed.**

**NOTE: When diagnosing a brake fluid leak or certain DTC's for hydraulic brake circuit leaks, such as C05B0, do not confuse excessive assembly grease as a brake fluid leak. If it is uncertain what is seen is assembly grease, then clean off the excessive grease and apply the brake pedal 20 times and re-inspect for a leak.**
