Technical Journal

Technical Journal Title ICUP "Searching for GPS" message in DIM / CSD		Ref. No. TJ 36691.5.0	
Issuer (Dept.) Technical Service		Issue Date 3/5/24	Status Date 3/14/24
Car Market United States and Canada	Partner 3 US 7510 Volvo Car USA	Function Group 3900	
Function Description Media, navigation and communication		Page Page 1 of 3

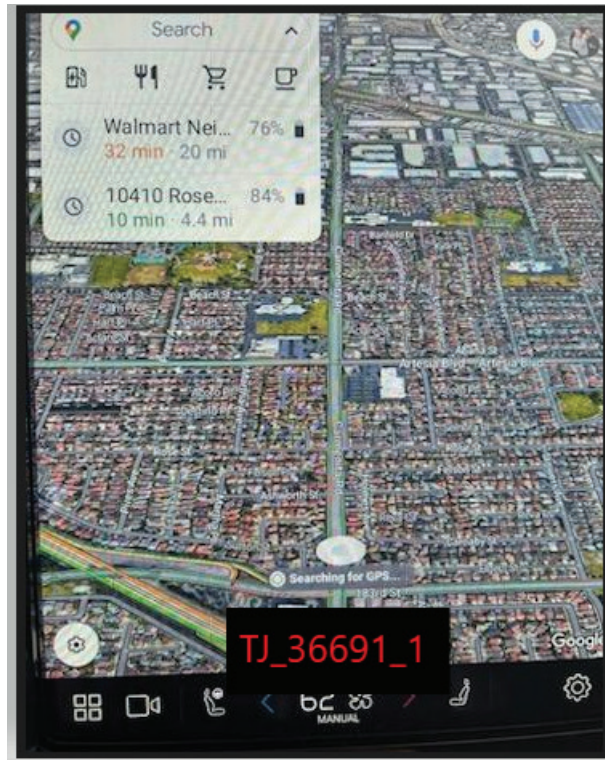
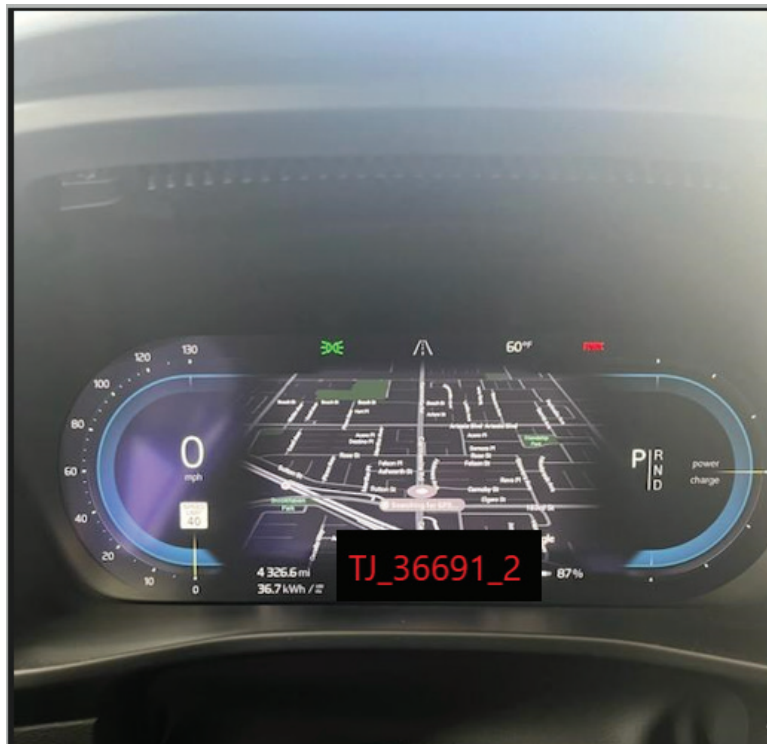
File Name	File Size
TJ_36691_1.PNG	0.4320 MB
TJ_36691_2.PNG	0.2862 MB

If the customer experiences a "Searching for GPS" message in the CSD and DIM during startup, while LTE connection is fully established (see attachment TJ_36691_1/2), then follow advice under "Service".

Do not replace any components for this issue.

*An Improved IHU software is planned towards year 2024 quarter 2 in VIDA.
