Countries: CANADA, UNITED STATES Document ID: IK2300017  
Availability: ISIS, Bus ISIS, NotSIR Revision: 3  
Major System: ELECTRIC VEHICLE Created: 5/24/2023  
Current Language: English Last Modified: 3/14/2024  
Other Languages: [Français](#), Author: Josh Bowman  
Viewed: 332

Title: Electric Vehicle Air Dryer Operation

Applies To: Electric CE Bus & eMV

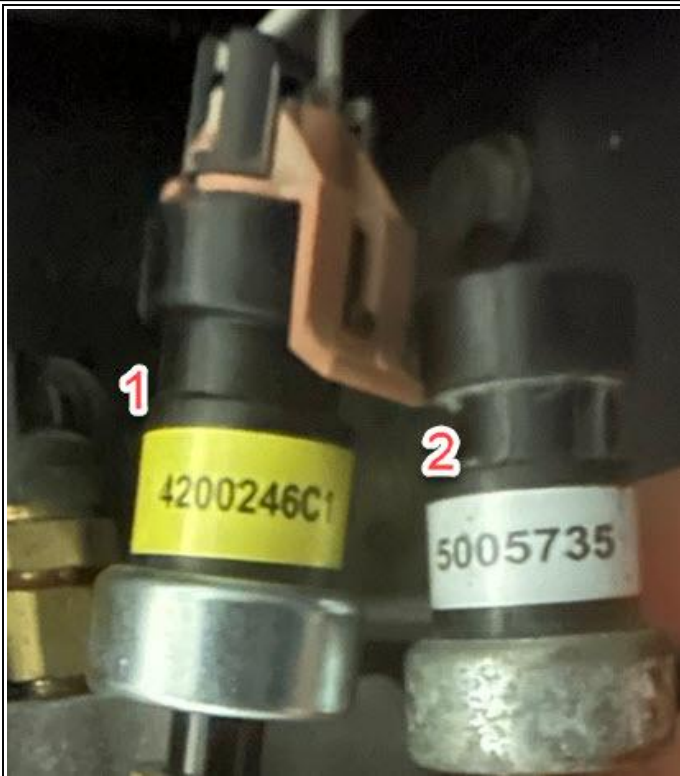
**Figure 1: Air Dryer Switch Comparison**

Item 1: Correct Sensor, Yellow Label

Item 2: Incorrect Sensor, White Label

Kit Description	Part Number	Quantity Required	Notes
Switch, sensor, pressure switch	4200246C1	1	Yellow label, normally closed

Step	Action	Decision
2	<p><b>DIAGNOSTIC:</b></p> <p>Does the air dryer purge, but develops a constant air leak at the purge valve.</p>	<p><b>Yes.</b> Inspect the governor pressure switch and verify the correct sensor is installed.</p> <p>Incorrect sensor will have a white label, with PN 5005735 printed on it.</p> <p>Correct sensor will have a yellow label, with PN4200246C1 printed on it.</p> <p>Install correct sensor and retest. (refer to Figure 1)</p> <p>If constant air leak is still present please proceed to step 3.</p> <hr/> <p><b>No.</b> No further action is needed, return vehicle back to service.</p>
