SERVICE BULLETIN

APPLICABILITY: 2019-25MY Forester

NUMBER: 07-218-23R

SUBJECT: Genuine Alternative Battery Replacement

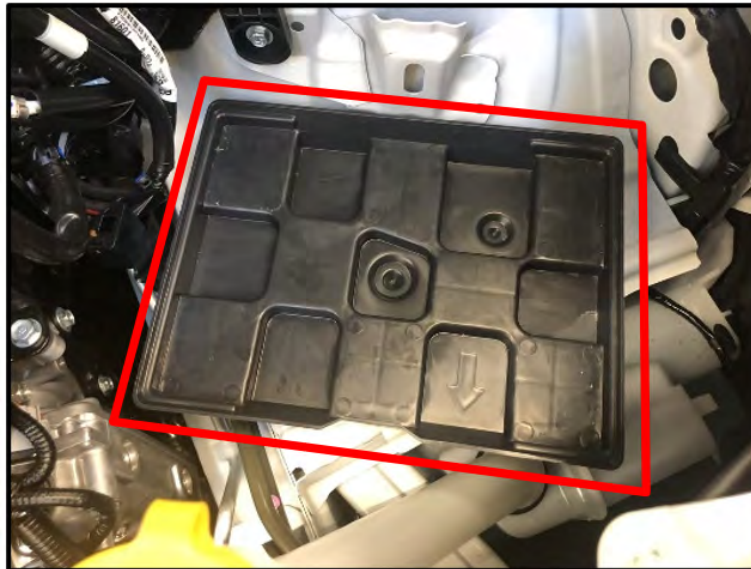
STEP 3: Replace the battery tray with the new part (p.n. 82190AN000).

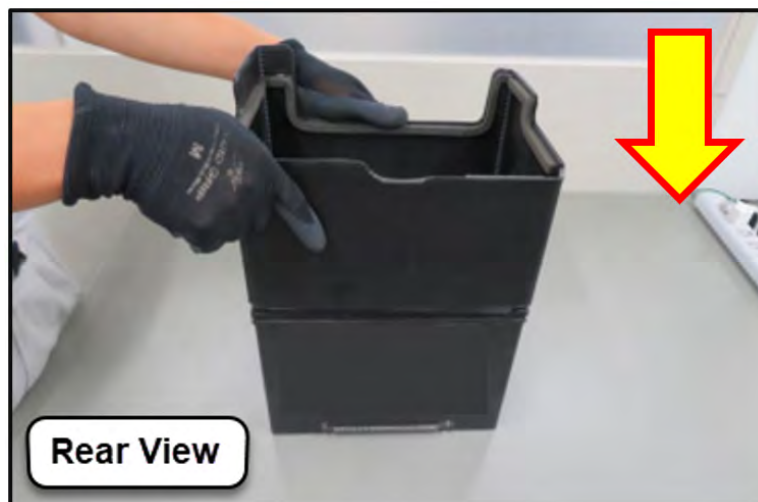
STEP 4: Install the NEW battery cover (p.n. 82123AN000) to the alternative replacement battery. Confirm the bottom of the cover is aligned flush with the bottom of the battery.

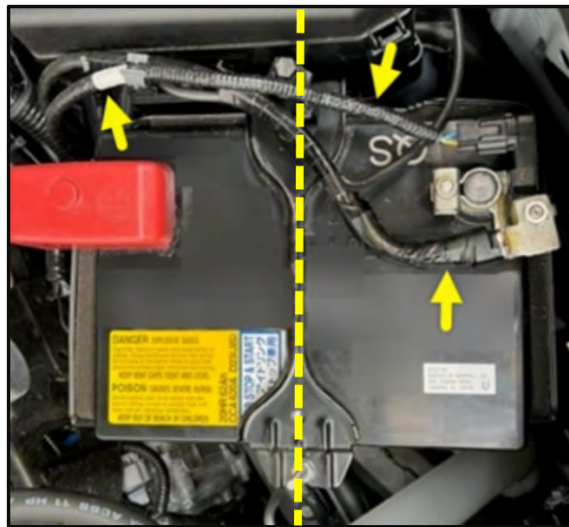
STEP 6: Install the original battery holder and holding rods on to the battery.

- A. Torque the two holding rod mounting nuts to **3.5 N·m (2.6ft.-lbs. or 31inch.-lbs.)**.
- B. Torque the positive terminal to **6 N·m (4.4ft.-lbs. or 53inch.-lbs.)**.
- C. Torque the negative terminal to **7.5Nm (5.5ft.-lbs. or 66inch.-lbs.)**.
- D. If the battery sensor is removed or disconnected torque to 7.5Nm (5.5ft.-lbs. or 66inch.-lbs.) while supporting the sensor with the other hand as outlined in the applicable Service Manual under: STARTING/CHARGING SYSTSEMS > Battery Sensor.

NOTE: Confirm the battery holder is center mounted with the battery cables secured and routed correctly.
