Service Bulletin

Bulletin No.: 19-NA-255

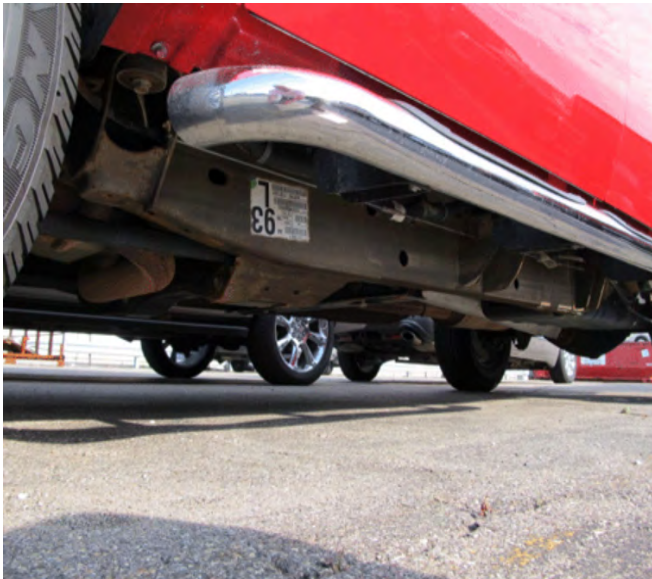
1. Raise and suitably support the vehicle. Refer to *Lifting and Jacking the Vehicle* in the Service Manual.

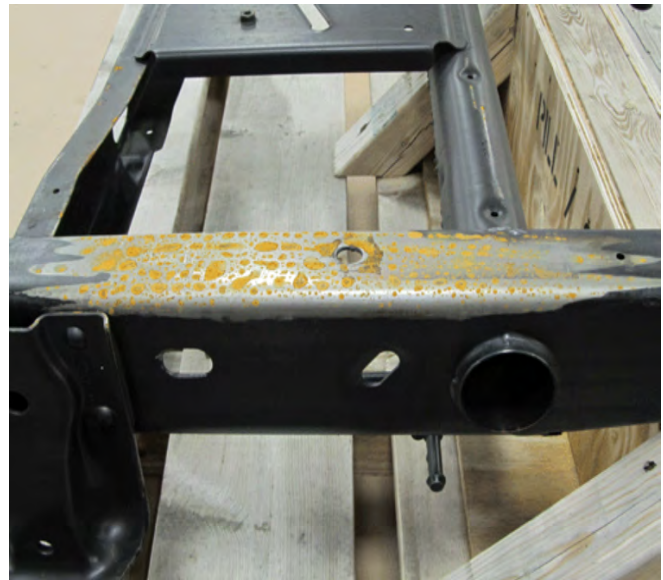
4. Determine a start and finish point on each side for the section/area of the frame to be repaired.

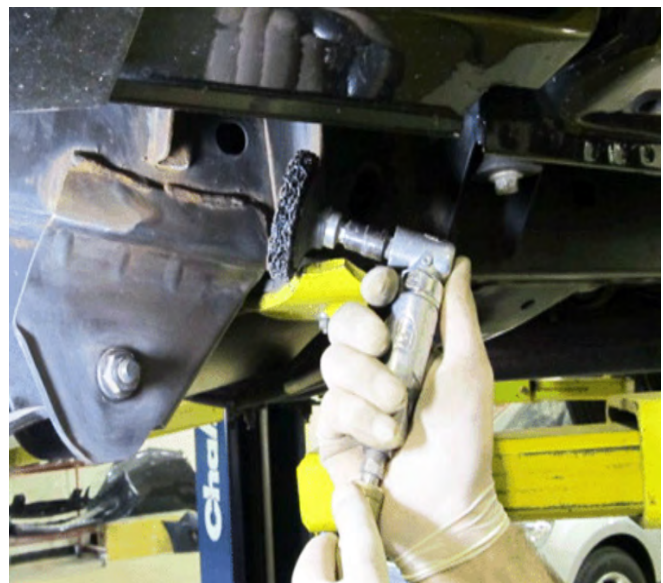
5. Using a rag and wax/grease removing solvent, remove the wax coating and any grease, oil, or undercoating from the truck frame in the affected repair area. The graphic above shows an example of a small portion of the wax coating removed.

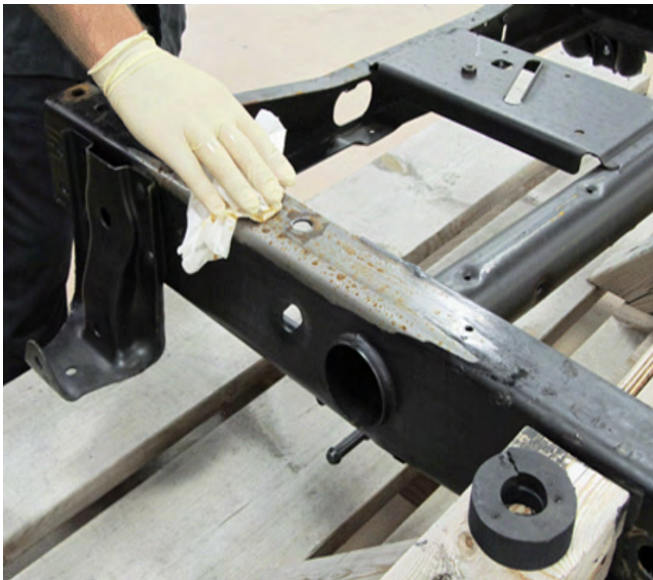
6. Any loose rust or loose flakes should be scraped, wire brushed or ground off.
7. Remove any residual wax, oil or rust by wiping the frame down with a towel or Scotch-Brite™ (3M) pad soaked with wax/grease remover.

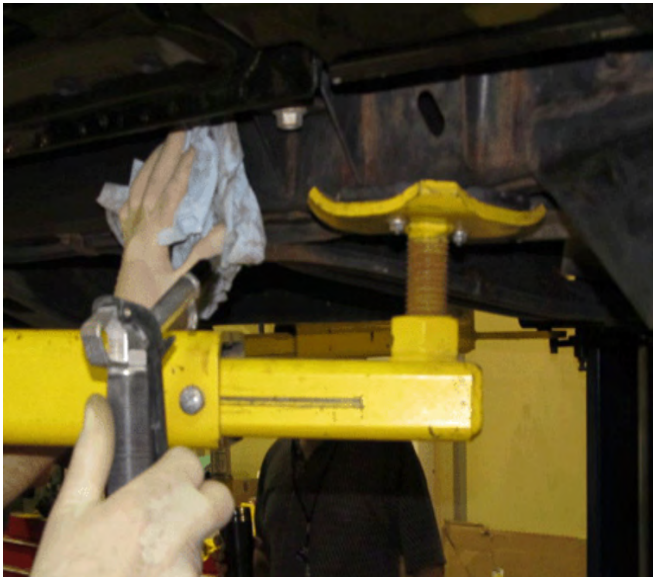
8. Using Lloyd's Pure Prep™ Metal Surface Preparation P/N 25418 (10 fluid ounce bottle), or equivalent, saturate a towel or Scotch-Brite™ (3M) pad with the pre-diluted solution and scrub the area well, rendering a foaming of the Pure Prep.™ This will greatly improve adhesion and corrosion resistance in the repair areas.

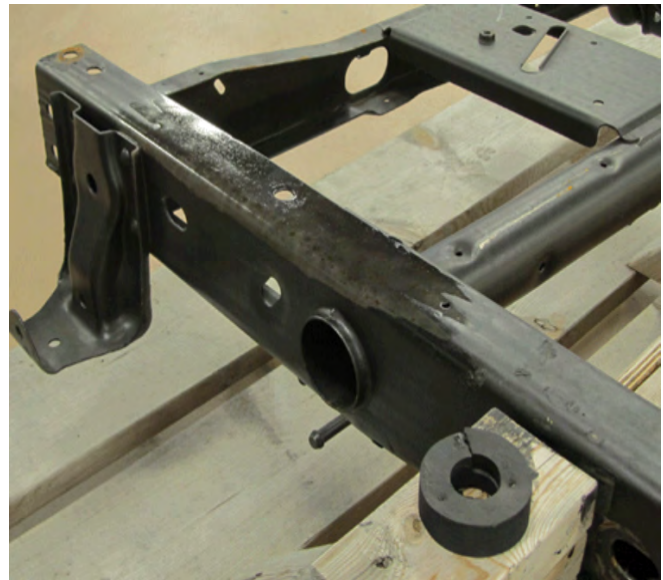
9. Using a water dampened clean towel, remove any residue and dry the affected area. Dry the repair area completely using an air hose to blow dry the frame.
10. Check the repair area for phosphate treatment by wiping it to see if any corrosion residue can be picked up. Correctly treated areas will not have any residue on the surface.

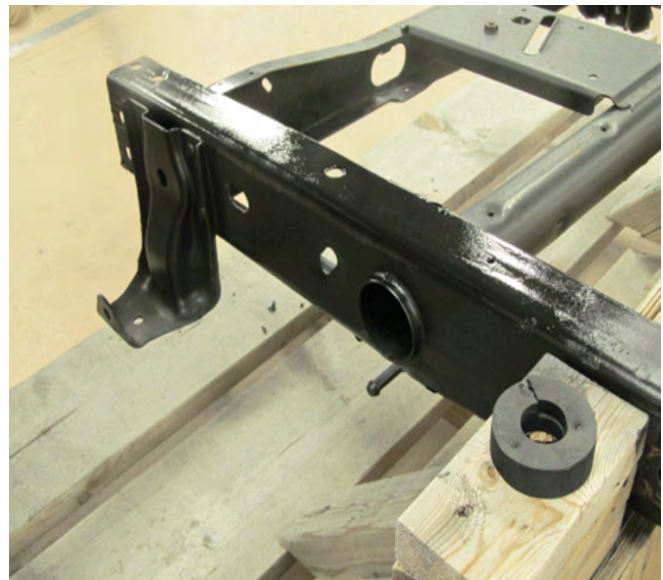
Note: Dried Lloyds Kryptonite will perform beautifully over time and actually get harder and more durable as it experiences heat.

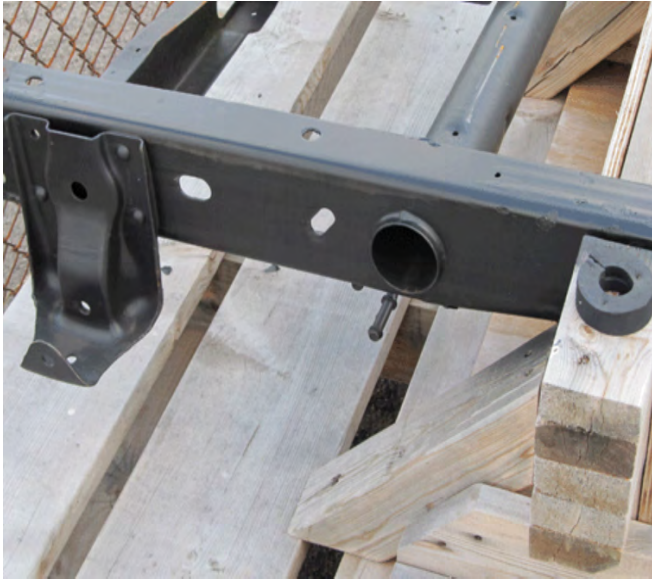
Note: As shown in the graphic below, besides adding a corrosion resistant layer, it dries to firm, wax-like film which will more closely resemble the appearance of the unrepaired areas of the frame.
