## Ember 'Congoleum' Repair Instructions

This document outlines the procedure to repair the linoleum floor according to Ember quality standards.

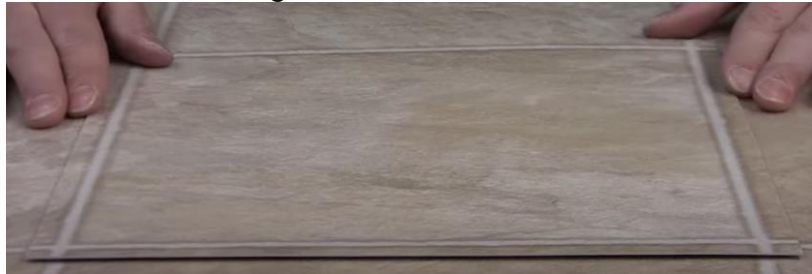
- [Traditional Repair Method](#)
  - [Bond & Seal Repair Method](#)
1. Identify the best match replacement linoleum section and cut the section with a minimum of 1/4" wider than the grout lines.

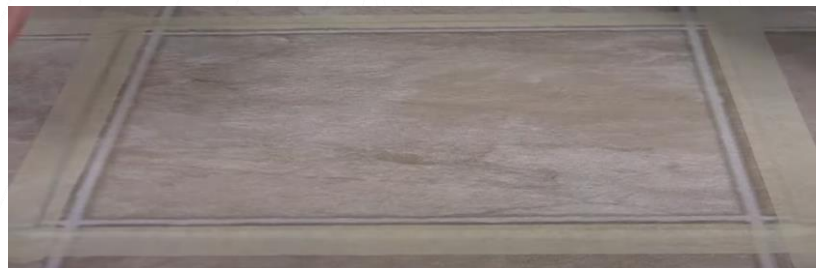
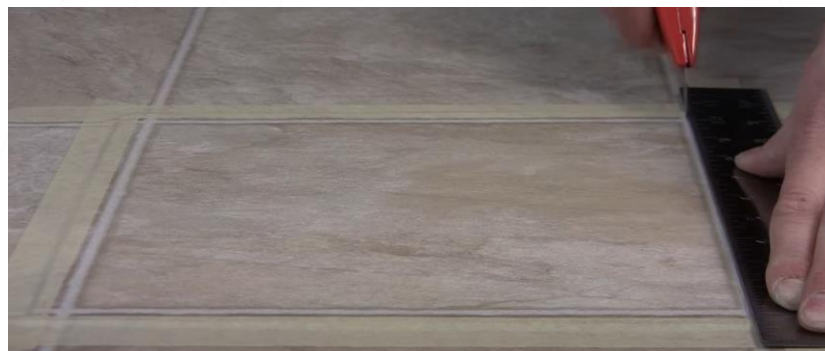
2. Secure the replacement linoleum with tape over the damaged area. Using a straight edge and utility knife cut through both layers around all four sides; be sure to have the blade perpendicular to the floor's surface.

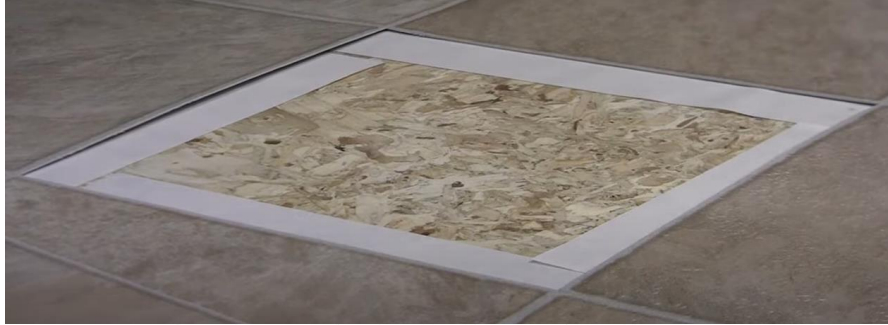
3. Remove repair and damage section; discard damaged section. Then apply Congoleum Quik Stick Tape QS120 about ½" under the main linoleum floor. Secure tape in place using the small hand roller.

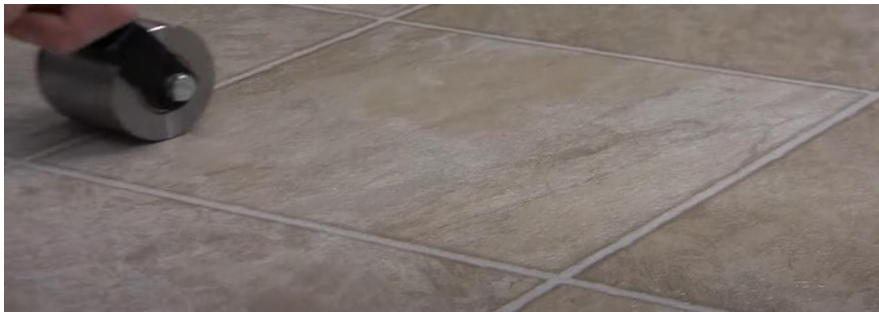
4. Remove the release liner from the tape. Lay the repair section into place ensuring all the seams are nice and tight. Use a small hand roller to embed the repair section into the adhesive.

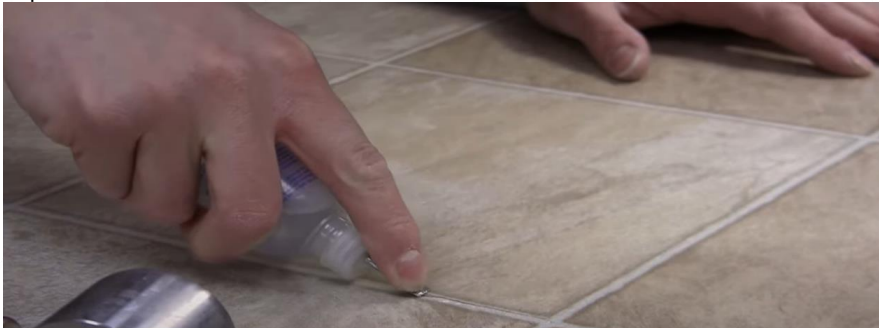
5. Apply Congoleum SU-80 Seam Sealer to all seams of the repaired area. Ensure seam applicator tip is inserted between the two sections.

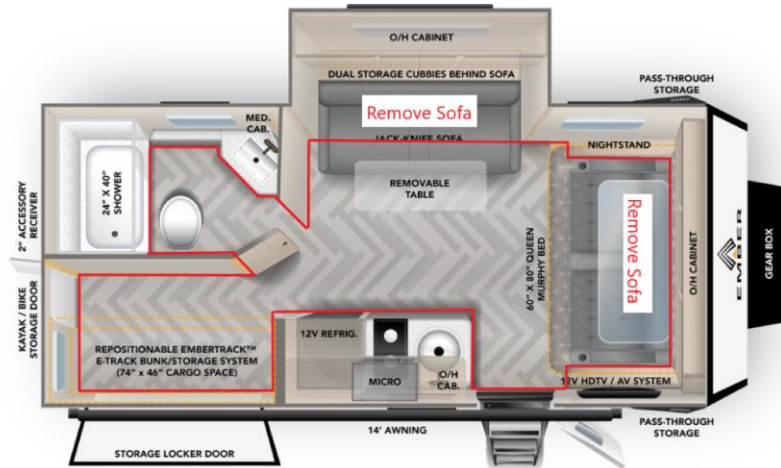
1. Remove the sofa, steps, and other furniture that is on the floor; do not remove cabinets, interior walls, or shower pan.
2. Using a utility knife remove the damaged linoleum by cutting around the cabinets.  
Note: You will use the damaged linoleum as a template for the replacement linoleum.

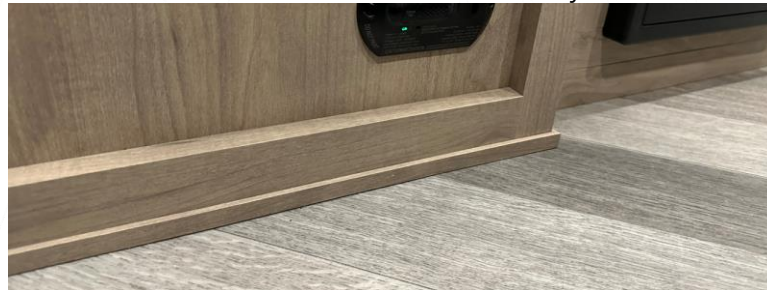
3. Clean the subfloor thoroughly and allow it to dry completely.
4. In an open area, lay the damaged linoleum over the replacement linoleum. Using a pencil trace pattern onto the replacement linoleum. Do not use a sharpie marker as it will stain and seep through the material.
5. Using heavy-duty scissors or a utility knife cut the replacement linoleum pattern.
7. Install replacement linoleum onto the subfloor and secure it with Air Step Adhesive around the floor openings. Use a small hand roller to embed the linoleum into the adhesive. Ensure the subfloor is dry before installation.
6. Use 1/2" batten trim around cabinet areas for extra security.
