Service Bulletin

Bulletin No.: 24-NA-055

Subject: Removable Sky Panel Creak Pop Snap Noise Hot Interior Temps

Brand:	Model:	Model Year:		VIN:		Engine:	Transmission:
		from	to	from	to		
GMC	Hummer EV Pickup	2023	2024				
	Hummer EV SUV	2024	2024

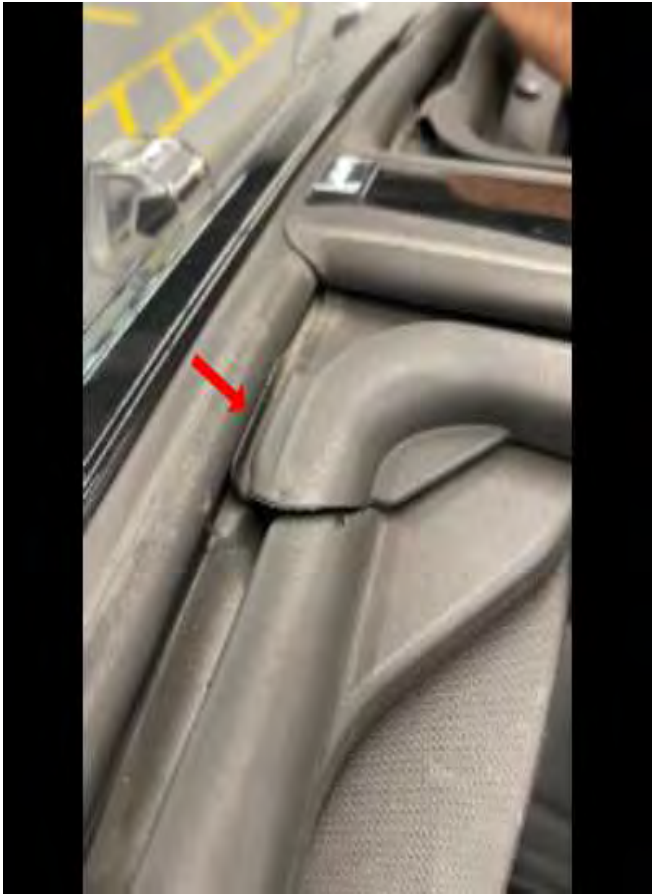
6425394

- Example of an unseated weather-strip. If the weather-strip is left unseated, it can cause water leaks into the vehicle.

Important: Ensure the weather-strip is secured and properly sealed.
